# EERI Earthquake Reconnaissance Team Report: M7.8 Muisne, Ecuador Earthquake on April 16, 2016

Forrest Lanning, Ana Gabriela Haro, Mei Kuen Liu, Alberto Monzón,  
Héctor Monzón-Despang, Arturo Schultz, Adrian Tola

October 2016

*A product of the EERI Learning From Earthquakes Program*

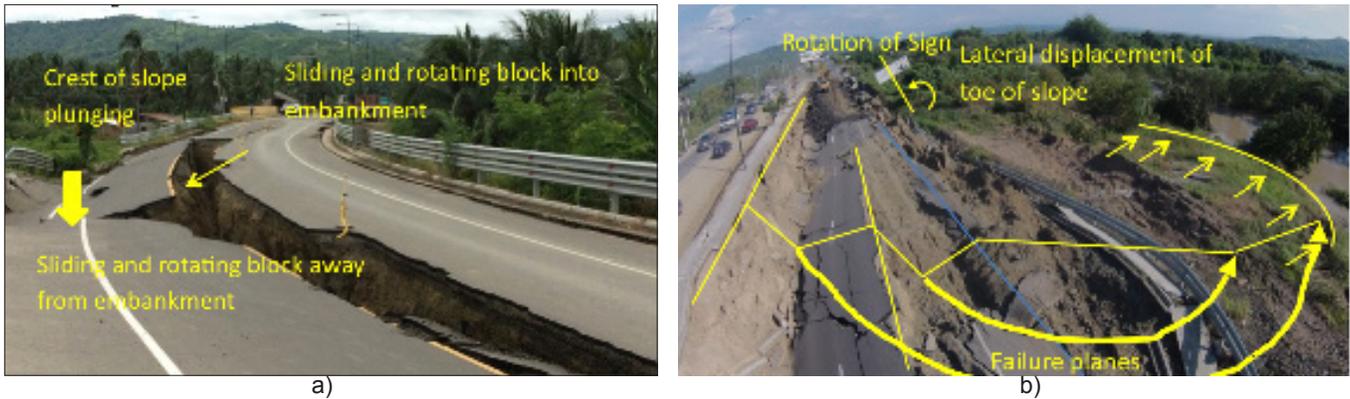
The Rio Chico Bridge had several modes of failure acting on the embankment. We observed large coherent cohesive blocks settle, slide, rotate and in several cases present a combination of these modes, which became evident with measurements of large cracks and displacements. At the Mejia Bridge the embankments appeared to have failed in a general global stability mode and damage was mostly found on the south embankment. Most of the damage to the bridge, walls, and embankments was focused on the south approach. There was some instability on the north side but it was relatively minor. Figures 2-5 shows some important observations.

Figure 2-5. Failure Modes of Embankments (a) Rio Chico Bridge ( $0^{\circ} 58' 38.09''S$ ,  $80^{\circ} 25' 25.67''W$ ); (b) Mejia Bridge ( $0^{\circ}59'24''S$ ,  $80^{\circ}28'11''W$ ) (photos: COE-3).

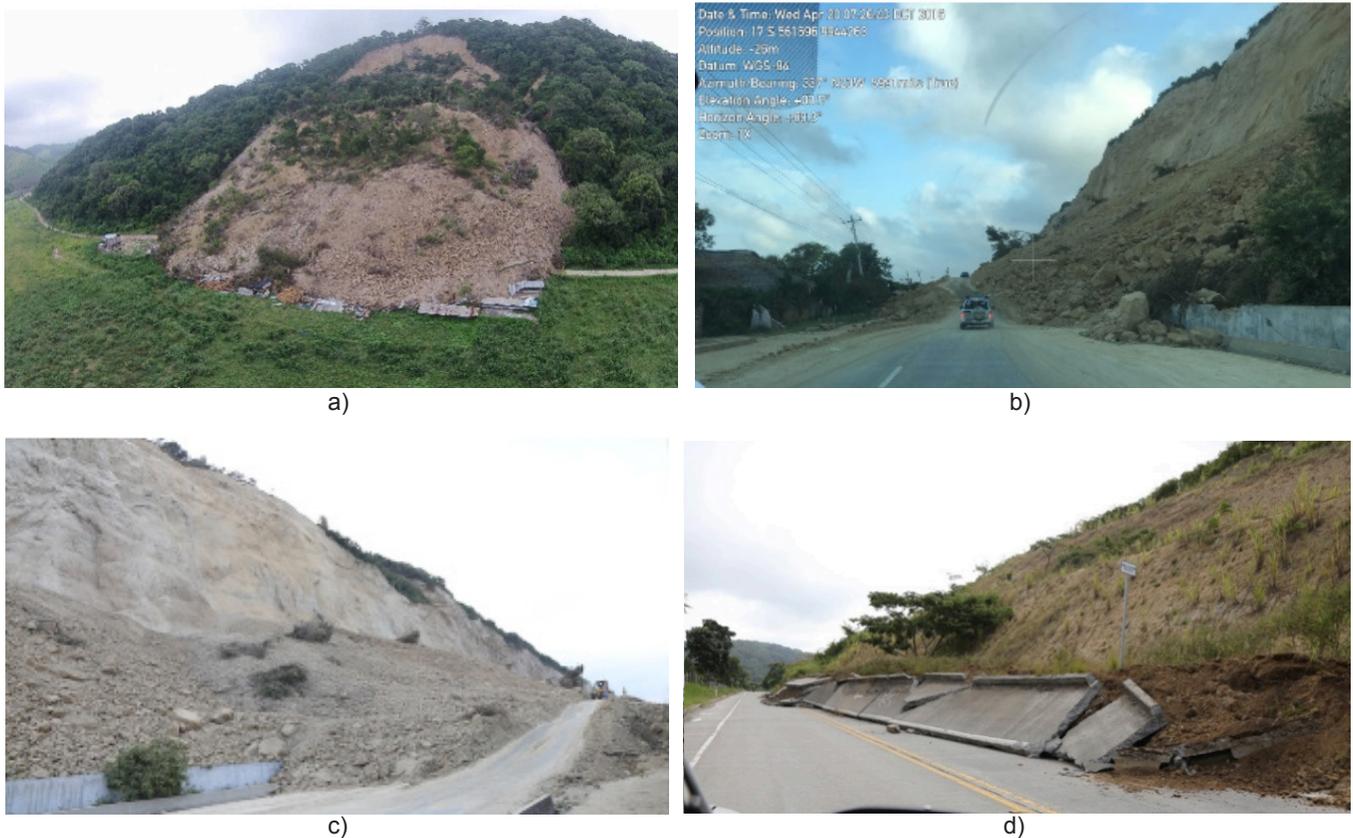
The Ecuadorian Emergency Operations Committee (COE3) recorded hundreds of landslides and rock falls along the west coast of Ecuador. The GEER-ATC team was able to identify many of them in the west roads between Manta and Pedernales. It was observed that, in general, roads along the Ecuadorian coast do not have any type of slope reinforcement, and that, if needed, a protection wall is built to safeguard the roads. The only slope treatment is typically flattening, which explains why landslides was such a common type of failure. Typical observed landslides and rock falls are shown in Figure 2.6.

Figure 2-6. Typical landslides and rock falls in Ecuadorian west coast roads: (a)  $0^{\circ} 33' 5''S$ ,  $80^{\circ} 25' 42''W$ ; (b)  $0^{\circ}30'15''S$ ,  $80^{\circ}26'44''W$ ; (c)  $0^{\circ}30'15''S$ ,  $80^{\circ}26'44''W$ ; (d)  $0^{\circ}25'44''S$ ,  $80^{\circ}26'59''W$  (photos: COE-3).

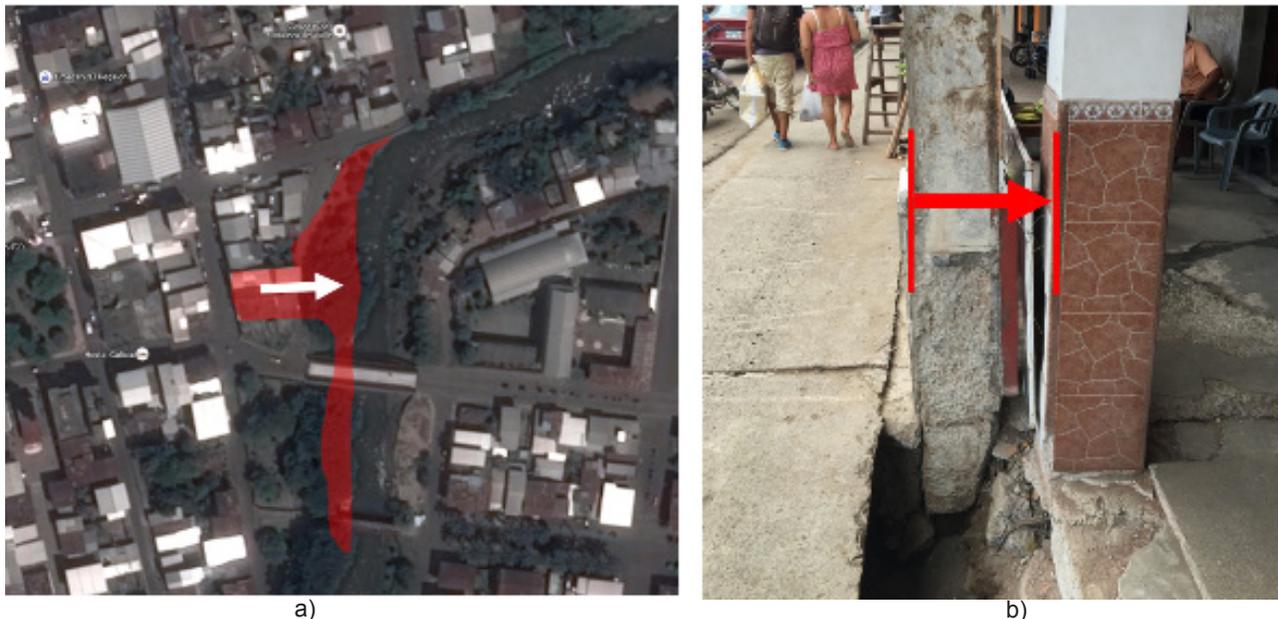
The column on Figure 2-15b laterally displaced 50 cm to the right, while the column on the left, which is part of the neighboring building remained relatively still.

Figure 2-15. (a) Area of lateral displacement (Image: Google Earth ©2016); (b) Lateral displacement of building.

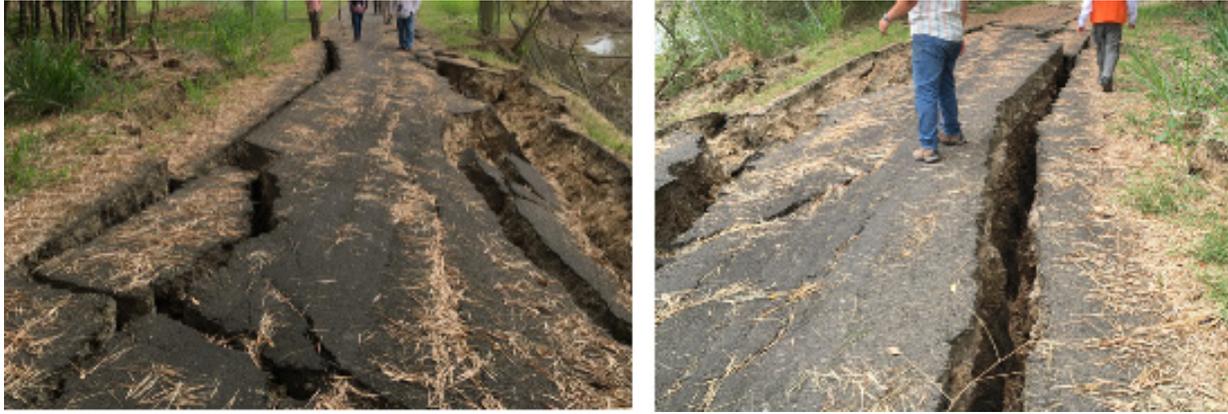
Outside of the town of Calceta, the team visited the Coliseum Manuel Felix Lopes at the Escuela Superior Politecnica Agropecuaria de Manabi. The coliseum sites within is 40 m of tributary of the the Rio Carrizal. Both Lateral spreading and liquefaction were observed in and around the coliseum, as shown on Figures 2-16 and 2-17. Figure 16 shows damage on access road. Figures 2-17a and 2-17b illustrate laterally displacement of 25cm and vertical displacement of 24cm in coliseum due to lateral spreading and liquefaction in the soils under the foundation.

Figure 2-16. Lateral spreading along the roadway to the coliseum.

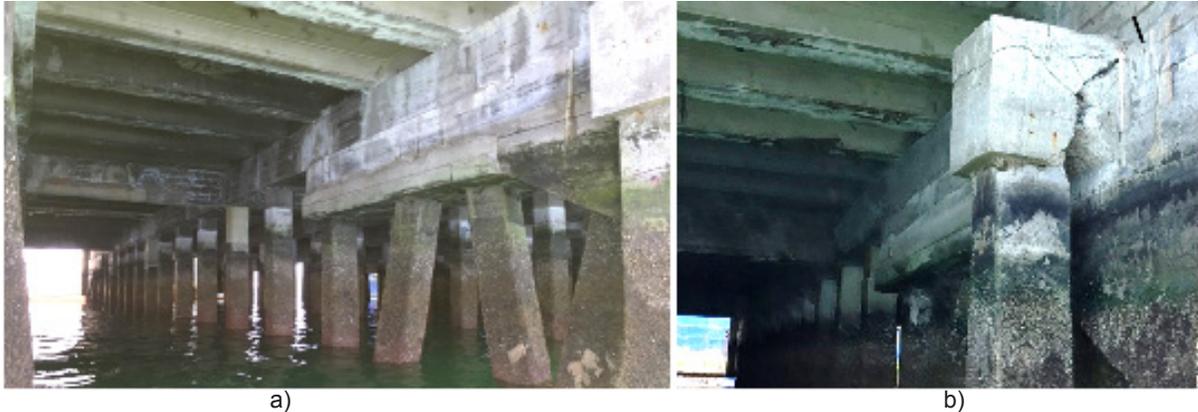
Figure 2-20. (a) Relatively undamaged rows of piles supporting the two piers on the northern end of the port and (b) shear cracking in shear beam attaching adjacent pile to pile cap (GPS coordinates: 0° 55' 58.2" S, 80° 43' 18.8" W)

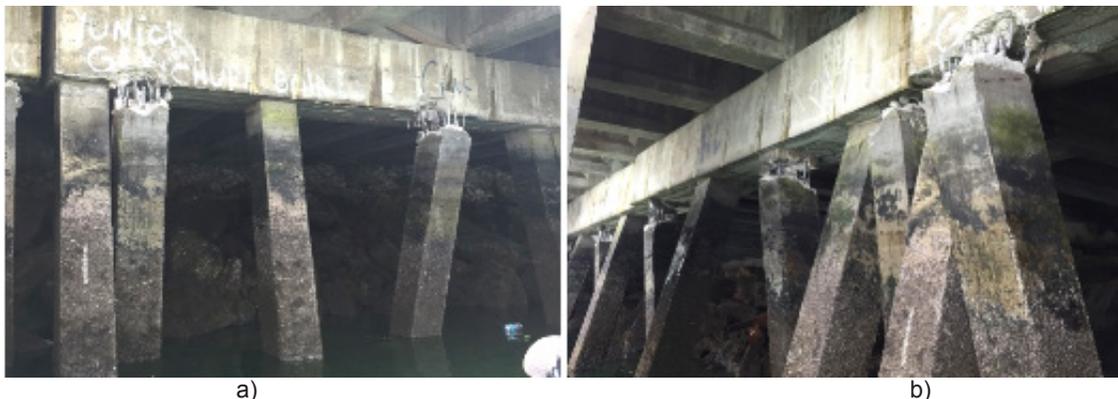
Figure 2-21. Photos showing cracking and shearing of pile head connection for piles with backward batter in comparison with minimal damage to piles with a forward batter at two locations along the wharf. (a) GPS coordinates: 0° 56' 14.42" S 80° 43' 27.41" W (b) 0° 56' 14.22" S 80° 43' 27.32" W

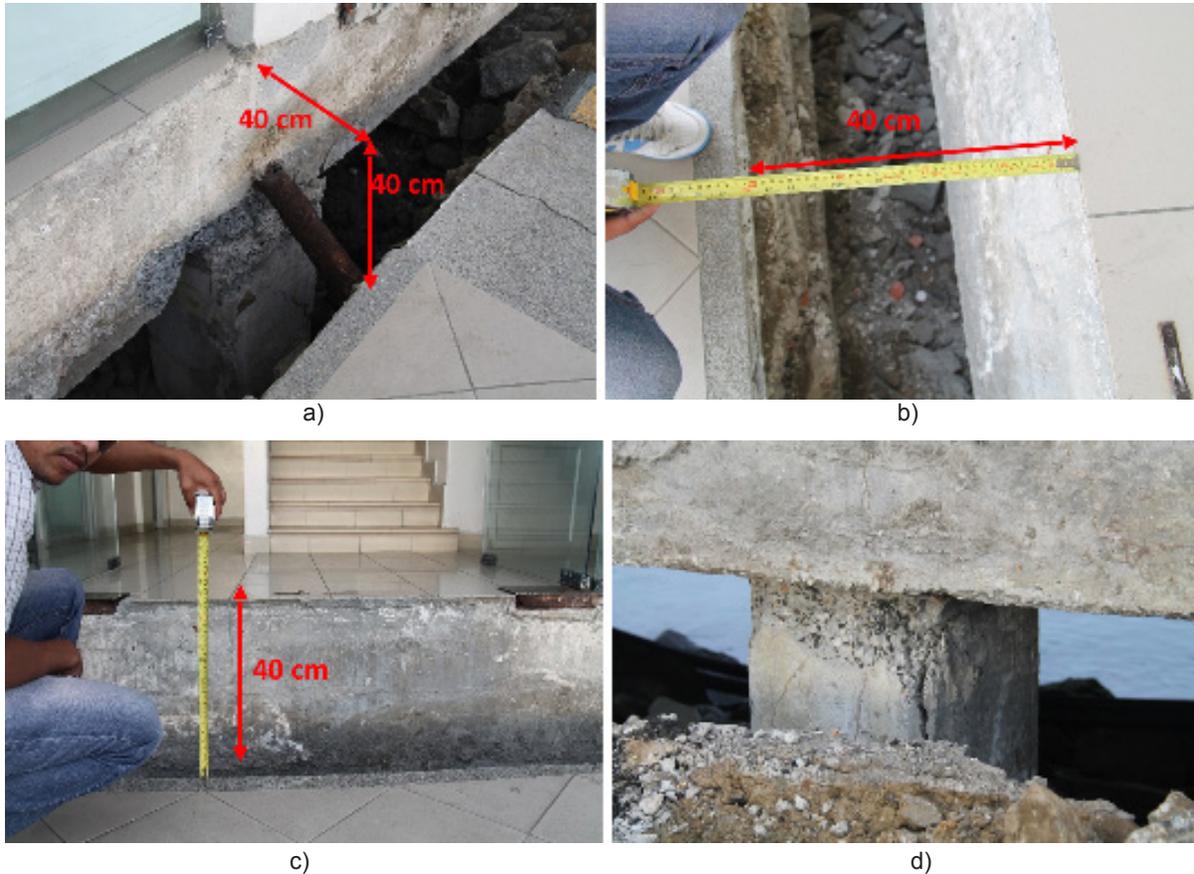
Figure 2-22. (a) Horizontal and vertical displacement of embankment relative to the building; (b) horizontal relative displacement between building and embankment; (c) vertical settlement of the embankment relative to the pile-supported building; (d) damage in the head of the building's pile (GPS coordinates: 0° 55' 55.2" S 80° 43' 19.56" W)

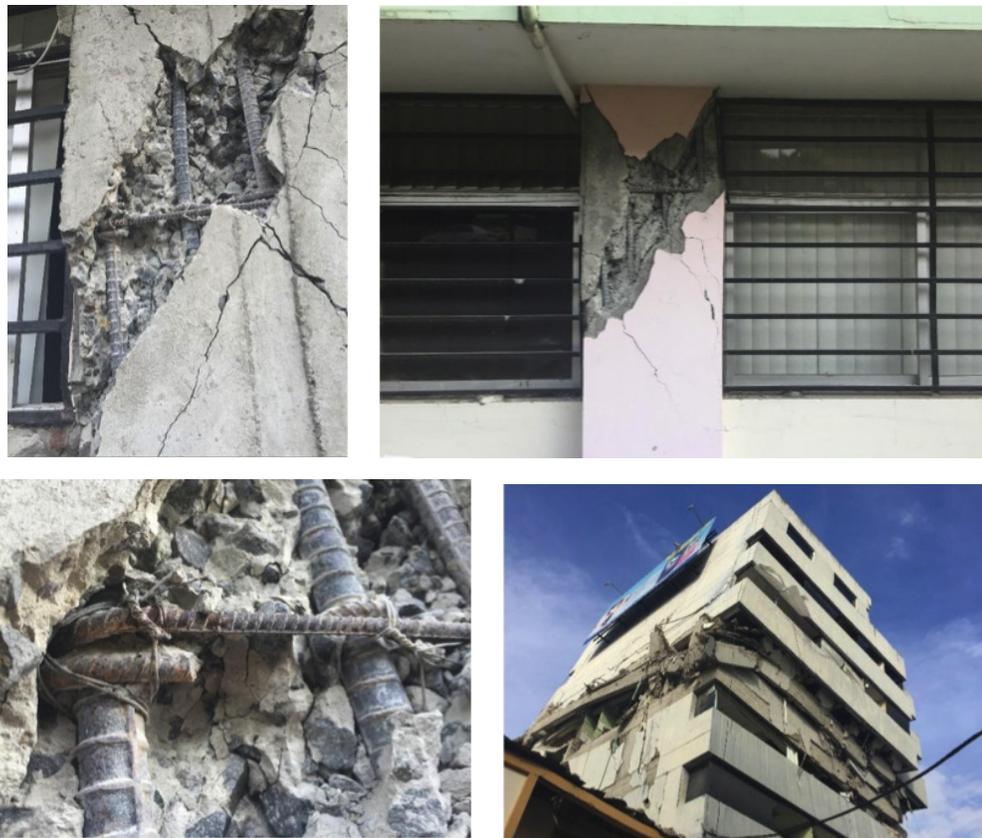
*Figure 3-1. Top left: Short exterior column of the Applied Sciences Faculty Building of Portoviejo's National University; damage caused by partial height masonry walls on adjacent sides of the column. Top right: Enlarged view of the column damage, showing large tie spacing and poor concrete quality. Bottom left: Seismic hooks on confinement hoops are nonexistent in most frame columns. Bottom right: Inadequate transverse confinement reinforcement may have been a contributing factor for the collapse of this mid-rise building in Portoviejo.*

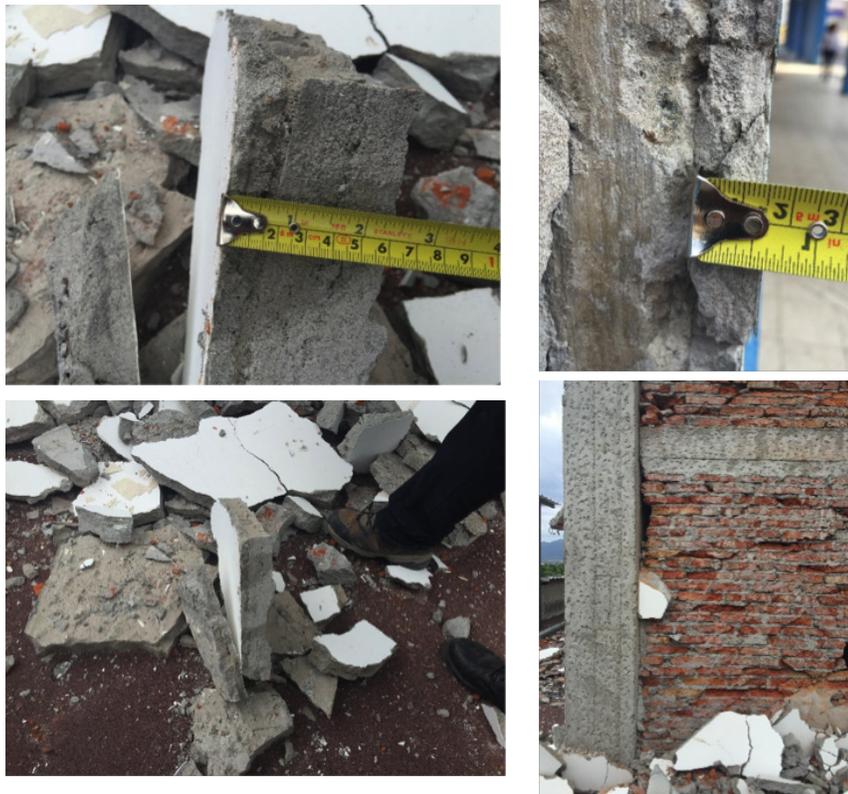
Figure 3-2. Left: Thick mortar finish for vertical alignments. Thickness of this mortar reached up to 6 cm. Right: Debris caused by unbraced infill walls to the main structure.

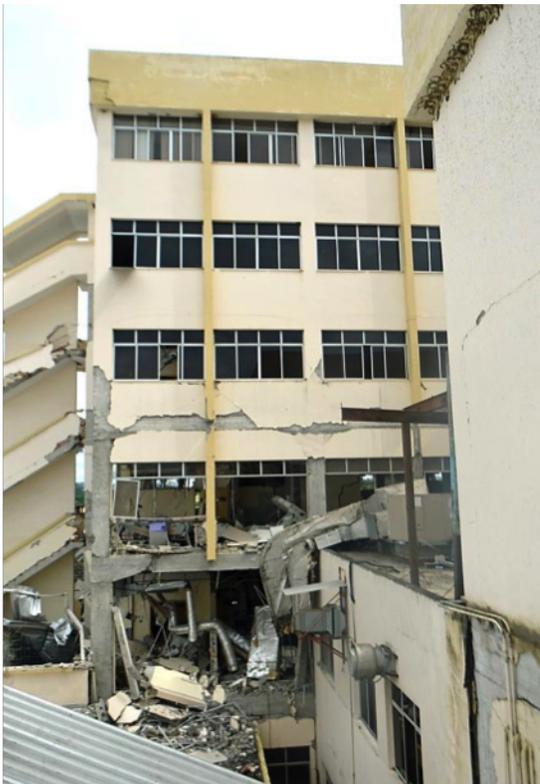
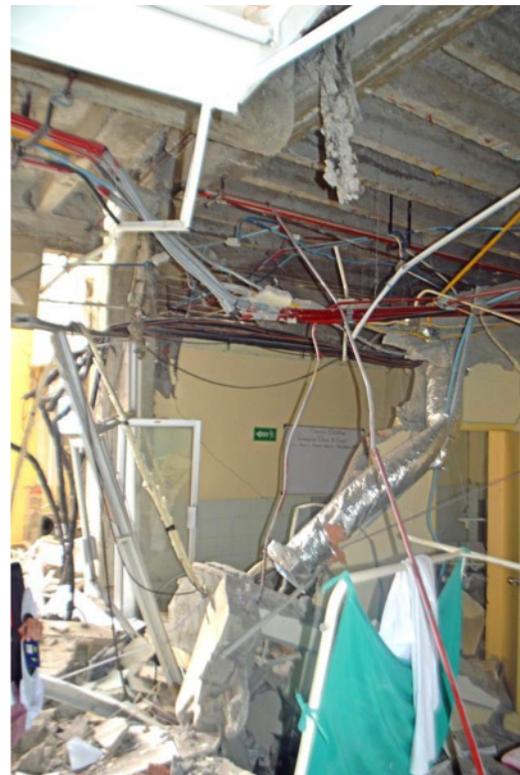
Figure 3-6. Left: Hospital in Chone. Consequences of pounding between structural units, Main building at background pounded against two-story unit seen in middle ground. Right: Hospital in Chone. Severely damaged interface along narrow joint due to impact between structural units

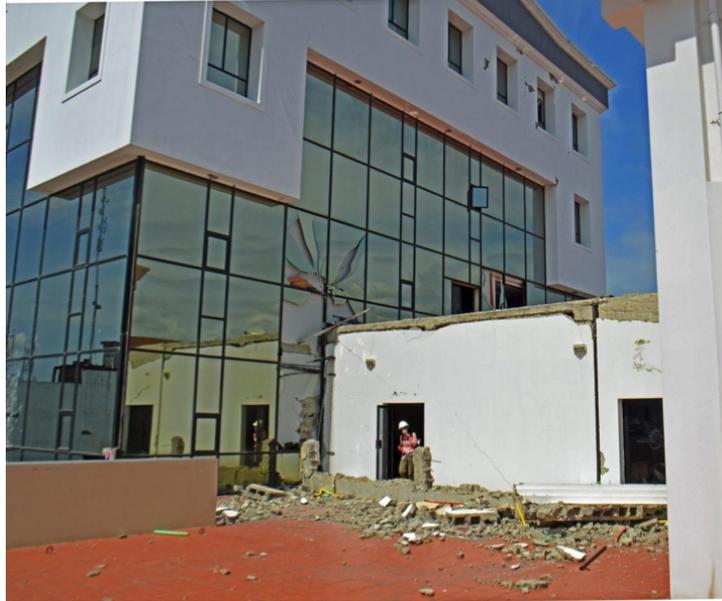
Figure 3-7. Main Judiciary Building in Portoviejo. Minor structural unit wedged between two larger units. The 5 cm gaps were too narrow during the seismic event. All three units underwent severe interior damage. The consequences of pounding are apparent in the glazing. A heavy ledge on the small unit collapsed.

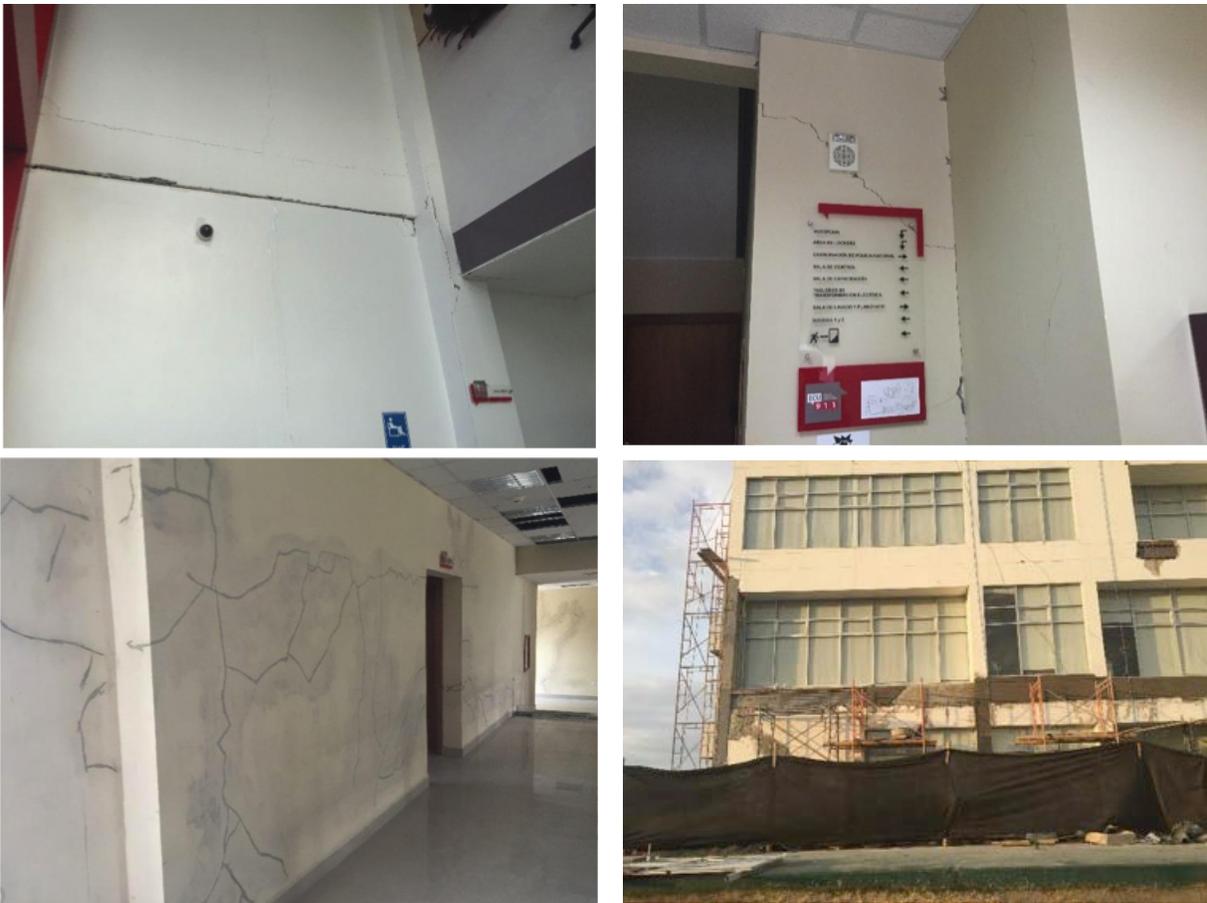
Figure 3-9. Damage in Portoviejo's 911 Centre was minor and primarily in nonstructural elements. After the earthquake, repairs began in the partition walls and the steel cladding, which is made of cement plaster (photos: Forrest Lanning).

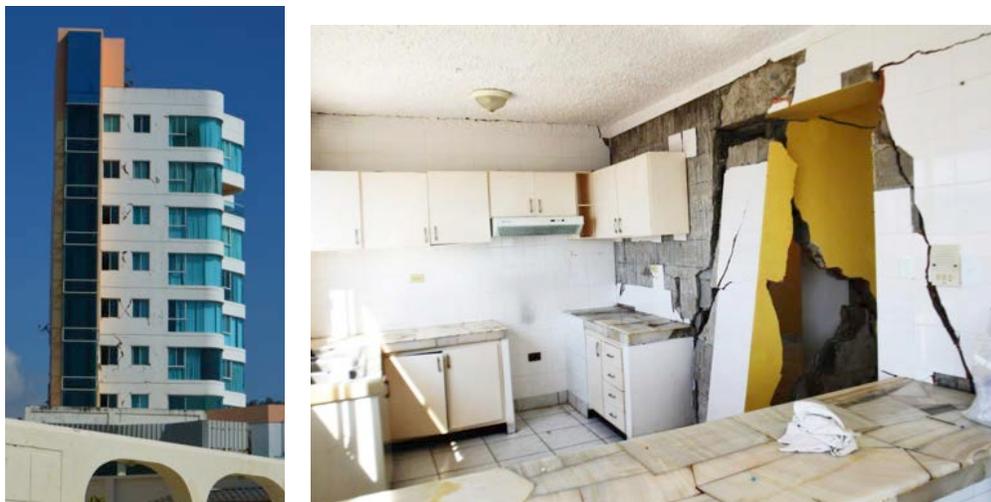
Figure 3-11. While the building exterior appears undamaged, there was heavy interior partition damage and some facade damage (photo: Hector Monzón).

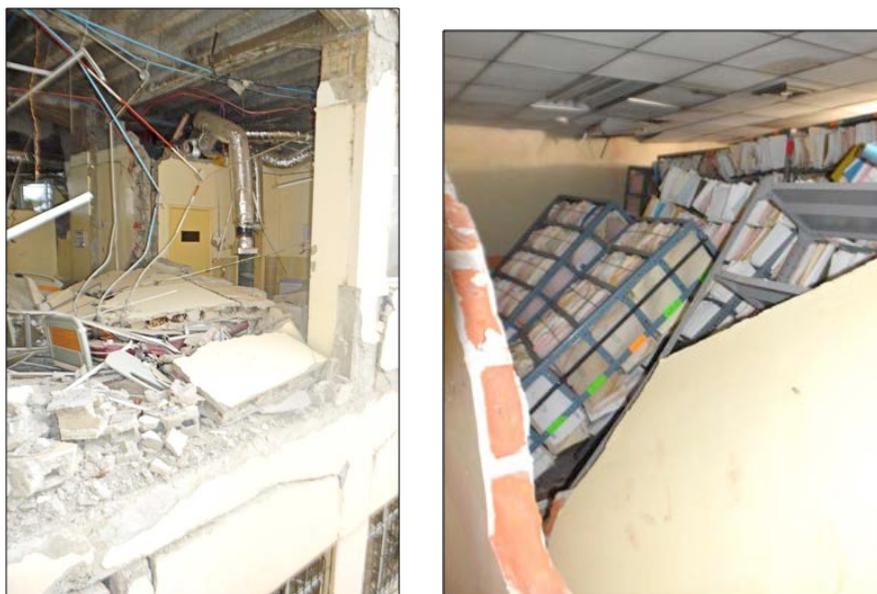
Figure 3-12. (Left) Partition and hanging ceiling collapsed on an unoccupied bed in a Hospital in Chone; (Right) Unreinforced partition collapse and facade panel on hospital records in Bahia de Caraquez Hospital (photo: Hector Monzón).

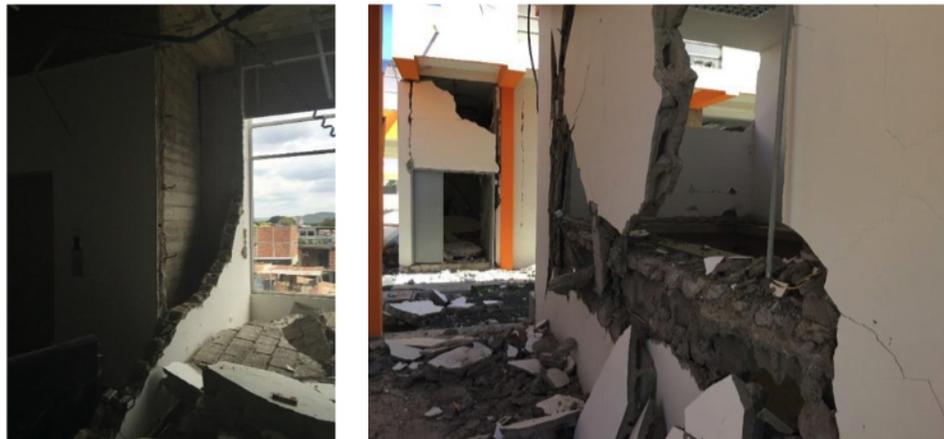
Figure 3-13. Left: Typical interior masonry wall in the Justice Building in Portoviejo. Use of unreinforced masonry is a normal practice. Right: School building in Bahía de Caraquez. Two-story buildings made of small concrete frames with masonry infill with extensive damage.

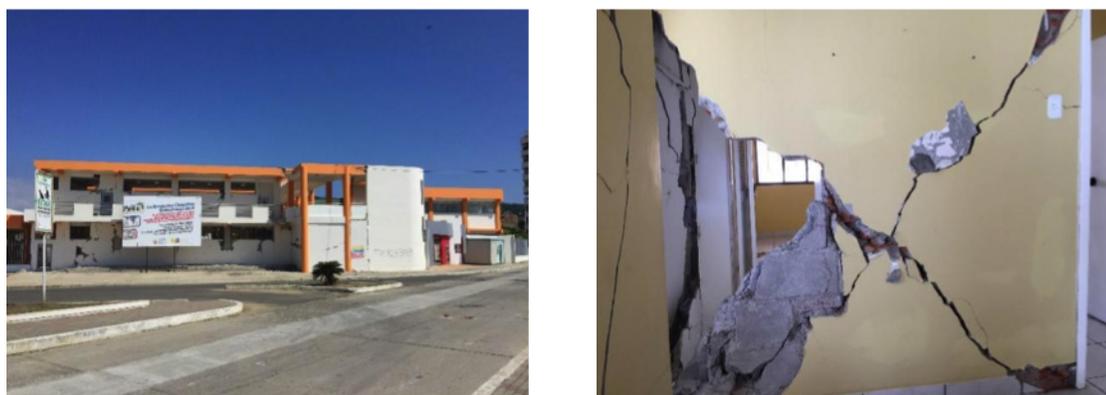
Figure 3-14. Left: Public school building in Bahía de Caraquez, showing visible damage in infill walls. Right: Masonry infill in a private, mid-rise residential building in Bahía. There are two types of masonry materials: the older masonry is fired-clay masonry, the 1998 earthquake partially destroyed the panel. Concrete masonry was added to repair the partition, no reinforcement was added in the repair.

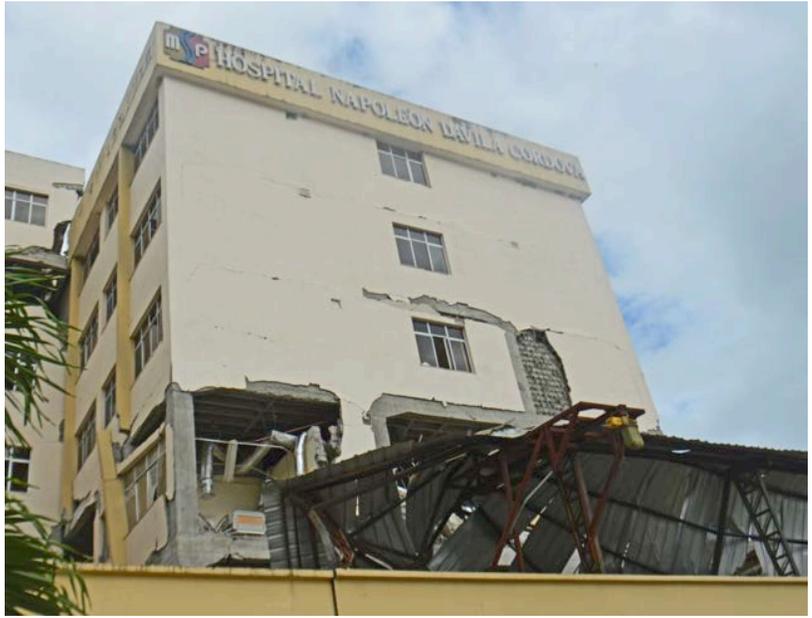
Figure 3-15. Left: Apartment building in Bahía. Unreinforced and poorly anchored masonry facade panels collapsed or cracked. Right: Inadequately anchored masonry panels collapsed on an ambulance parking canopy roof (photo: Hector Monzón).

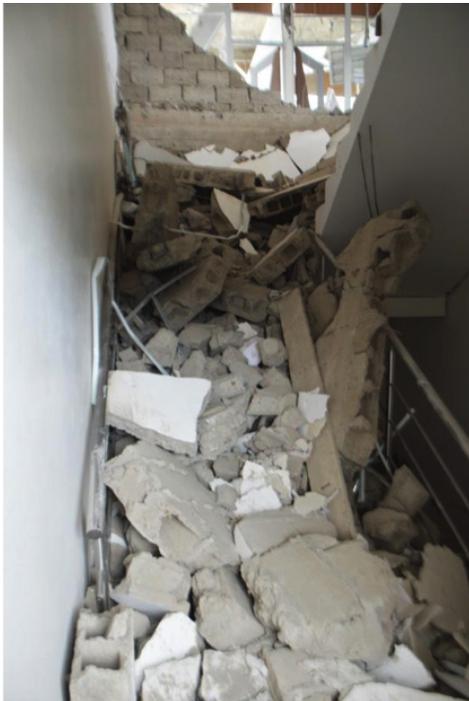
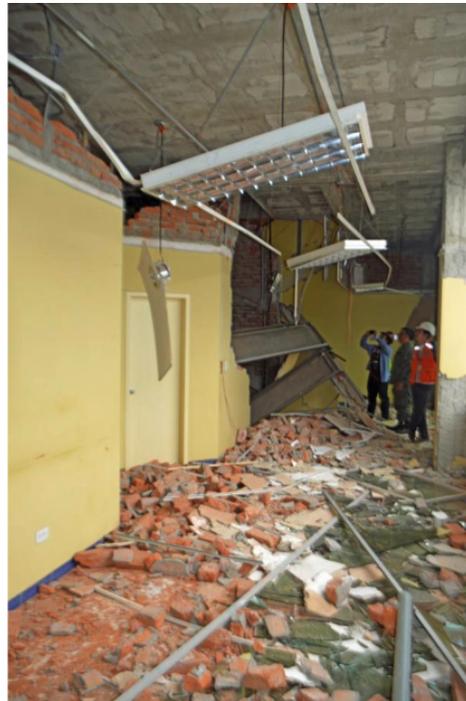
Figure 3-16. Left: Public building in Portoviejo. Staircase enclosure walls collapsed due to inadequate reinforcement in a frame building without structural damage. These were the only exit stairs. Fortunately, no injury was caused because the earthquake took place on a Saturday evening. Right: Oncology Unit Portoviejo: The corridor leading to the only exit stairs and elevators. Brick debris was ground from the top of unreinforced, unbraced masonry partition. The debris is mixed with large non-tempered glass shards from a large window (not seen) at right.

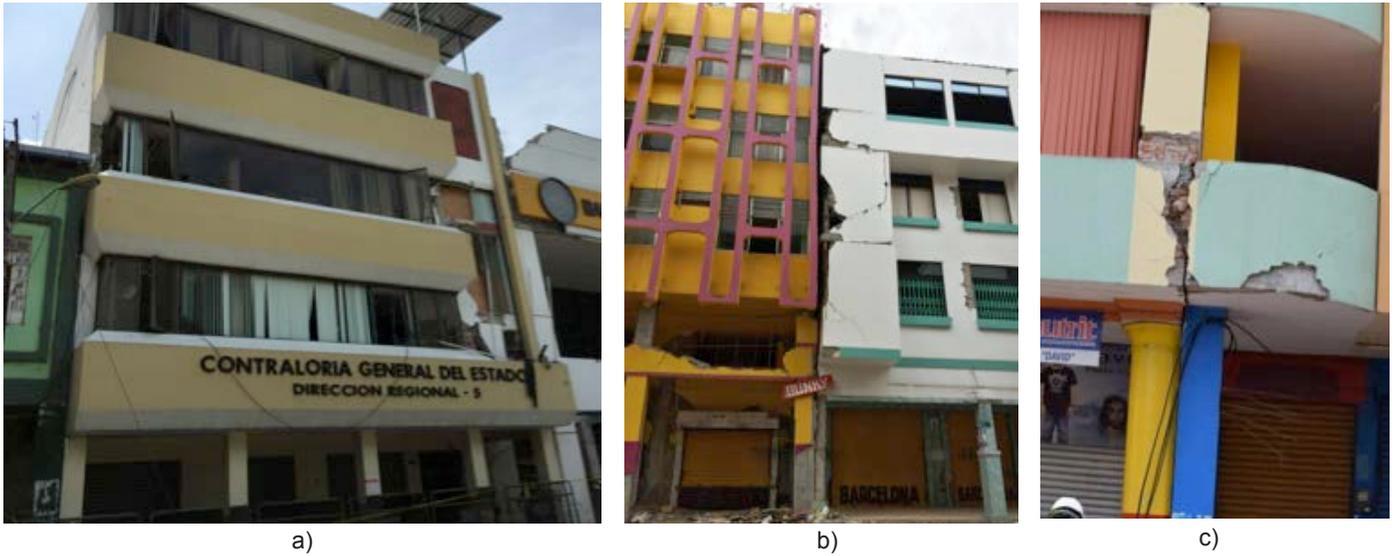
Figure 3-36. Pounding between buildings: a) Contraloría General del Estado building affected by two adjacent structures; b) adjacent slabs at different heights; c) restricted differential movement. (photos: Ana Gabriela Haro and Arturo Schultz)

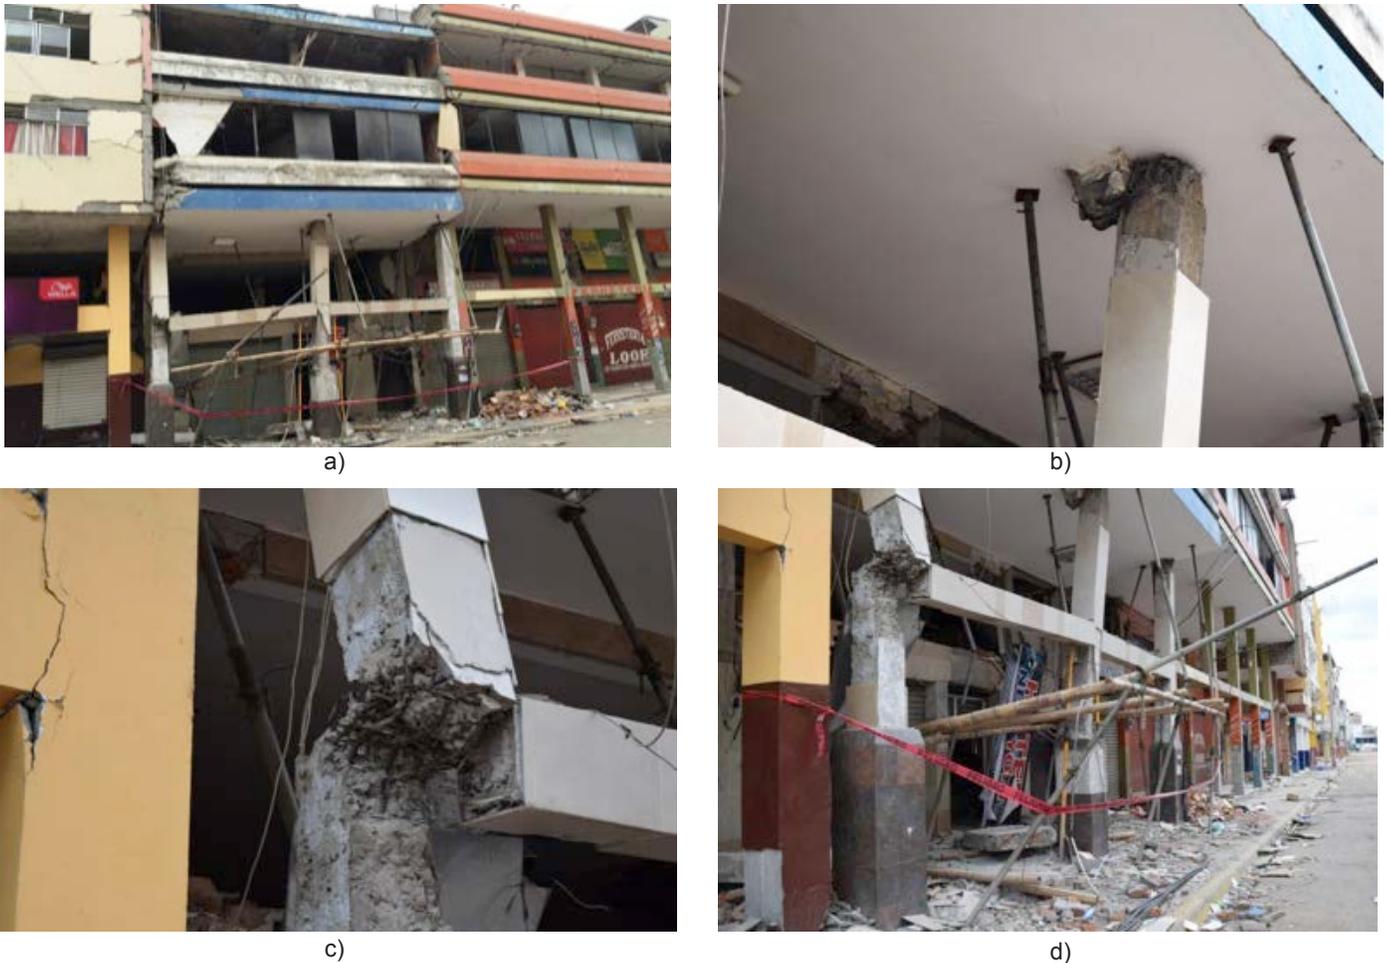
Figure 3-37. RC three-story building partially collapsed: a) general view of the structure; b) column failure; c) joint failure and beam detail; d) attempt to prevent total collapse. (photos: Ana Gabriela Haro and Arturo Schultz)

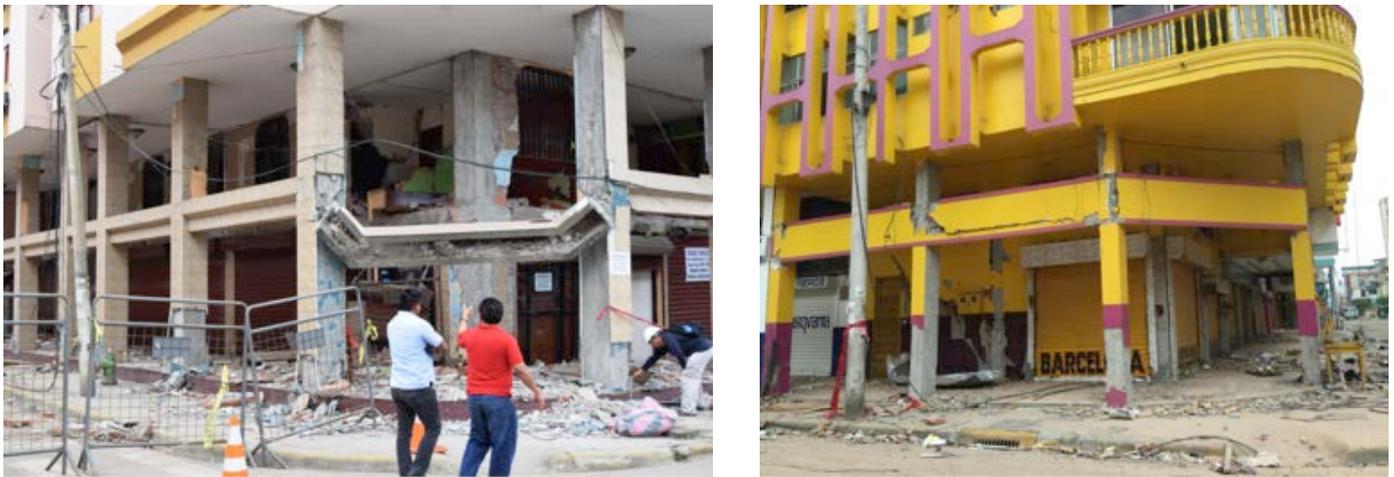
Figure 3-38. Beam-column connections damage. (photos: Arturo Schultz and Ana Gabriela Haro)

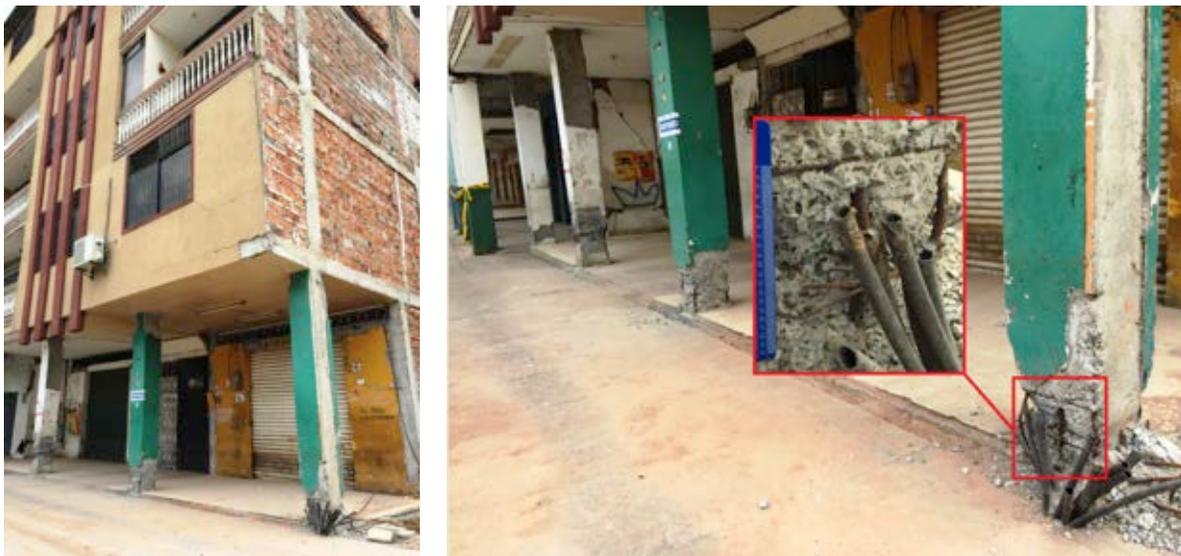
Figure 3-39. Plastic hinges evidenced in a five-story RC building. (photos: Ana Gabriela Haro)

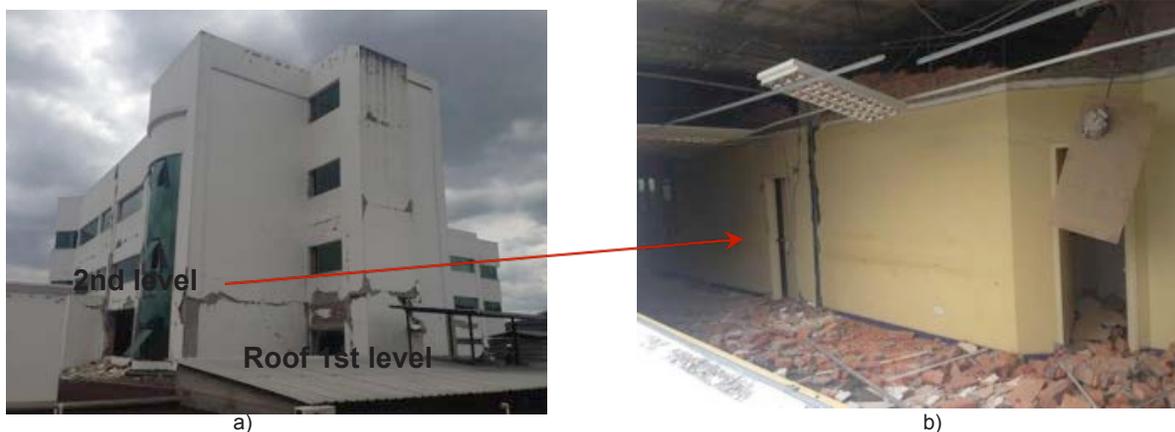
Figure 4-5. Damage in the walls in the first two floors in Hospital SOLCA (photo: Adrian Tola).

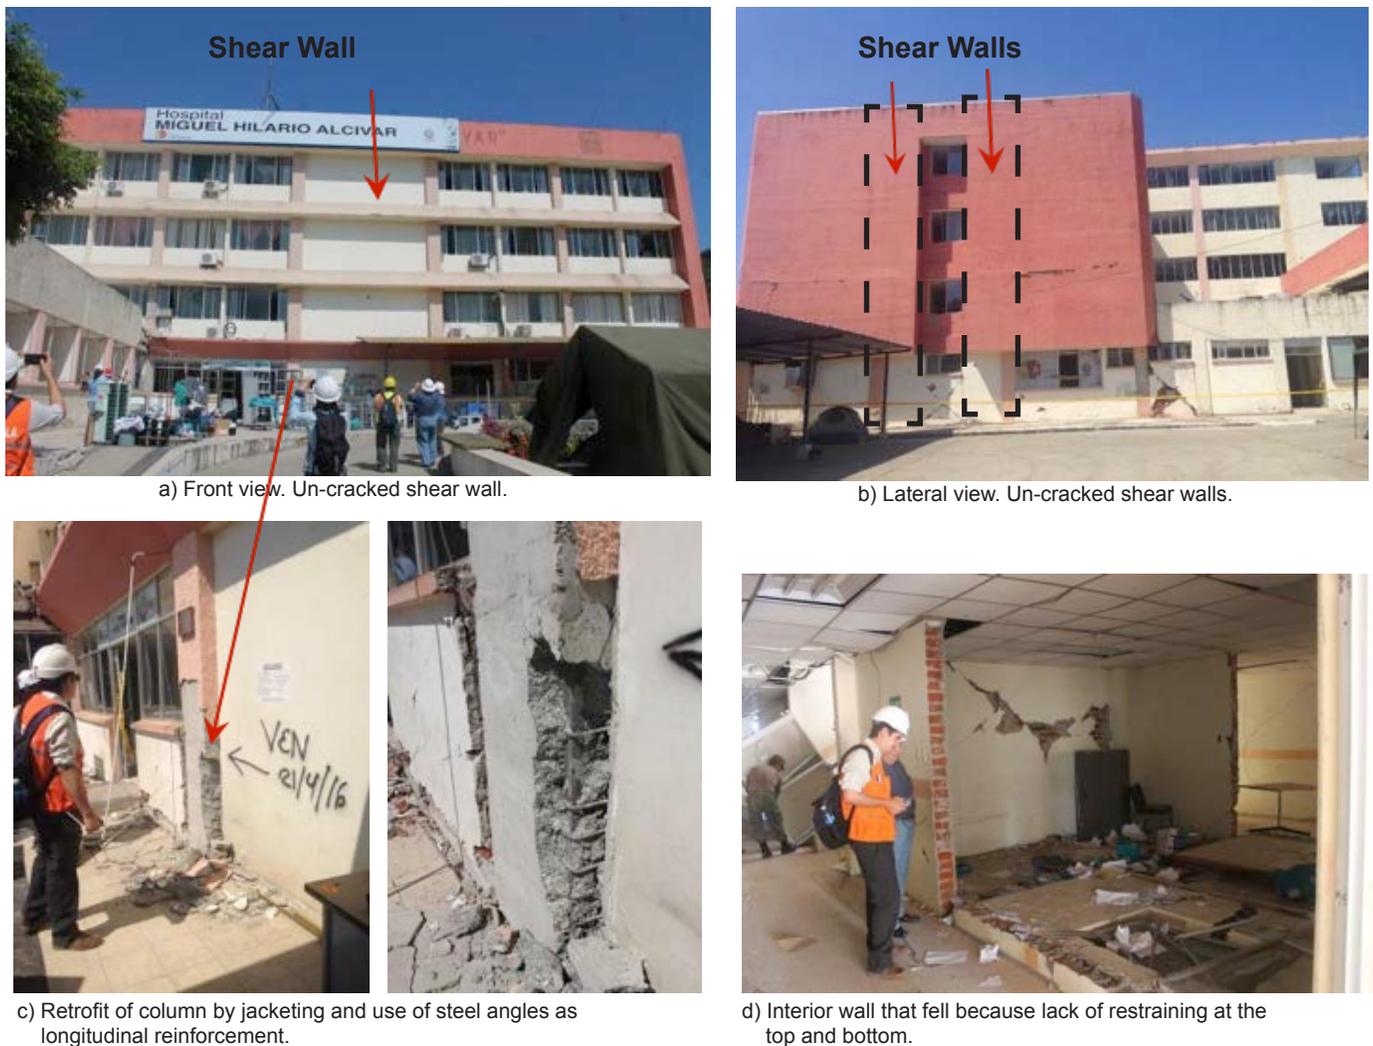
Figure 4-7. Damage in Hospital Miguel H. Alcívar in Bahía de Caráquez (photo: Adrian Tola).

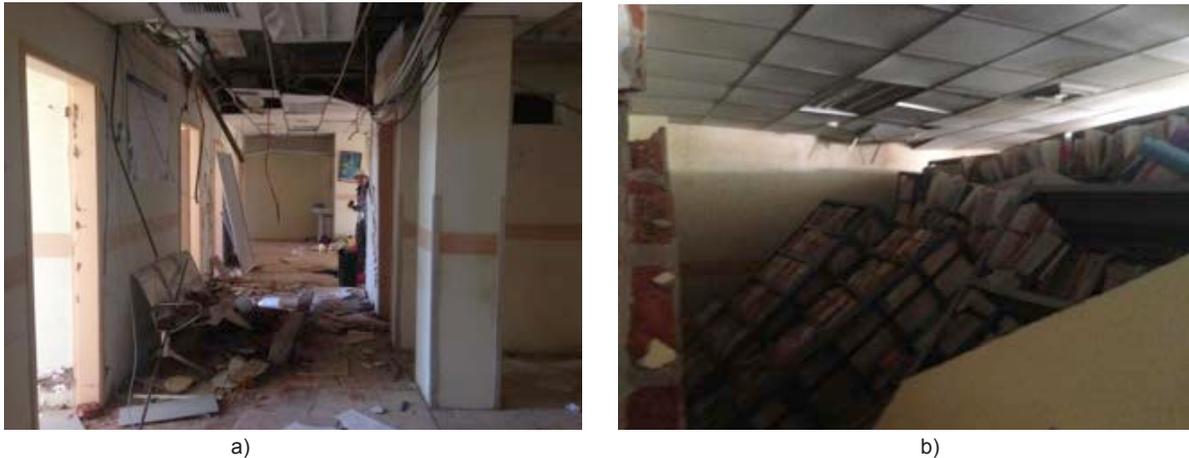
Figure 4-8. Damage in non-structural components in Hospital Miguel H. Alcívar (photo: Adrian Tola).

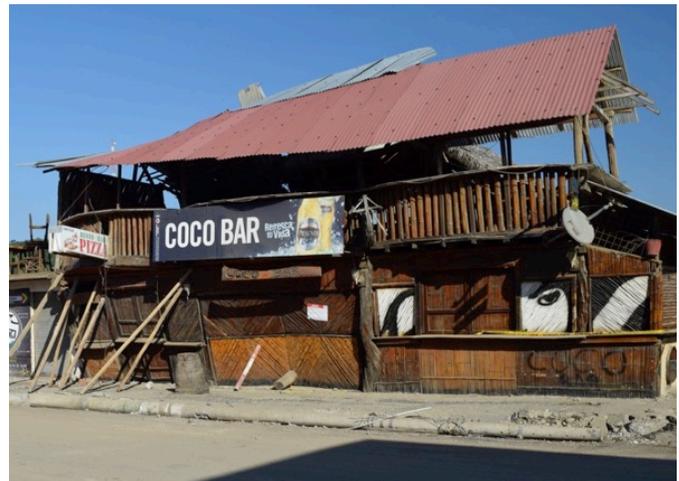
Figure 5-8. Failed façade of bamboo building in Canoa (photo: Arturo E. Schultz).

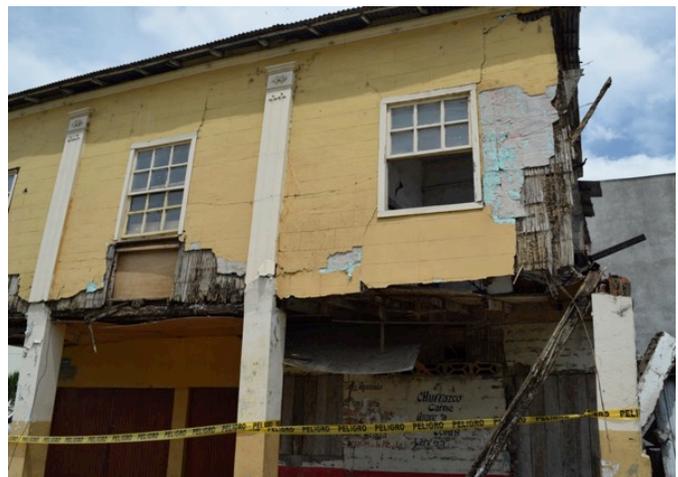
Figure 5-12. Deteriorated bamboo laths and timber posts and beams (photo: Arturo E. Schultz).

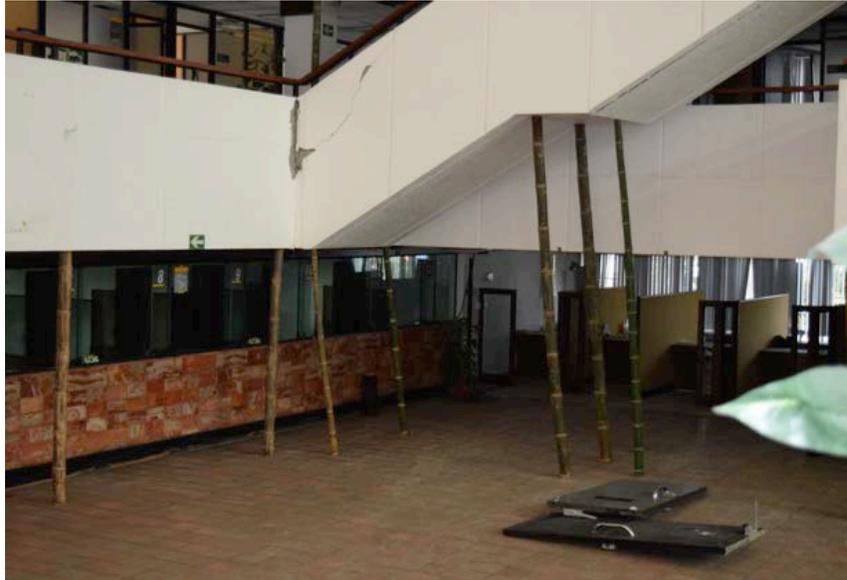
Figure 7-10. Cracking damage to staircase (photo: Arturo Schultz)
