LANDSLIDE INVENTORY IN AN URBAN SETTING IN THE CONTEXT OF CHITTAGONG METROPOLITAN AREA, BANGLADESH

Appendix A: Detail Landslide Inventory of Chittagong Metropolitan Area

Appendix B: A Sample of Detail Inventory

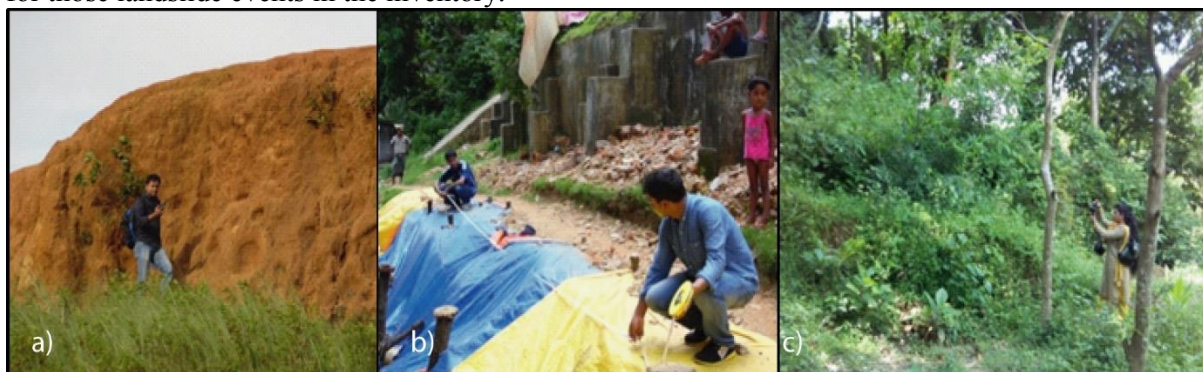
Figure 1: Field Survey (a) Taking GPS measurement (Latitude, longitude, and elevation) (b) Measuring displacement of mass, (c) Taking Photographs; Source: Field Survey, August, 2014

During the field survey, it was difficult to identify the exact landslide occurrence locations. Landcover alteration process remove the signature of landslides. In this field visit, information on location name, coordinates (latitude, longitude), area of displacement mass, rainfall information, landslide mechanism (type of movement, state, distribution, style, water content, material), existing land cover/ use type, causes of movement, landslide history (date of occurrence, duration of rainfall), consequences (casualties, injuries, damages, impacts) and future risk of landslide were collected as much as was available. Location name was collected by interviewing people. Coordinate values of landslide locations was determined by using GPS [Fig.1-a]. In case of some restricted/unreachable places, information was collected through interpreting Google earth image. The displacement of mass has been measured where possible [Fig.1-b]. Ground photographs of landslide site taken during field visit has also been added to the inventory [Fig.1-c]. Besides, landslide mechanism, causes of movement, landslide history and consequences have been collected from the local people as the collected documents could not provide sufficient information. The daily rainfall during and before the event from Bangladesh Meteorological Department is added to the inventory. However, for some landslide events, the exact date could not be found, as a result the rainfall data could not be provided for those landslide events in the inventory.

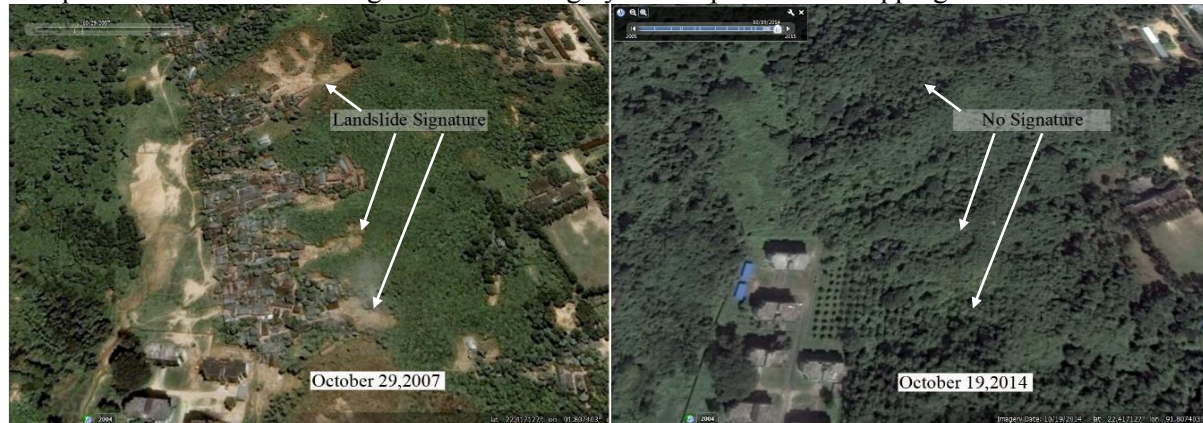
image. The visual image interpretations technique has been applied to draw the polygon around the displacement mass. The figure 2 shows Kaichaghona area near Chittagong cantonment where a devastating landslide in June 2007 took many lives from foothill slum. Documentation of such landslide events in these restricted area is much more challenging. The remote sensing imageries are useful to deal with these challenges. Landslide signature extraction from visual or digital interpretation of remote sensing time series imagery can help landslide mapping.

Figure 2: Image shows the signature of October 29, 2007 landslide (left) and the current situation during field visit in October 19, 2014 (right); Source: Google Earth

Many landslides have been identified, however some of the information was difficult to find, for instance the surface area of displaced mass. The signatures of past landslide have been removed through land cover alteration and morphological change [Fig.2]. The goal is to draw the polygon of displacement mass to support landslide studies based on landslide density (e.g. empirical modelling such as information value, weights of evidence). The Google Earth time slider tool is providing free access to fine resolution (pan-sharpened submeter originally 2.5m DigitalGlobe image) historic

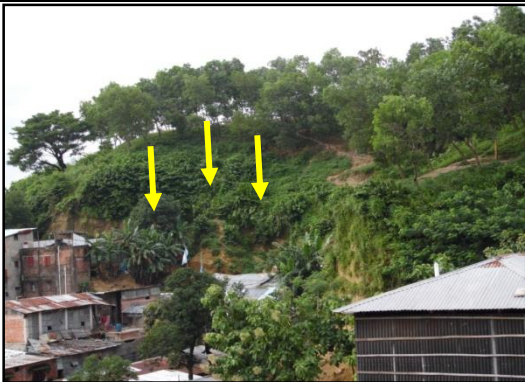
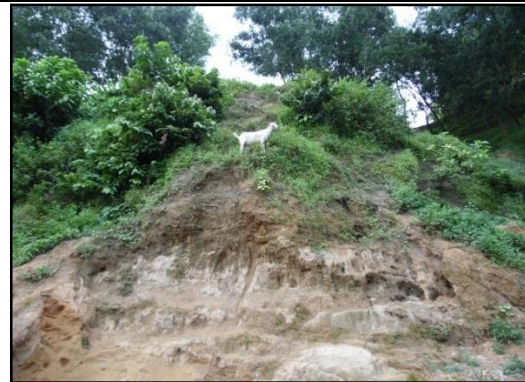
Basic Information	
<p>Landslide ID : 05 Landslide Location: Tanker Pahar, Motijhorna Coordinates: 22° 20'54.27"N, 91° 48'51.60"E</p>	<p>Datum: WGS 1984 Elevation (m): 41.18 Area of Displaced Mass (sqm): 331.84 Rainfall: Unknown</p>

<p>Source: <i>Field survey, August 2014</i></p>
Landslide Mechanism	
<p>Type of Movement: Slide State: Active, Reactivated, Suspended Distribution: Advancing</p>	<p>Style: Single Water Content: Moist Material: Soil/Earth</p>
<p>Land Cover/Use Type (%): Herbaceous vegetation is the Primary land cover of Tanker Pahar. Forest/ woodland type is also visible in this hill.</p>	
<p>Causes of Movement: Hill cutting is the major issue that caused landslide in this area and intense rainfall acted as a triggering factor for landslide.</p>	
Land Slide History and Future Risk of Landslide	
<p>Landslide in this site occurred in 1982, 1989, 1991, 1994, 1996 and 2013. 10 houses got damaged and almost 22 people died due to landslide at different periods. Utility facilities were highly damaged in this incident. Economic activities were hampered so does the social life of people. Environment has been found to be severely damaged. Still there are many houses located at the down slope of the hill. Soil of this site has been found to be sandy. The escapement slope is found to be near vertical. The failed mass is a part of upper portion. Vertical Slope characteristics can be considered as a contributing factor to future landslide for this hill. Settlements located at the down slope of this hill are at a huge risk of massive landslide. The risk is high (Field survey, August 2014).</p>
