# EERI Earthquake Reconnaissance Team Report: M7.8 Muisne, Ecuador Earthquake on April 16, 2016

Forrest Lanning, Ana Gabriela Haro, Mei Kuen Liu, Alberto Monzón,  
Héctor Monzón-Despang, Arturo Schultz, Adrian Tola

October 2016

*A product of the EERI Learning From Earthquakes Program*

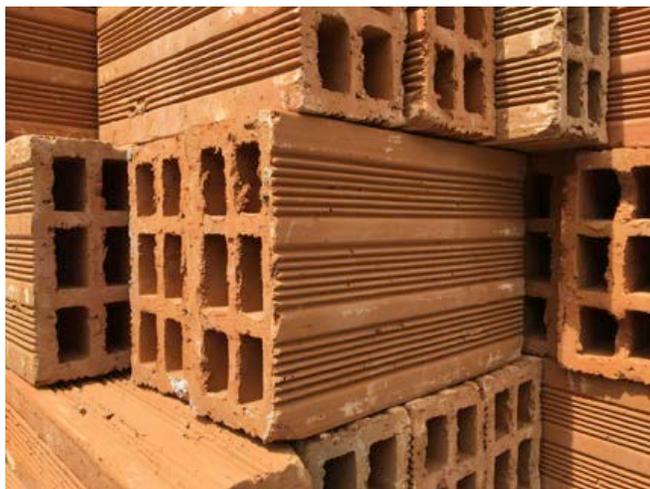
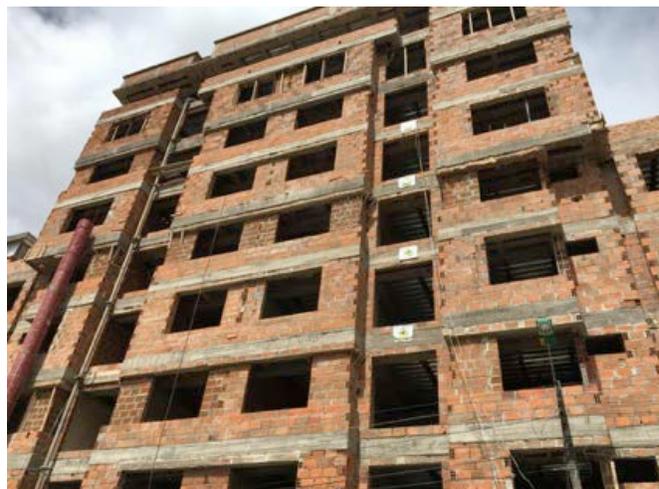
Figure 1-3. Typical masonry used for wall infill on reinforced concrete framed buildings.

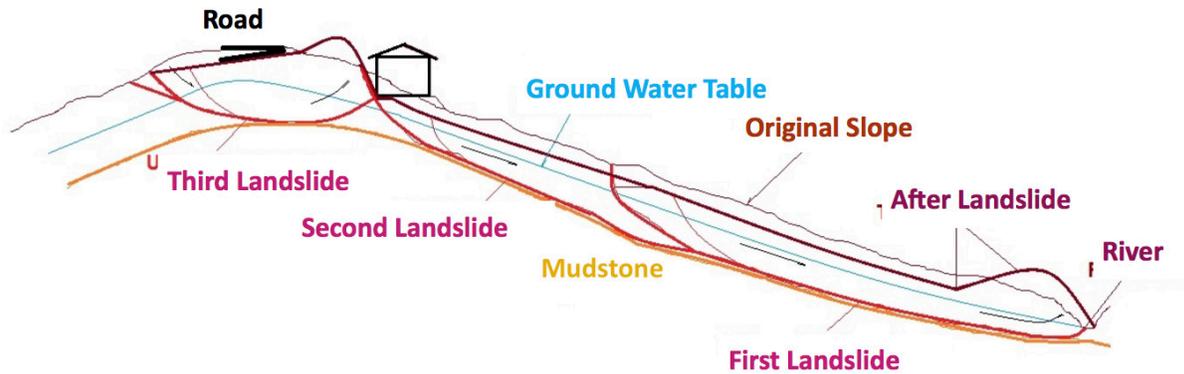
Figure 2-7. Scheme of succession of landslides at Loor Site (image: Ripalda 2016b).

The main event triggered a first landslide that affected the inferior zone of the slope, and possibly the middle zone as well. This first landslide seemed to be translational at the top and rotational at the base of the slope. The translational portion is evident due to lateral movement of soils, with standing trees that didn't lose their verticality. The rotational portion showed rotated and fallen trees, and earth lifting at the base stopping at the river. This first landslide left the upper portion, where the house and barn were located, without support, leading possibly to a second landslide almost instantly.

The second landslide was triggered seconds after the first one. Earth lifting at the west of the house, rotation of the house, and cracks through the house and barn were observed after the second landslide.

A third landslide took place in a rotational mechanism at the head of the slope.

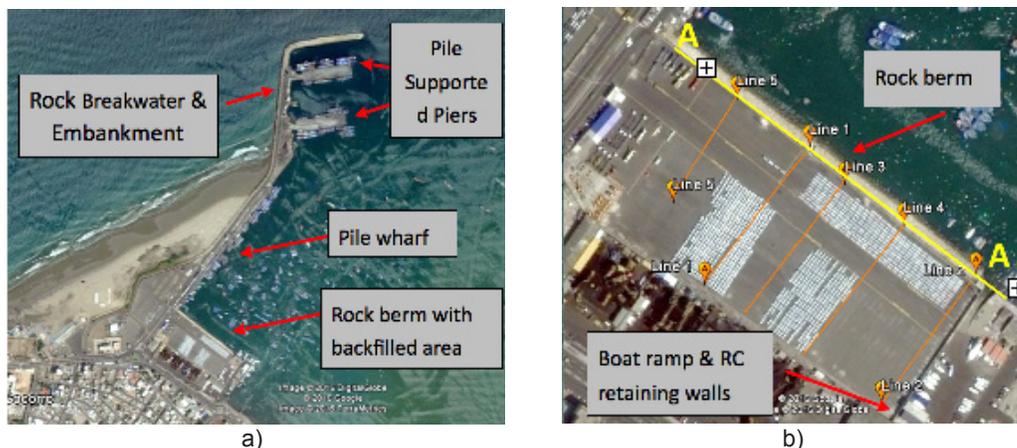
A significant vertical offset in the pavement was observed running roughly parallel to the wall at a distance of about 3.5 m landward from the wall (Line A-A in Figure 2-11b). Typically, the ground settled downward on the landward side relative to the seaward side. To quantify the variation in offset, offset measurements were made at 5 m intervals along the line. Figure 2-14 shows the offset plotted versus distance along the line. The maximum offsets was 50 cm and -14 cm with an average of 15 cm.

Figure 2-11. Aerial View of (a) Port at Manta (b) backfilled area behind rock berm used to store imported cars. Lines along which settlement and lateral displacement were measured are also shown (D. Globe ©2016).

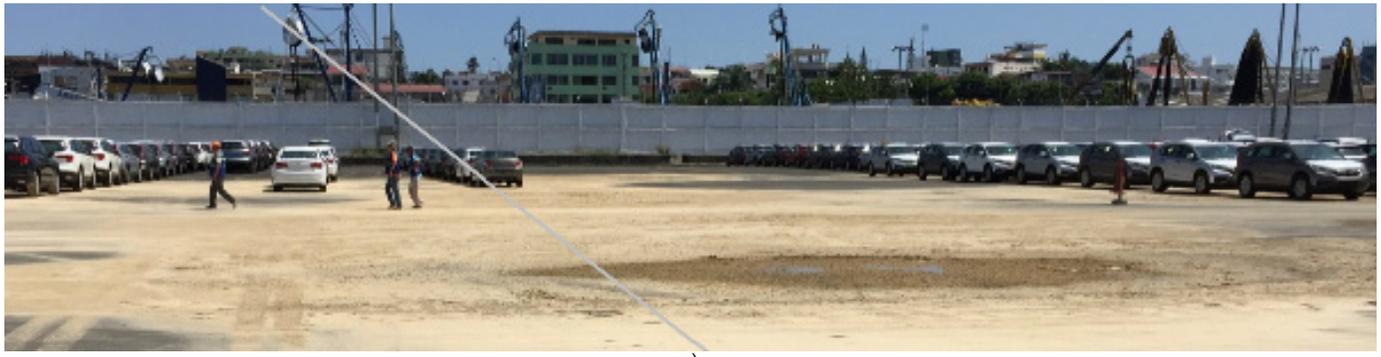
a)

A Google Earth image of the import car storage area behind the rock berm is provided in Figure 2-11b. Liquefaction-induced lateral spreading towards the rock berm produced a number of cracks parallel to the rock berm along with ejecta. In addition, large sand boils erupting from a single point developed at several locations. The soil type of the ejecta ranged from sand to silt and samples were obtained for subsequent laboratory testing. Figure 2-12a shows one of the large soil boils that erupted primarily from a single vent in the pavement. Eyewitness accounts indicated that water sprayed out of the ground as high as a meter immediately following the event. In contrast, Figures 2-12b and 2-12c show sand ejecta that emanated from transverse cracks in the pavement as a result of lateral spreading.

Figure 2-12. Photograph of (a) concentrated sand blow in the center of the pavement, (b & c) sand vents erupting from cracks in the pavement formed by lateral spreading (d) Lateral movement (40 cm) of 4 m tall retaining walls adjacent to boat ramp, and (d & e) heave and longitudinal cracking of base slab (GPS coordinates: (a) 0° 56' 27.61"S 80° 43' 29.36"W (b) 0° 56' 26.91"S 80° 43' 29.53"W (c) 0° 56' 29.45"S 80° 43' 27.77"W (d & e) 0° 56' 28.87"S, 80° 43' 26.78"W

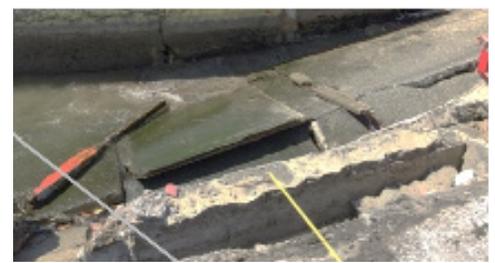
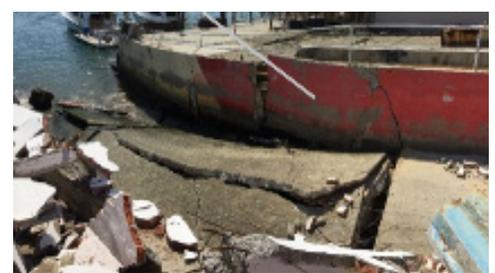
Liquefaction and lateral spreading caused foundations for light poles to rotate and sink into the ground. Rotation was approximately  $2^\circ$  towards the rock berm and  $1.5^\circ$  towards the west. A boat ramp on the southeast side of the area (see Figures 2-12d and 2-12e) with 4 m high reinforced concrete retaining walls moved about 40 cm outward at the top of the wall as shown in Figure 2-12d. This led to significant vertical cracks in the walls on either side of the boat ramp. In addition, the floor slab at the base of the boat ramp heaved upwards and developed significant longitudinal cracks (see Figure 2-13e).

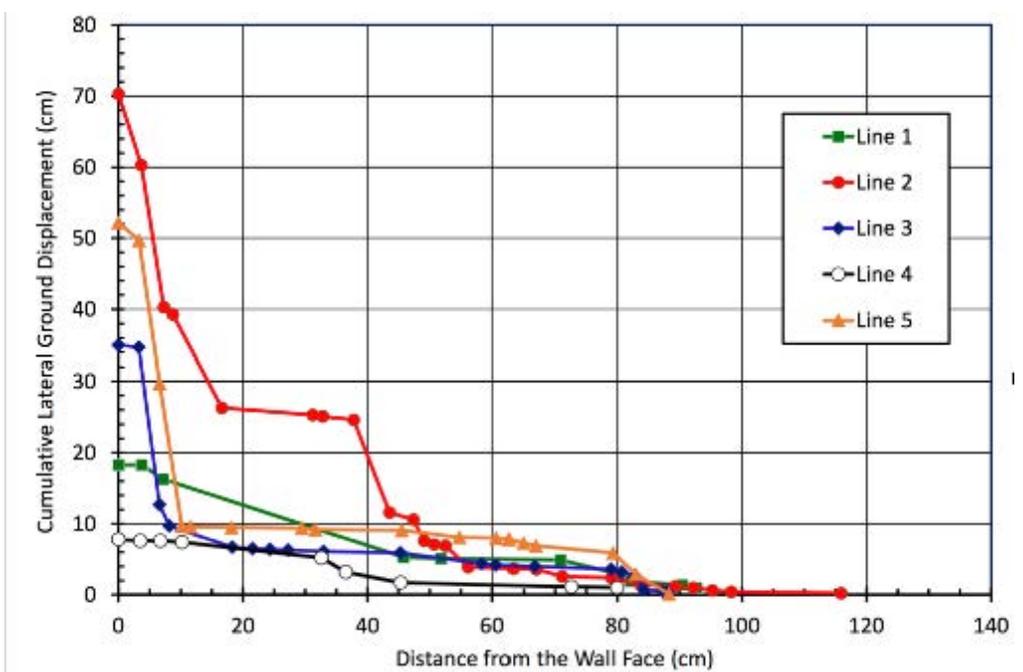
To document the lateral spreading displacements that occurred in this area, crack widths along five lines normal to the rock berm were measured. In addition, the distance to each crack was measured relative to the face of a concrete panel wall running roughly parallel to the top of the rock berm as shown in Figure 2-11b. Figure 2-13 provides plots of cumulative lateral displacement up to the wall, which is considered the zero reference point for each line. The average lateral spreading displacement was about 37 cm, with a range between 8 and 70 mm. Lateral displacement increased substantially within about 10 m of the wall as the edge of the rock berm slope was approached. Displacements were less than about 2 cm beyond 90 m behind the wall. The measured variation in the lateral spreading displacements could potentially be useful in evaluating the effect of subsurface stratigraphy and soil properties in lateral spreading displacement prediction models.

Figure 2-13. Cumulative lateral spread displacements measured along five lines perpendicular to the shoreline.

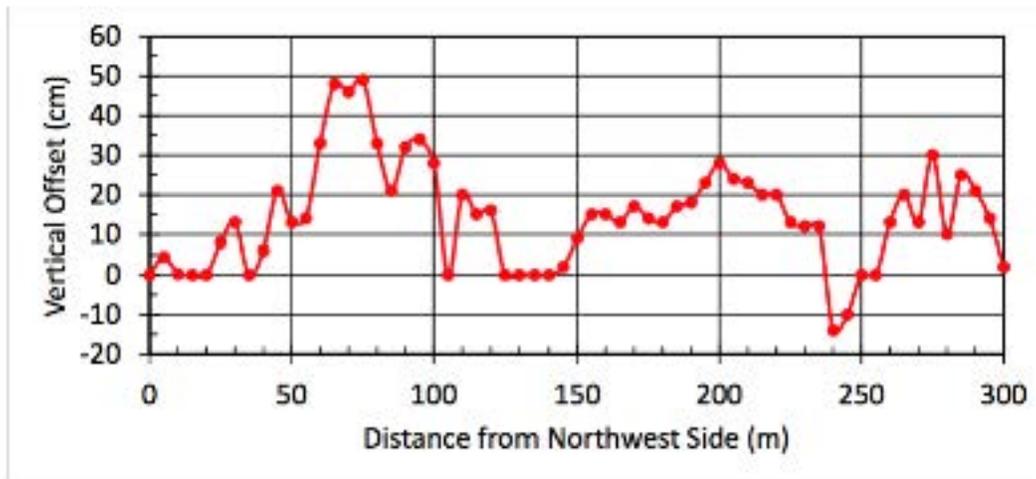
Figure 2-14. Vertical offset in concrete pavement produced by lateral spreading along line A-A at 5 m intervals. Line A-A is roughly parallel to the concrete wall at a distance of about 3.5 m from the wall face

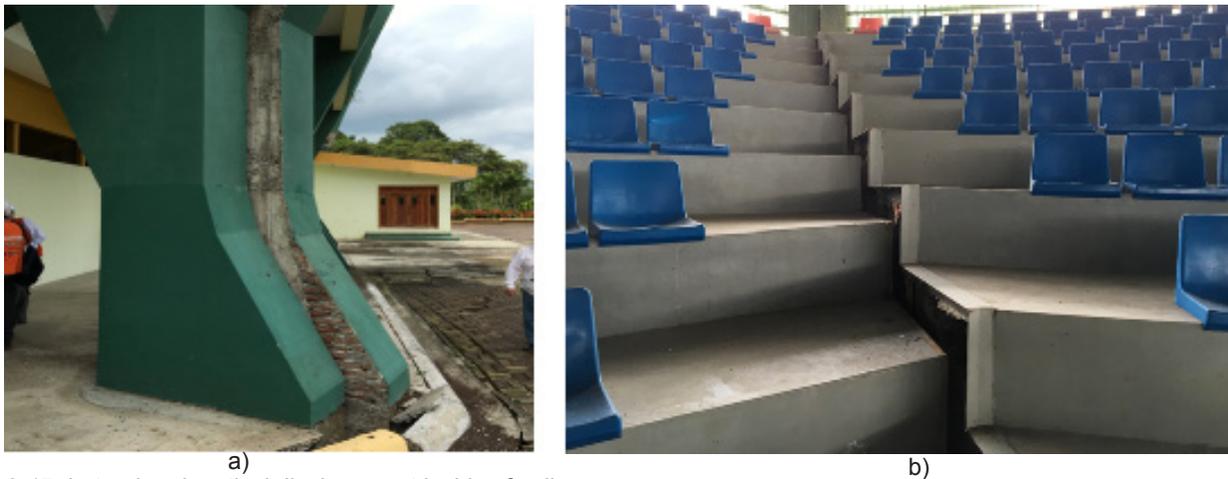
Outside of the town of Calceta, the team visited the Coliseum Manuel Felix Lopes at the Escuela Superior Politecnica Agropecuaria de Manabi. The coliseum sites within is 40 m of tributary of the the Rio Carrizal. Both Lateral spreading and liquefaction were observed in and around the coliseum, as shown on Figures 2-16 and 2-17. Figure 16 shows damage on access road. Figures 2-17a and 2-17b illustrate laterally displacement of 25cm and vertical displacement of 24cm in coliseum due to lateral spreading and liquefaction in the soils under the foundation.

Figure 2-17. Lateral and vertical displacement inside of coliseum.

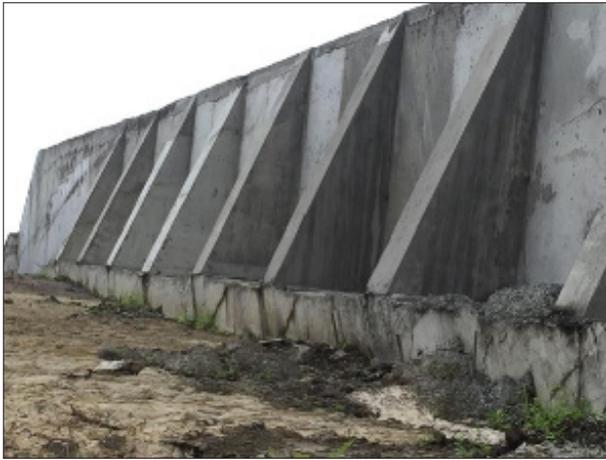
Figure 2-18. a) Cracks in spillway slab, wall and counterfort, Chone Dam, Manabí, Ecuador, 2016 (GPS coordinates: 0° 42' 02.01" S, 79° 59' 25.89" W); (b) Slope instability at right abutment, above Chone Dam, Manabí, Ecuador, 2016 (GPS coordinates: 0° 42' 01.62" S, 79° 59' 10.85" W).

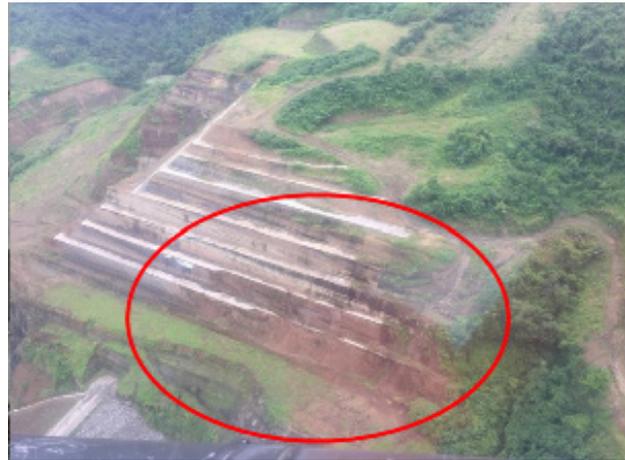
b)

Chone Dam is a multipurpose dam currently under construction in the province of Manabí to be finished this year. The dam is a zoned embankment dam with a maximum height of 57.5 m and a total crest length of 276 m. At the dam embankment, no settlement or deformations were visible to the inspection teams. Leaks at the downstream face and spillway contact were not visible either. No significant damage was observed at the spillway, chute or stilling basin. Some cracking at the spillway training walls, counterfort and slab was visible as shown in Figure 18a, but it is unknown when these cracks occurred. Some, but not all of the cracks appear to have vegetation growth so the assumption is that they have been present for some time although this cannot be confirmed. There was some damage visible to the gate seal of the low flow outlet. Based on project personnel, the defect in the gate seal had occurred prior to the seismic event and a replacement was planned. Grout injections are also planned in the outlet tunnel to mitigate leakage. This work was also planned prior to the seismic event. The outlet tunnel which is 3 m in diameter was not dewatered or inspected. Slope instability at the cuts at the right and left abutment were visible at the time of the inspections. Based on discussions with project personnel, some instability had occurred due to the heavy rains a few days before the seismic event. Further instability may have occurred due to the earthquake. Slope instability is shown in Figures 2-18a and 2-18b.

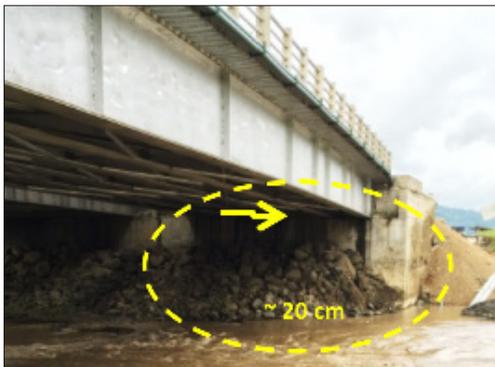
a)

Figure 2-19. Typical damage observed (a) Damage to eastern abutment, wing wall, and gabions in Mejia Bridge (GPS coordinates: 0°59'22.73"S, 80°28'11.14"W); (b) Collapse of unreinforced stone masonry of Bahia wall (0°36'30.61"S, 80° 5'25.03"W); (c) Damage and partial collapse of the wall at the Manta Port (0°56'28.86"S, 80°43'26.69"W); (d) Wall at Velboni supermarket in Portoviejo (1°3'37.78"S, 80°27'29.27"W)

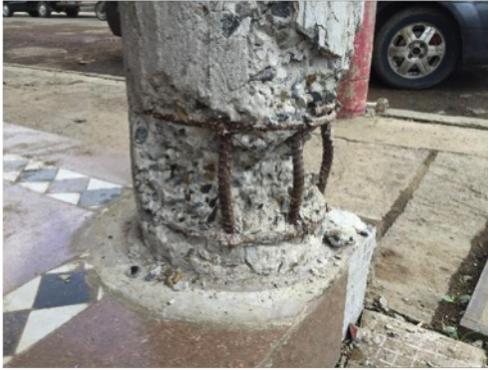
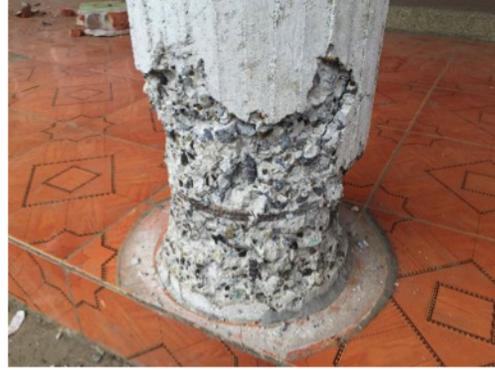
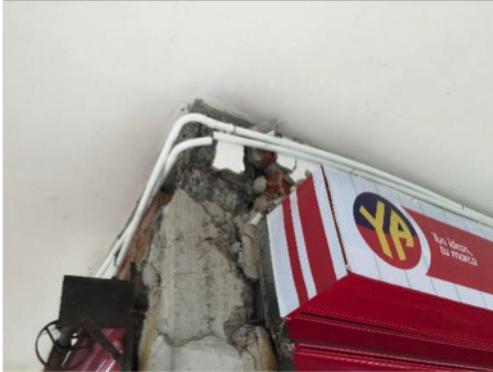
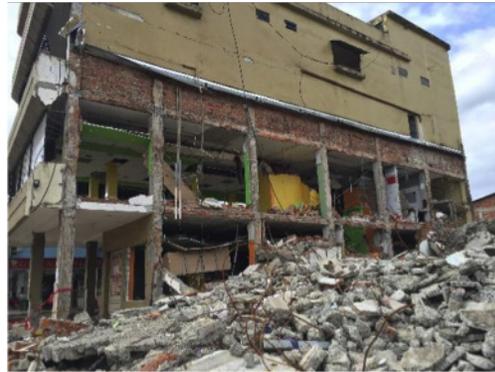
In the coastal area of the country, there is a widespread reinforcement corrosion problem. Spalling of concrete cover during the earthquake exposed corroded reinforcement in both older and newer buildings. See Figure 3-3. Many factors seem to promote corrosion:

Figure 3-3. Spalling of concrete cover and longitudinal reinforcement buckling was found in frames of small residential structures, typically in beam-column joints and at the base of columns.

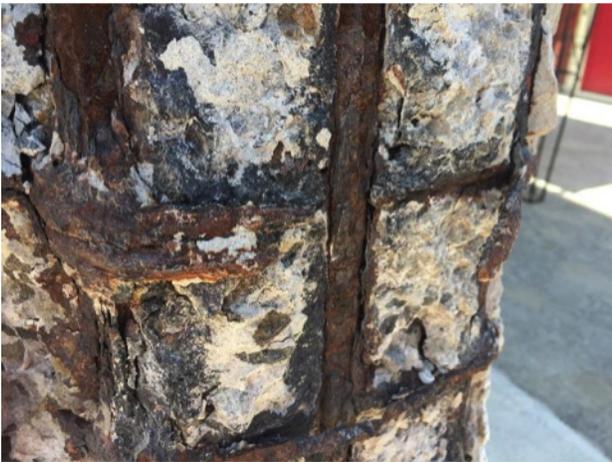
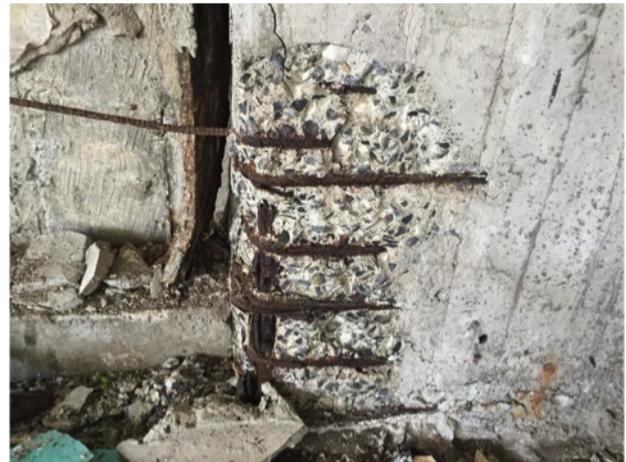
Figure 3-4. Left: Corrosion in rebar due to exposed reinforcement in Bahía de Caráquez. The structure is located near the bay's shore. Right: An abandoned mid-rise building in Bahía shows a column with little concrete cover, which is typical and enables and accelerates corrosion.

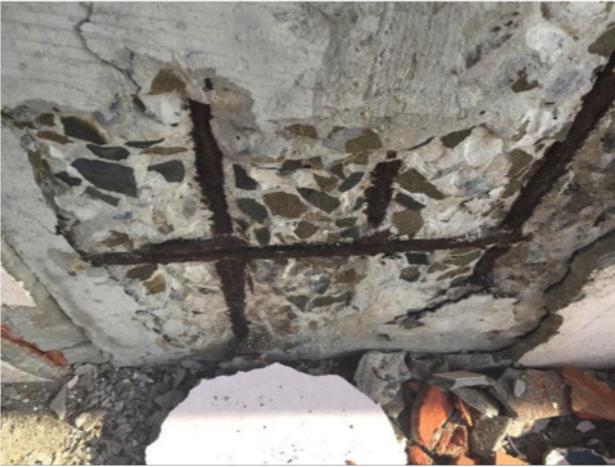
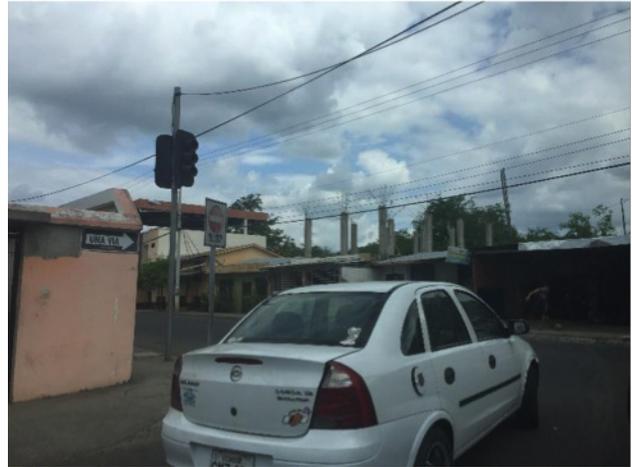
Figure 3-5. Left: Corrosion of reinforcement in a column at Portoviejo's National University. Right: One story structures are typically constructed with the intention to build a second floor in the future. Second-floor columns are built with the first slab. Rebar dowels are not protected from the environment and are prone to corrosion.

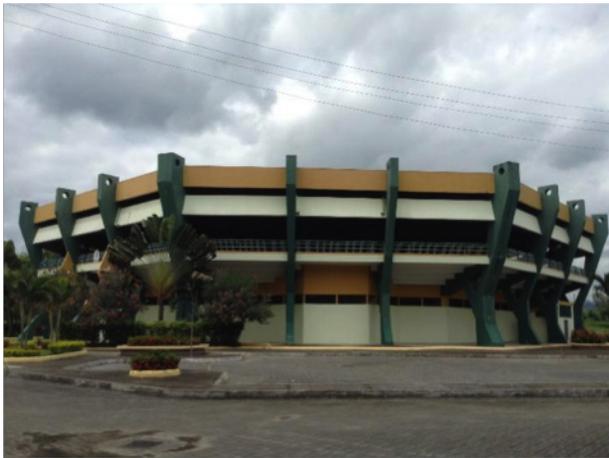
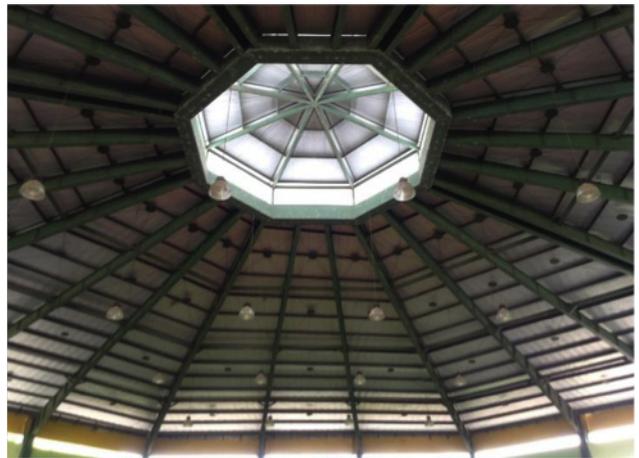
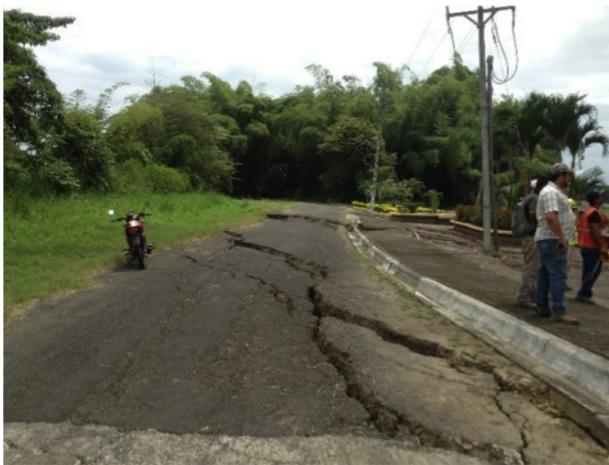
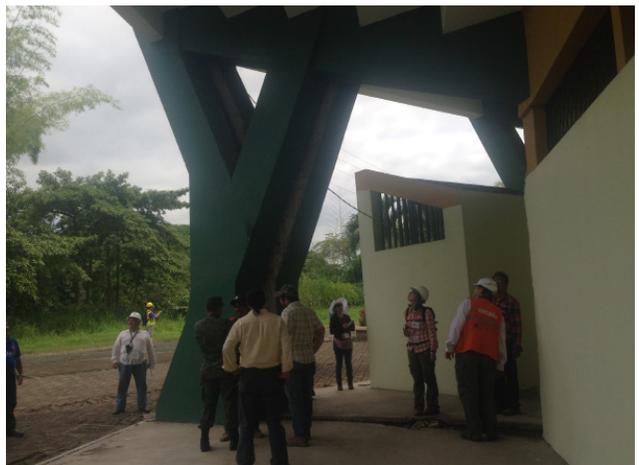
Figure 3-8. Steel stadium from the National University at Calceta. Liquefaction and lateral spreading of soil caused adjacent segments of the structure to drift differentially and away from each other. Damage in the structure was found only in the masonry infill walls (photos: Forrest Lanning).

Two steel buildings were evaluated: the ECU911 in Portoviejo and the steel coliseum in Calceta, which belongs to the National University. The latter structure showed minor structural damage, primarily due to soil liquefaction. The structure was comprised of several structural segments and, in one instance, two adjacent segments moved approximately 27 cm from each other. However, it should be noted that no critical damage was found in the steel structure. The masonry partitions were the only elements that showed substantial damage, and these elements are not part of the main structure. See Figure 3-8. The coliseum, however, was not completely made of steel. The building had piers made of concrete and the structure supporting the roof was made of steel members.

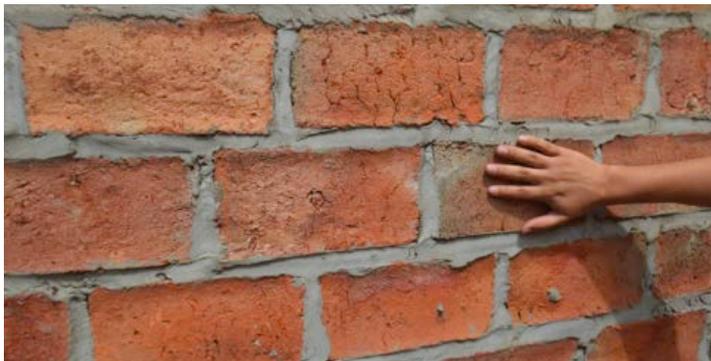
Figure 3-10. Typical brick masonry partition (photo: Hector Monzón).

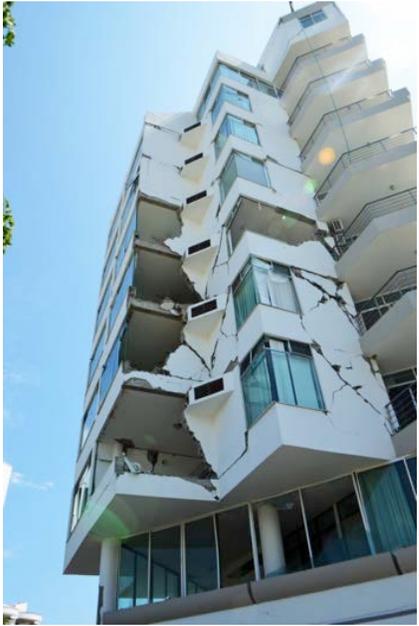
Figure 3-15. Left: Apartment building in Bahía. Unreinforced and poorly anchored masonry facade panels collapsed or cracked. Right: Inadequately anchored masonry panels collapsed on an ambulance parking canopy roof (photo: Hector Monzón).

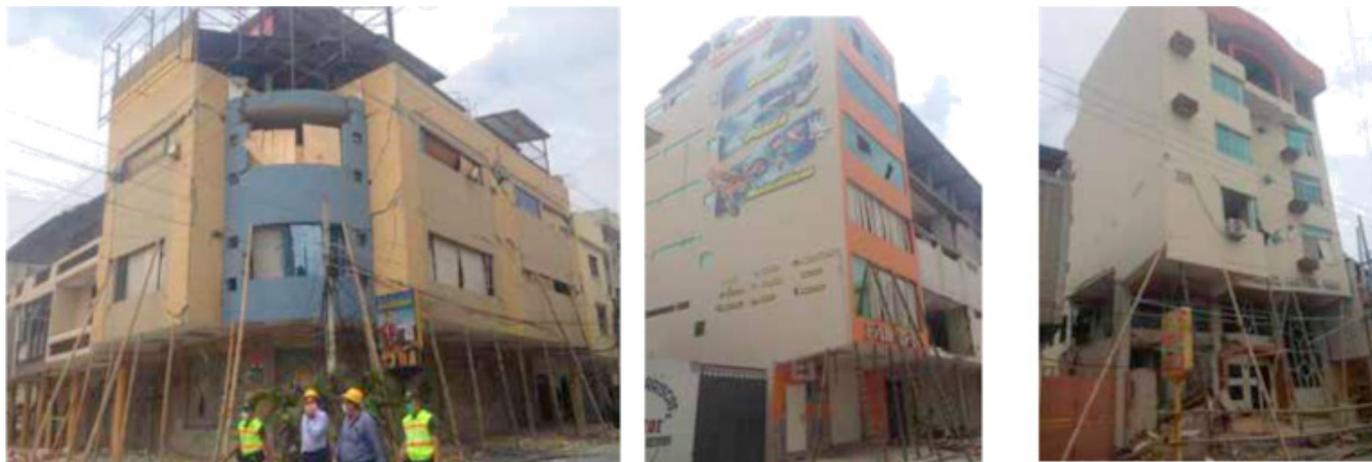
The damage observed in Tarqui buildings varied from non-structural damage to complete collapse. Some of the buildings still standing were shored with sections of bamboo (See Figure 3-17), a material readily available in this part of Ecuador. Although this type of temporary shoring could work as an immediate measure to protect the buildings, it is not clear how long the bamboo will hold—its performance in aftershocks and over time remains unknown. There were also several buildings with long cantilevers on the front elevations, making them more susceptible to vertical accelerations in ground shaking.

Figure 3-17. Temporary shoring of buildings using sections of bamboo (photos: Adrian Tola and Mei Kuen Liu).

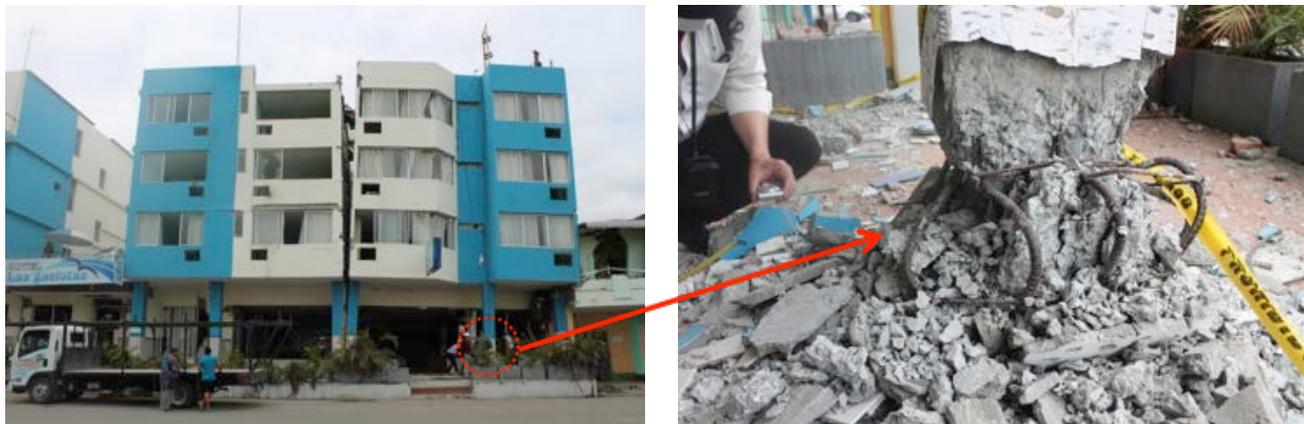
a) La Barca Restaurant

While some buildings in Tarqui were standing at the time of the team visit, they were structurally unstable. Figure 3-18a shows the La Barca Restaurant building complex, where one of its two buildings was leaning toward the right; the building had not collapsed, possibly because of the unintended support provided by the adjacent two-story building. The concrete exposed at the bottom of one of the building columns (Figure 3-18a) revealed poor construction quality; cohesion of the existing concrete was very weak, as it was possible to pick away pieces of it using fingers. Confinement ties in the column were spaced much farther than recommended and only had 90-degree hooks, as opposed to the 135-degree hooks recommended for construction in seismic regions.

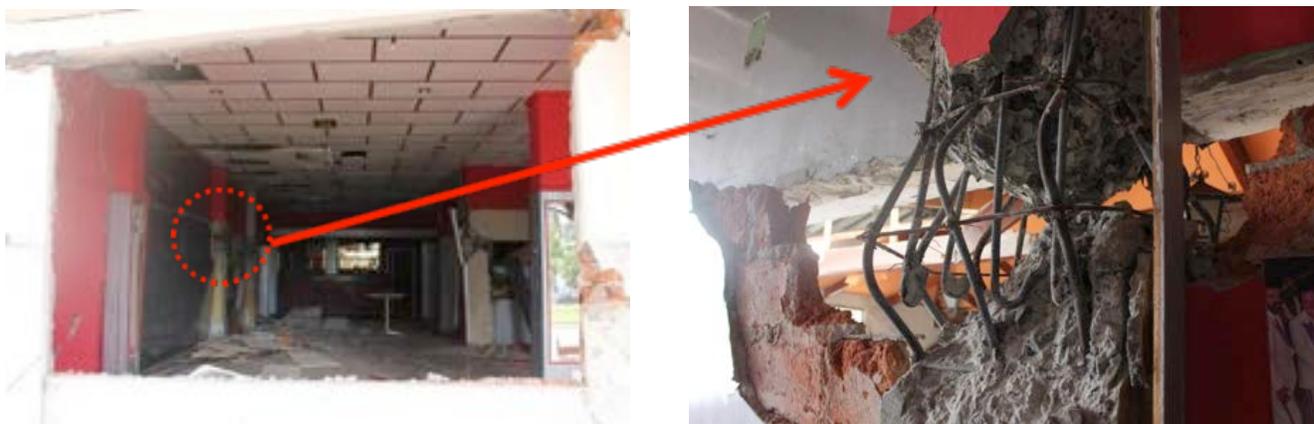
b) Las Gaviotas Hotel

Figure 3-18b shows the Las Gaviotas Hotel building. Many of the concrete columns failed, possibly due to “short column” behavior, in which partial height masonry walls were constructed immediately adjacent to concrete columns, in

essence reducing the buckling length and inducing an unintended large amount of shear force in the column, causing shear failure. Lap splices of longitudinal rebar in these columns were placed at the same elevation, whereas the current recommendation is to have the splice location staggered to avoid a weakened plane in the column section. It was peculiar that the upper longitudinal rebars terminated in 180-degree hooks (see right part of Figure 3-18b), which may suggest that the splices may not have had enough development length. It is worth noting that smooth (un-deformed) rebar was used for both longitudinal and confinement reinforcement at the failed columns in this building; this fact might have corresponded to the materials and applicable regulatory codes available at the time of construction.

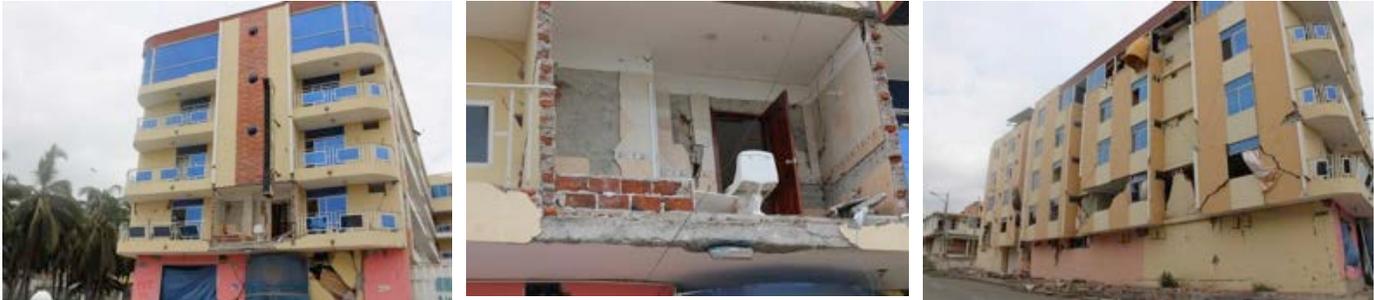
The hotel Vista Alegre, which is located in the same block as La Barca Restaurant and Las Gaviotas Hotel, is shown in Figure 3-19. There was severe damage to the unreinforced masonry façade. See the masonry infill section of this report for further discussion on this topic. Also, from Figure 3-19, it is apparent that masonry debris from upper floors poses a falling hazard and could easily cause injuries to pedestrians. It should be noted again that this section of Tarqui had been evacuated and limited access was granted to few.

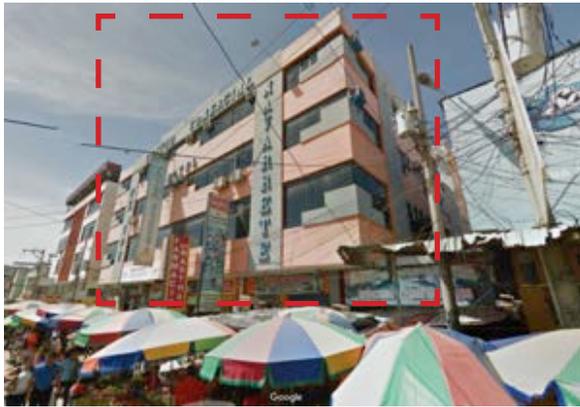
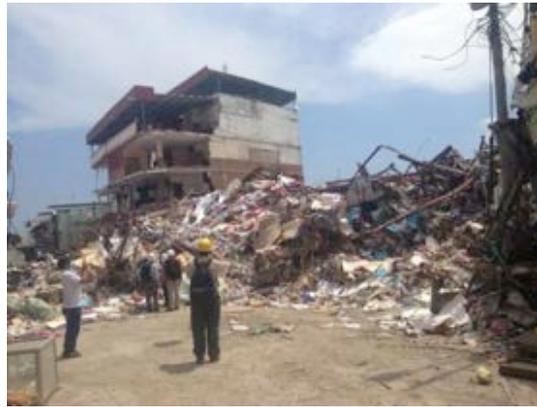
a) Centro Comercial Navarrete

The left side of Figure 3-20a shows the Centro Comercial Navarrete four-story building, while the right side shows the debris from the collapsed building—all that remained 23 days after the earthquake. Ninety-one people lost their lives in this building, according to the local newspaper. The collapse of this building alone accounted for approximately one-third of deaths in Manta from the April 16 earthquake.

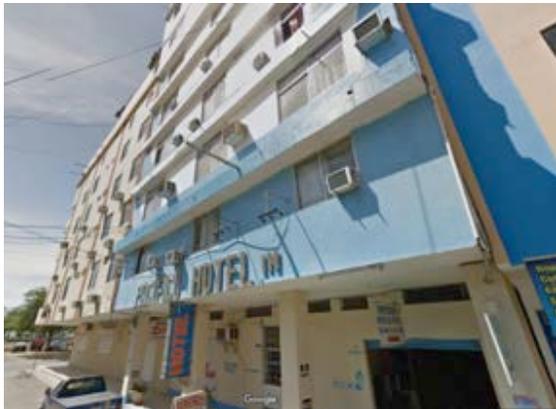
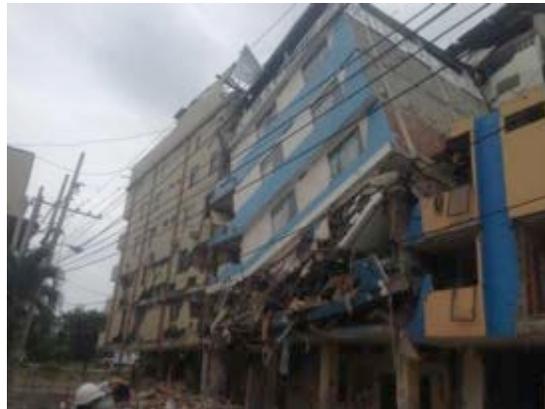
b) Hotel Pacifico

Figure 3-20b shows the Pacifico Hotel building (white-blue) leaning toward the Las Rocas Hotel (yellow) due to a probable soft-story mechanism in one of the upper floors of the Pacifico Hotel.

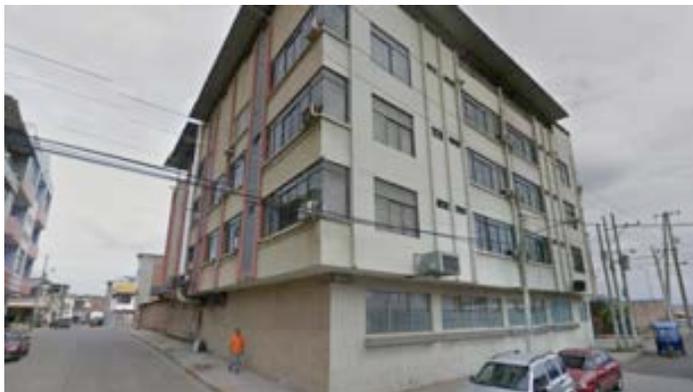
a) Before the earthquake

Figure 3-21b shows a building that collapsed due to a soft-story mechanism, while Figure 3-21a shows the same building before the earthquake, obtained from Google Street View. Soft-story mechanism failures were relatively common in areas affected by the earthquake throughout the country, due to a typically taller ground floor story height and fenestration.

Figure 3-21. Soft-story mechanism in a building at 11th Avenue and 2nd Street (photos: Adrian Tola and Mei Kuen Liu).

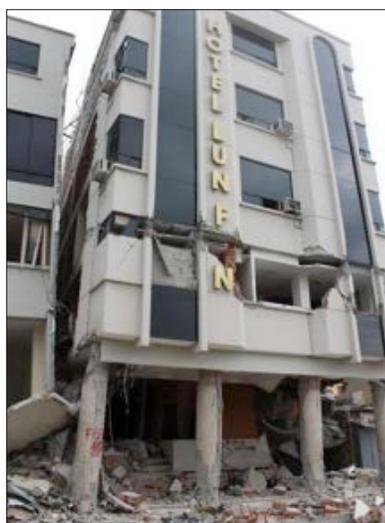
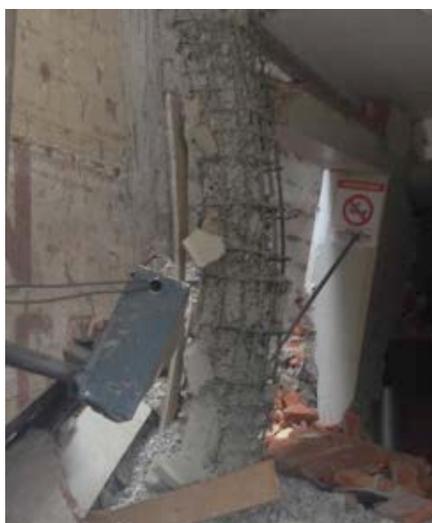
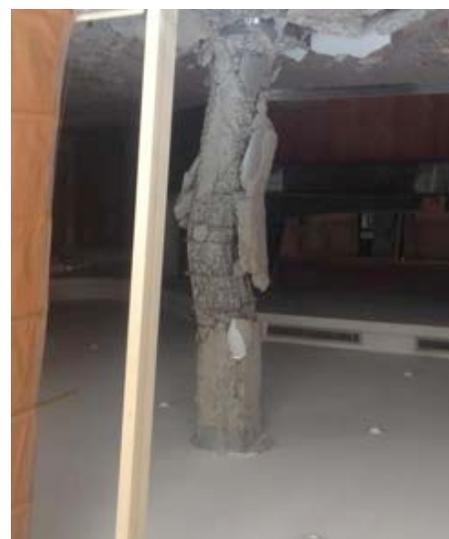
Figure 3-22 shows the Hotel Lun Fun, which is adjacent to the building shown in Figure 3-21. It suffered severe damage in the base of the columns, as shown in the figure below.

Figure 3-22. Hotel Lun Fun (photos: Adrian Tola and Mei Kuen Liu).

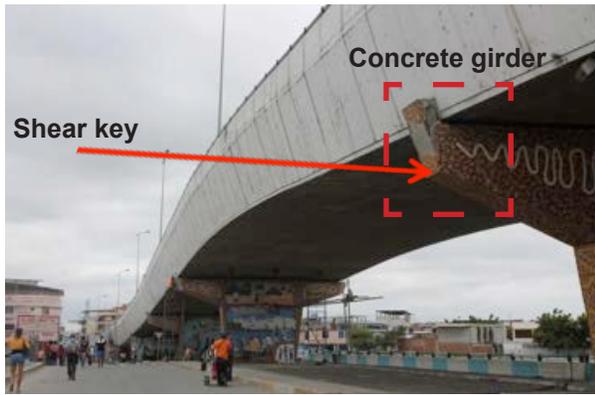
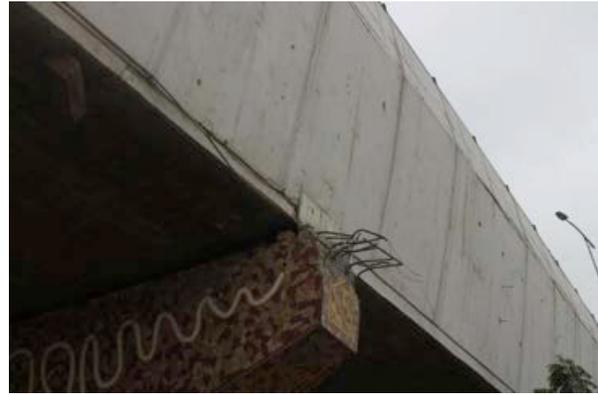
A bridge along the November 4th Avenue is shown in Figure 3-23. The earthquake displaced the concrete box girder relative to its pier and toward the two shear keys located at the end of each bridge support. The shear keys were cracked or pushed to the ground due to the strong lateral force induced from the box girder. The shear keys that were damaged during the earthquake were already undergoing reconstruction at the time of the EERI team visit.

Figure 3-23. Bridge along November 4th Avenue (photos: Adrian Tola and Mei Kuen Liu).

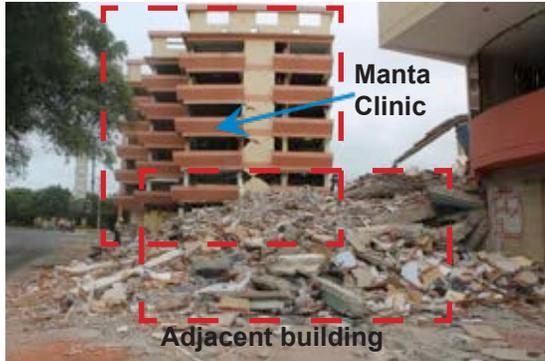
a) Manta Clinic and adjacent building

Another building observed was the seven-story Clinica Manta building, located near the intersection of November 4th Avenue and J-12th Street. This building was used for medical care, and as shown in Figure 3-24, it had several contributing factors to the building's apparent instability. The building experienced damage in the façade (Figure 3-24a and c), as well as structural damage due to short-column mechanisms as explained earlier in this section (Figure 3-24b). Concrete spalled off several joints, revealing no joint confinement reinforcement (Figure 3-24c). There was also severe cracking in interior columns at the ground level (Figure 3-24d).

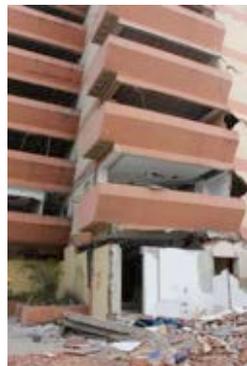
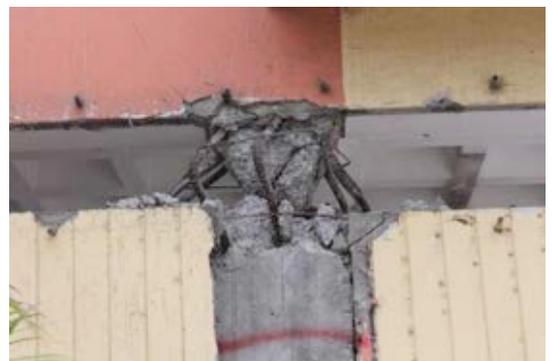
Figure 3-24. Clinica Manta (photos: Adrian Tola and Mei Kuen Liu).

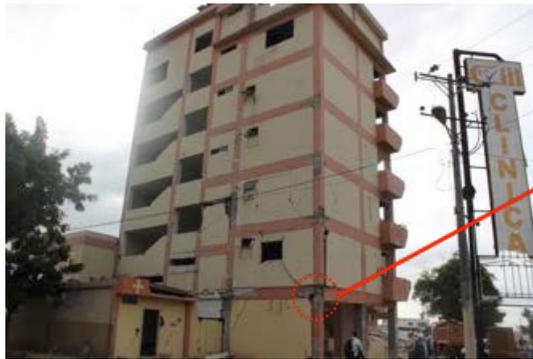
b) Short column mechanism

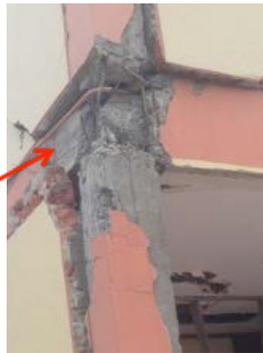
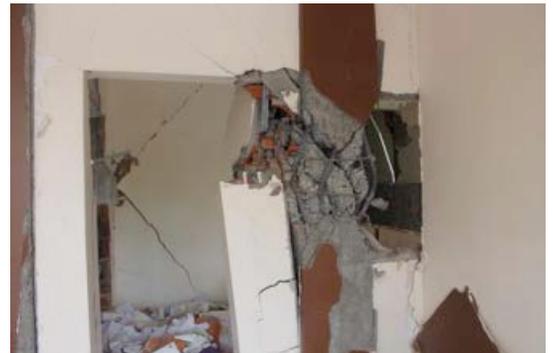
c) Compromised joint without joint confinement reinforcement

d) Cracks in 1st floor column with short column mechanism

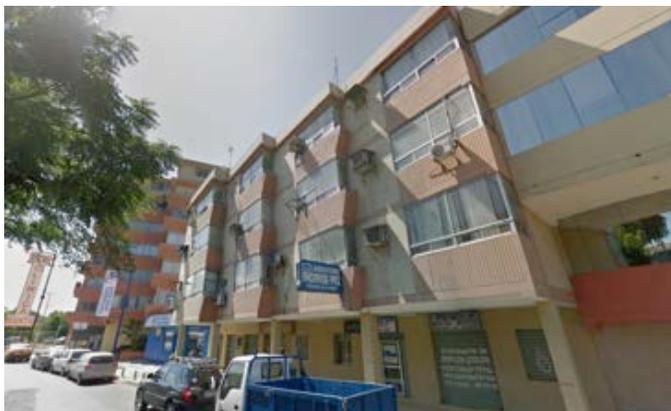
a) Before the earthquake

Damage was also observed in a building adjacent to the Clinica Manta. As shown in Figure 3-25, this four-story building was reduced to a small pile of debris (before photo from Google Street View). Suspended floor slabs were visible, as seen in Figure 3-25b. The pile of debris appeared small for a four-story building. It was not clear whether any debris had been taken away but the team did observe local youth playing in and with the debris.

Figure 3-25. Building adjacent to the Clinica Manta (photos: Adrian Tola and Mei Kuen Liu).

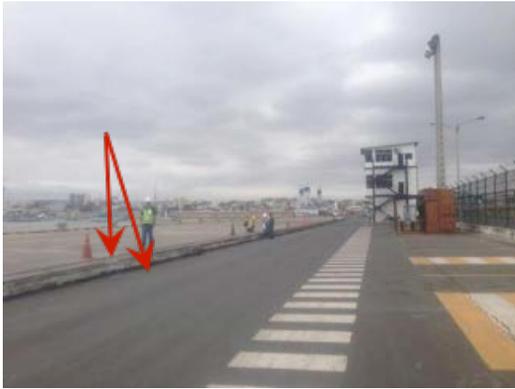
Long cracks were visible, parallel to the circulation line. There was also a change of vertical elevation on both sides of the cracks (See Figure 3-27a), which measured approximately 45 cm at certain points. Moving toward Modules 1 and 2, there were more cracks parallel to the circulation line (See Figure 3-27b), suggesting that this cracking might have occurred due to lateral spreading of the soil under the port. Toward the end of the pier, a metal fence was partially suspended in the air, evidence that substantial differential ground settlement occurred (see Figure 3-27f).

a) Long cracks parallel to circulation line

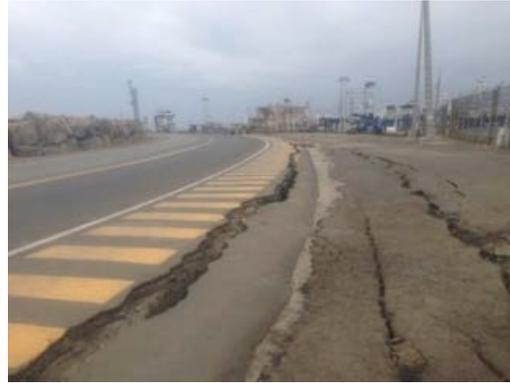
b) Long cracks parallel to circulation line

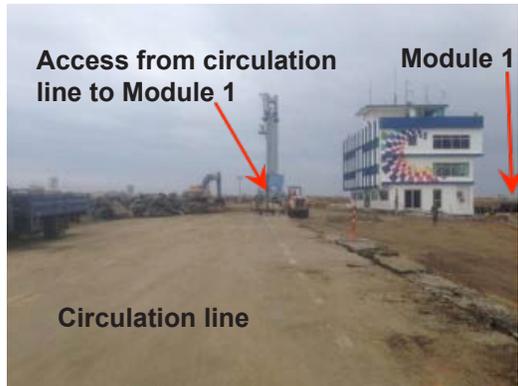
Access from the circulation line to Module 1 was under reconstruction at the time of the team visit (see Figure 3-27c). One of the engineers in charge of the reconstruction informed the EERI team that the access to Module 1 collapsed during the earthquake, most likely due to an undesired rigid connection between Module 1 and the circulation line. Module 2 was operating, but the maximum allowed loads on the module have been lowered because of damage observed in the piles under it.

c) Re-construction of access to Module 1

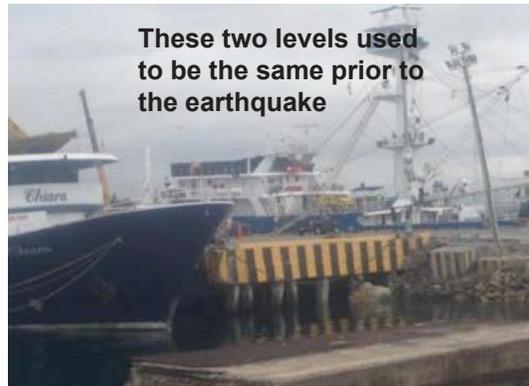
d) View of Module 2

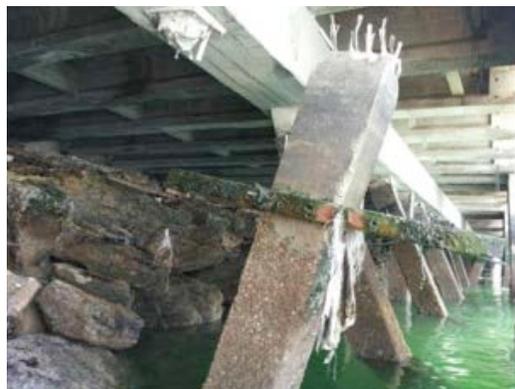
e) Damaged piles under modules

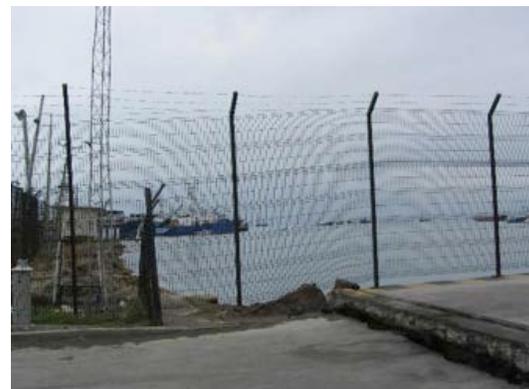
f) Metal fence detached from slab, suggesting ground settlement

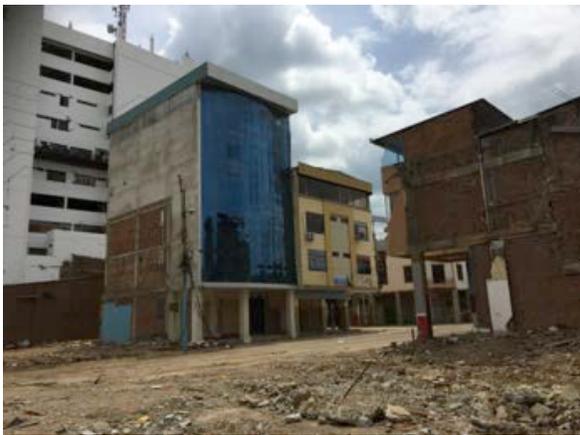
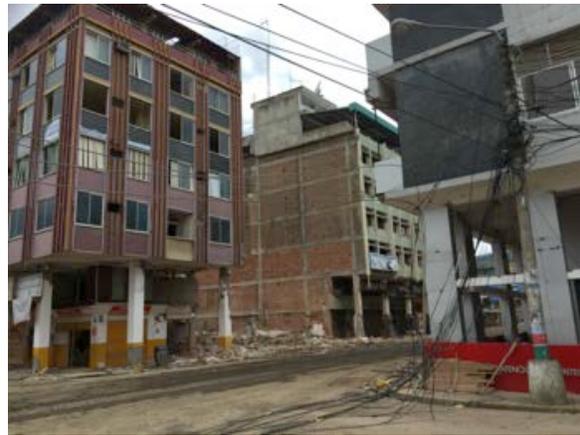
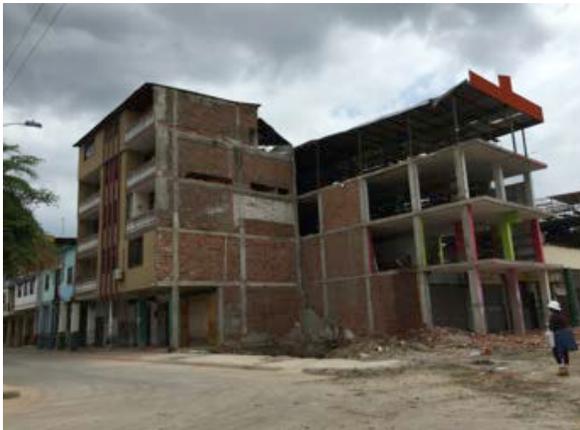
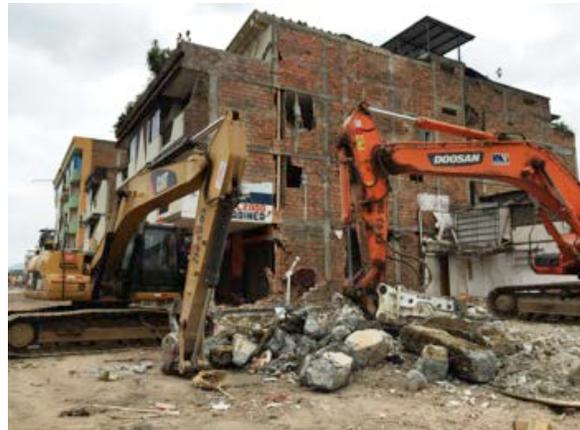
The EERI reconnaissance team was able to access the Ground-Zero zone controlled by the Ecuadorian Army Forces, and rapid visual observations of the exterior and interior of select buildings were conducted. In general, the team noticed that the RC frame buildings were extremely flexible to withstand the lateral displacements induced by the earthquake since small cross sections are used in columns and beams. In addition, the team observed that the debris of many low-rise collapsed buildings had already been cleared, and further demolition and debris clearance was in progress during the team visit. See Figure 3-30.

Figure 3-30. Cleared areas of collapsed buildings (photos: Ana Gabriela Haro).

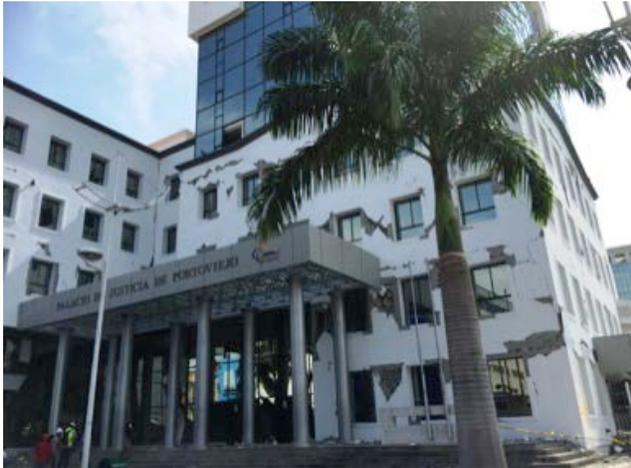
Figure 3-31 shows the Palace of Justice of Portoviejo, which is a nine-story frame building with two main sections placed in an “L” shape. According to a source within the Army, the foundation consists of piles. The main building and its annexes were separated by approximately 2-inch (50 mm) wide seismic joints, which appeared ineffective in the places where they were filled with inappropriate material. Unreinforced hollow concrete block masonry was used in facade and interior partitions. Failure of structural elements was not evident, but as observed in other buildings throughout the affected area, masonry elements were substantially damaged. Regarding the contents of the building, significant disruptions were observed as the building had been vacated. This indicated a greater need for adequate workplace security, resiliency measures, and planning for post-disaster operations.

Figure 3-31. Palace of Justice of Portoviejo: a) general view of the structure; b) damage to joints; c) shear failure in partitions; d) fallen contents (photos: Ana Gabriela Haro).
