# EERI Earthquake Reconnaissance Team Report: M7.8 Muisne, Ecuador Earthquake on April 16, 2016

Forrest Lanning, Ana Gabriela Haro, Mei Kuen Liu, Alberto Monzón,  
Héctor Monzón-Despang, Arturo Schultz, Adrian Tola

October 2016

*A product of the EERI Learning From Earthquakes Program*

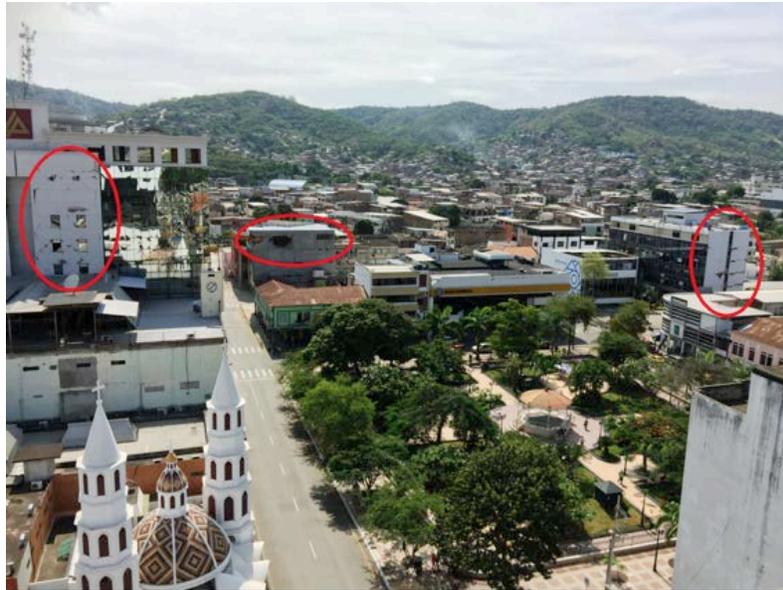
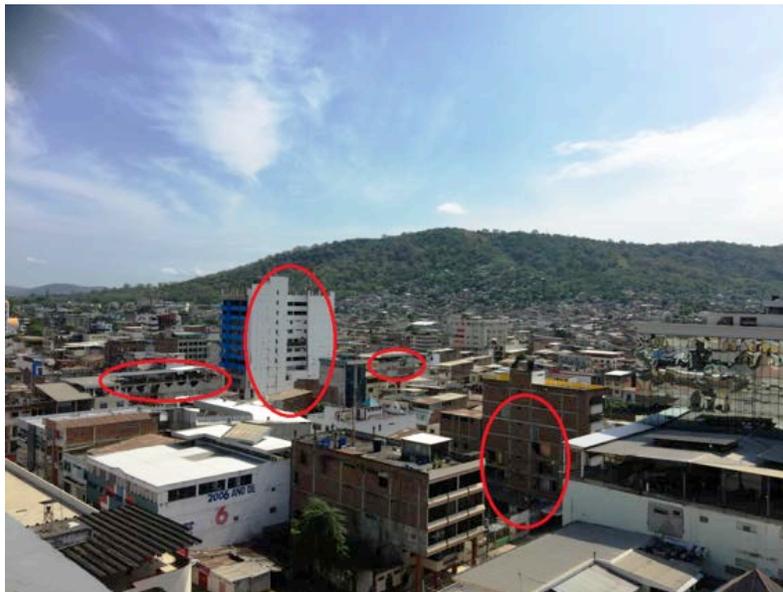
Numerous low- and medium-rise buildings exhibited non-structural failure associated with shear cracks in masonry infill walls, as stated previously. Figure 3-32 shows some cases with minor to severe damage where brittle, heavy, unreinforced facades were not designed and detailed for deformation compatibility with the lateral deformations of the frame buildings. The observed damage suggests that a change in the procedures to connect the infill walls to the main structure could improve building performance in future earthquakes.

Figure 3-32. Examples of facade damage in Portoviejo. (photos: Ana Gabriela Haro).

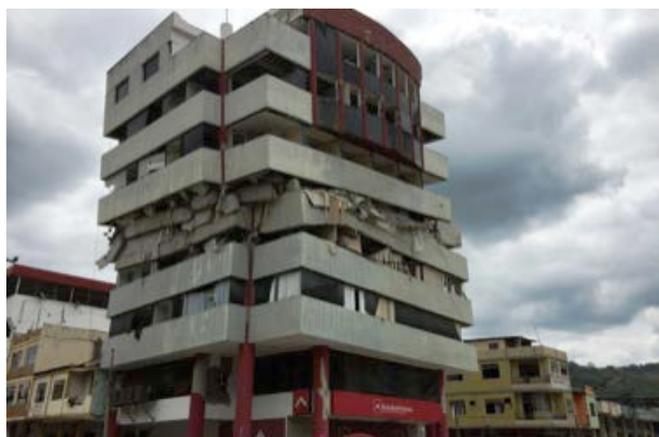
Several medium-rise buildings collapsed partially, jeopardizing the adjacent structures. Figure 3-33 shows the Mutualista Pichincha building, which originally had ten levels. Stories five to seven completely collapsed causing the upper levels to lean toward the west. Short columns with reduced cross sections were observed in the upper level.

Figure 3-33. Mutualista Pichincha Building: a) general view of the damage; b) close view of the collapsed floors; c) short column and shear failure on beam; d) location (Google Maps) (photos: Ana Gabriela Haro and Arturo Schultz).

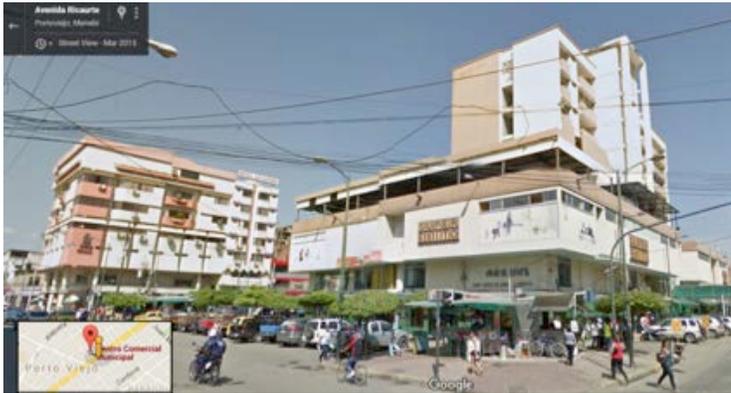
The upper two stories of the two annexes of the Centro Comercial Municipal collapsed as shown in Figure 3-34, where the original configuration of the structure before the earthquake has been included for reference. Poor detailing and a lack of structural robustness and redundancy contributed to the partial collapse, see Figure 3-34b. The main structure is a nine-story building, which experienced damage to the infill walls, especially in the stairs.

Figure 3-34a also shows the location of the IESS and the Hotel Alejandro buildings before the April 16 earthquake, both seven-story RC structures. Figure 3-35b also shows the space left by the first building after its complete collapse due to a first floor soft-story collapse, and the partial collapse of the second building where the upper four levels collapsed, endangering the small structure on its right.

Figure 3-34. Centro Comercial Municipal: a) structure before earthquake (Google Street View); b) general view of damaged building; c) close view of the collapsed floors; d) damage on infill walls. (photos: Ana Gabriela Haro and Arturo Schultz)

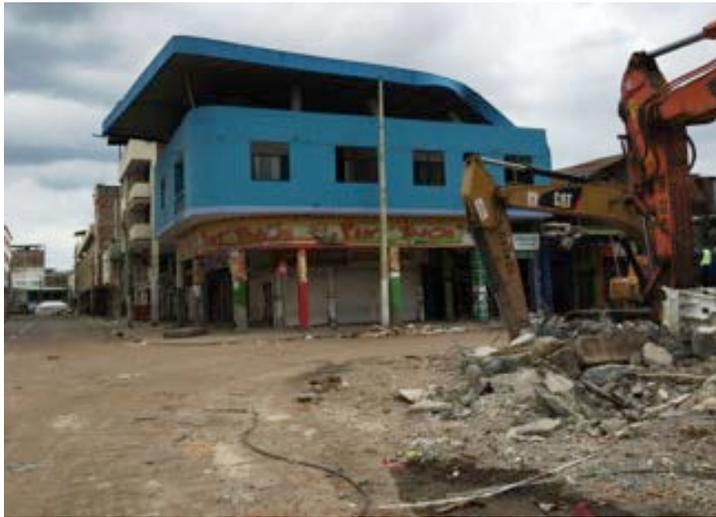
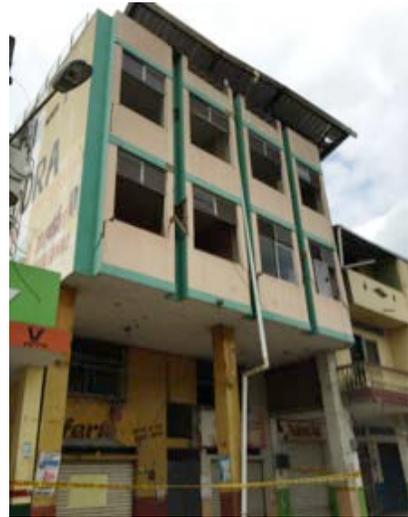
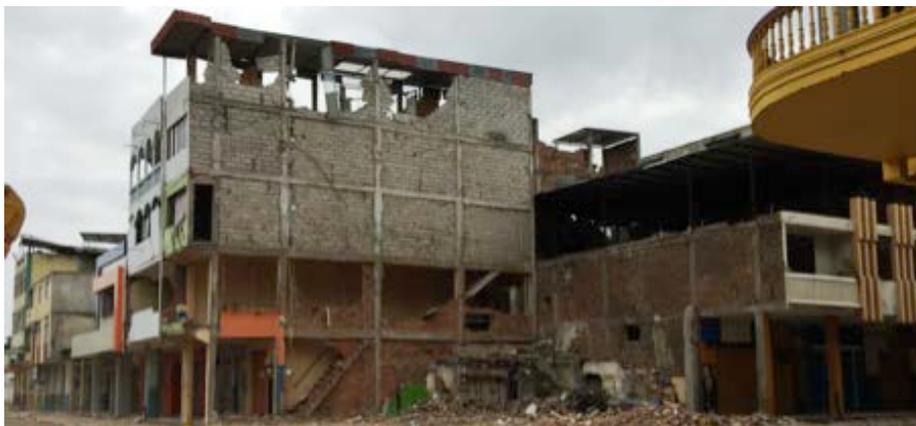
Figure 3-40. Cases of structural alterations. (photos: Ana Gabriela Haro)

Structural alterations of RC buildings were also observed during the reconnaissance, which can lead to building vulnerability. An increment in the gravity loading increases the lateral loading when an earthquake strikes, and consequently buildings are subjected to forces that were not considered during their design. The situation becomes more critical when the conception of these structural alterations lacks basic design and construction procedures to resist earthquake forces. In Portoviejo's Ground Zero, some added systems were different from the original construction system of the building and the lack of seismic design of these alterations was clearly noted as illustrated in Figure 3-40.

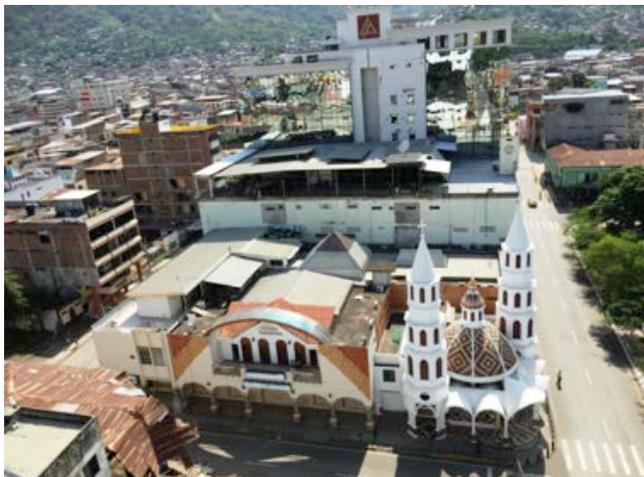
Figure 3-41. Church at Vicente Amador Flor Park: a) general view; b) damage localized at one of the dome supports. (photos: Ana Gabriela Haro)

The two inspected churches were partially damaged and performed better than most of the other RC buildings in Portoviejo. Figure 3-41a shows the general view of the church located at Vicente Amador Flor Park; and Figure 3-41b shows detailing of the main dome support, which was damaged during the earthquake. Concrete cover spalling was observed at this support.

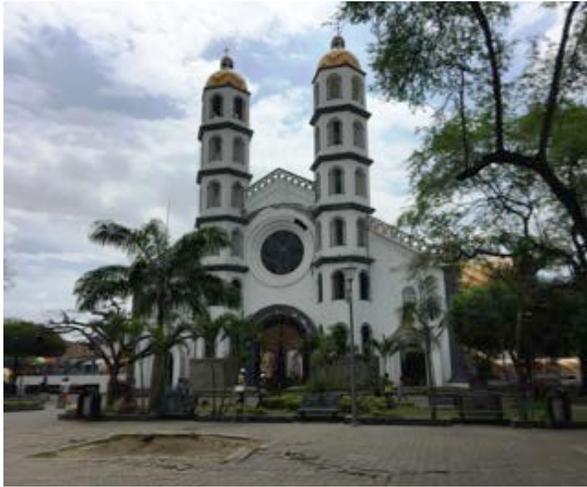
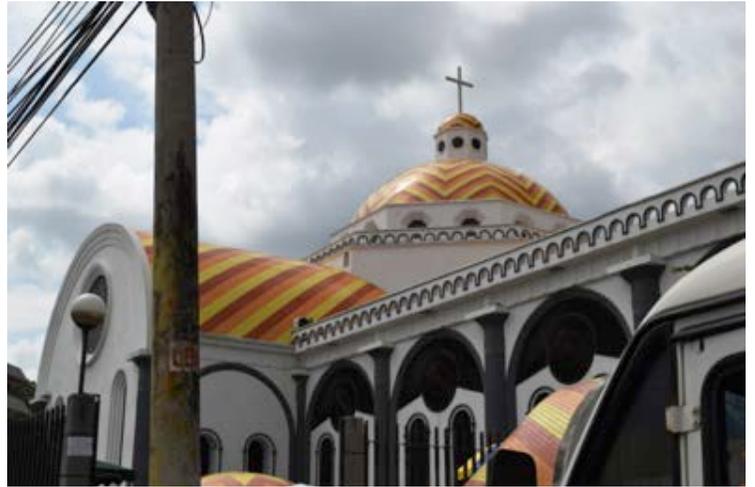
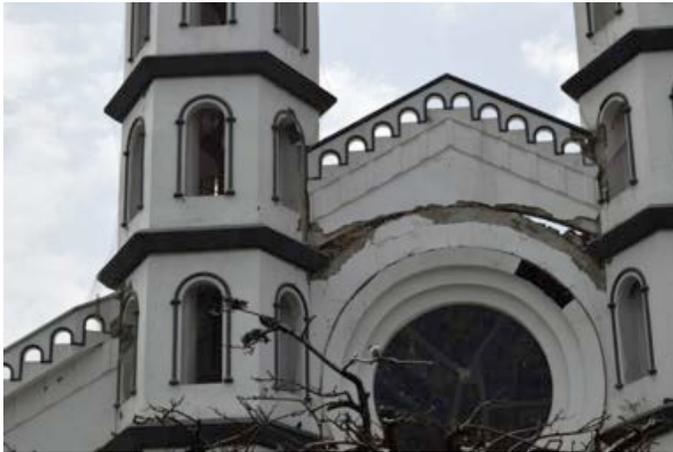
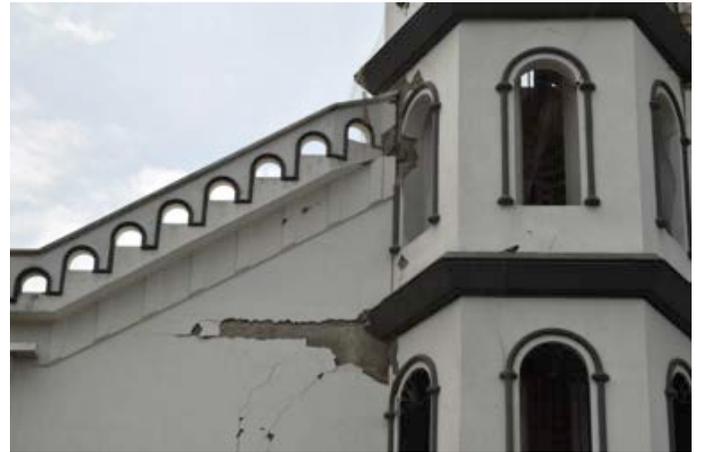
Figure 3-42. Church at Vicente Amador Flor Park: a) general view; b) damage localized at one of the dome supports; c) damaged connections; d) damage in masonry (photos: Ana Gabriela Haro and Arturo Schultz)

The Cathedral Jesús del Buen Pastor, experienced minor damage in infill walls. In addition, the connections between the towers and the adjacent parapets failed, as can be seen in Figure 3-42c and 3-42d. The main structure, consisting of big domes, apparently performed well, as can be seen in Figure 3-42b. Flexural cracks were observed in the structure surrounding the top of the stained glass circular window, probably caused by the stresses transmitted from the interaction between the towers and the connecting curved beam.

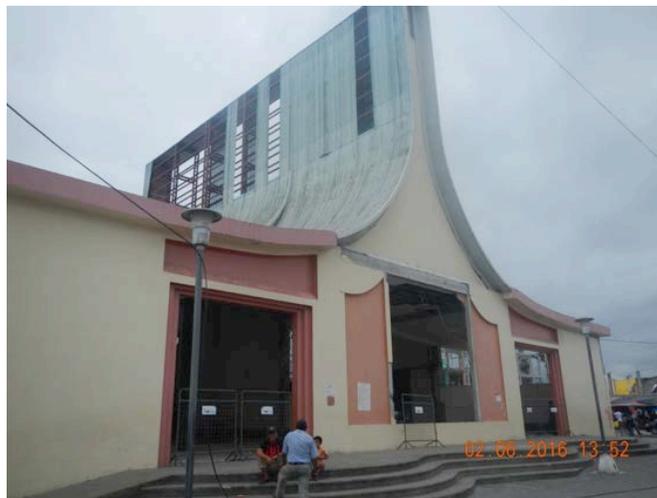
A detailed survey of the cathedral was also conducted (See Figure 3-43). The cathedral is primarily RC construction with an architectural steel truss roof. Masonry was used throughout for infill, gable, and external walls. Non-structural damage was heavy, with some significant masonry wall damage, and dislodged heavy ceiling tiles. Roof cladding panels had also fallen during the earthquake and caused fatalities. The observed structural damage was light and appeared to be caused by connections to the masonry infill walls.

Figure 3-43. Pedernales cathedral on Plaza Central (photo: EEFIT).

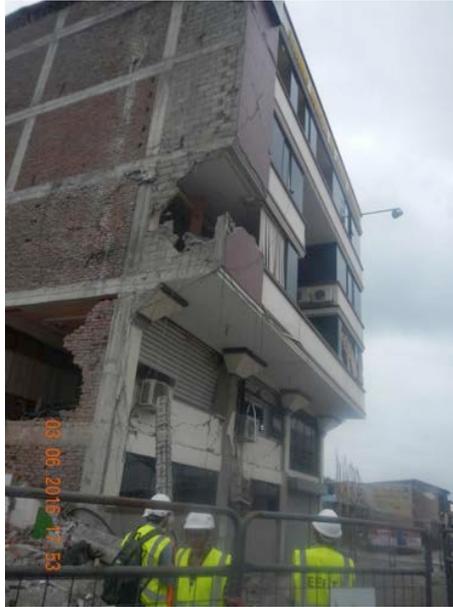
Figure 3-44. The main municipality building in Pedernales (photo: EEFIT).

A detailed survey of the main municipality building (Figure 3-44) was also conducted. This building is a five-story building of RC frame construction with masonry infill in the internal and external walls. The team surveyed the building internally on level 1 and externally, and observed moderate structural damage, including cracks and spalling of concrete in the top of the columns, and heavy damage to the RC staircase. Non-structural damage was heavy with the failure of full wall panels internally and externally.

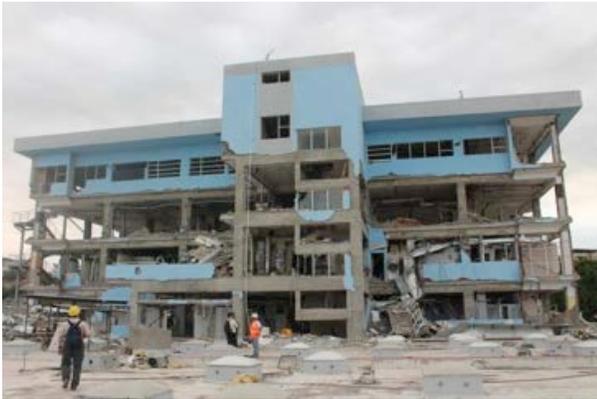
Visual inspections of the columns and beams of the Hospital IESS in Manta did not reveal visible damage (although detailed inspection of every beam, column, and joint would be needed for definitive conclusions), but both exterior and interior unreinforced masonry walls were severely damaged throughout the building (see Figure 4-1). Debris from infill walls was a falling hazard (see Figure 4-2), and it most likely caused obstructions for building occupants trying to exit the building. The attachments for non-structural elements such as ceilings, pipes, ducts, and ceiling-supported equipment performed poorly. Major mechanical and medical equipment had been taken out of the building and relocated elsewhere on the hospital complex. Excessive cover (over four inches) was noted in some of the columns.

Figure 4-1. Widespread damage to exterior infill walls (photo: Adrian Tola).

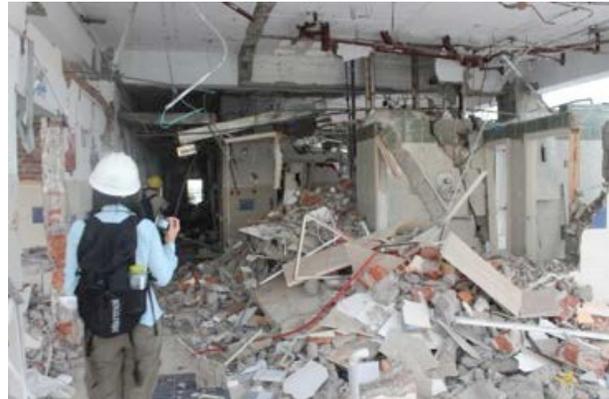
Figure 4-2. Obstructions caused by infill wall material debris (photo: Adrian Tola).

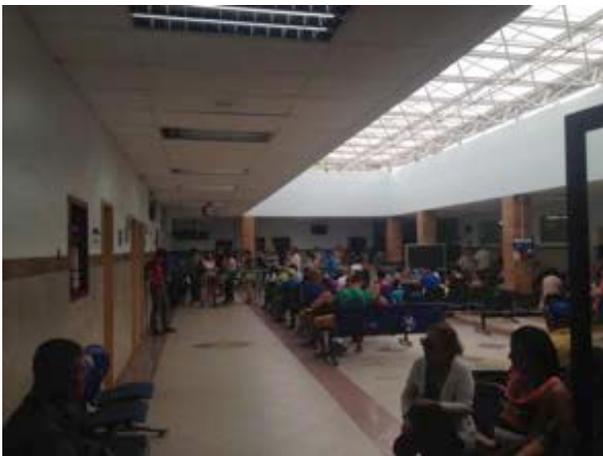
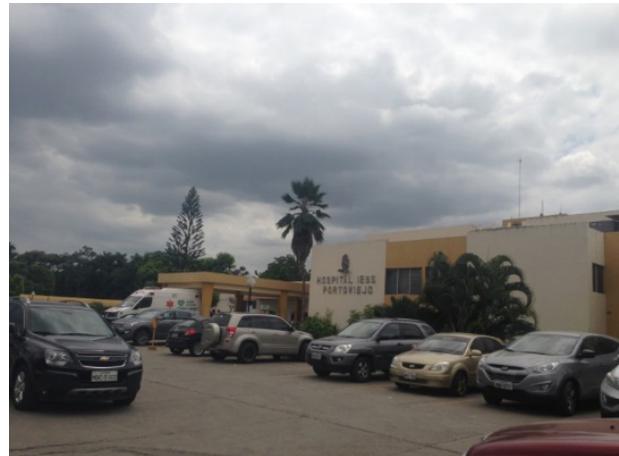
Of the five hospitals visited, the Hospital IESS in Portoviejo (see Figure 4-3, left) had the least amount of damage. The building includes a large segment, one story in height, and a smaller segment three stories in height, and both of them were fully operational at the time of our visit (see Figure 4-3, right). No cracking of walls was observed. Minor damage was seen in the building at a seismic joint on the ground floor (see Figure 4-4). Hospital employees reported that people evacuated the hospital on April 16 for security reasons; however, because of the minor damage, it was re-opened a few days after the earthquake.

Figure 4-3. (Left) No observed damage at the interior of the hospital. (Right) Exterior of the fully operational hospital (photo: Adrian Tola).

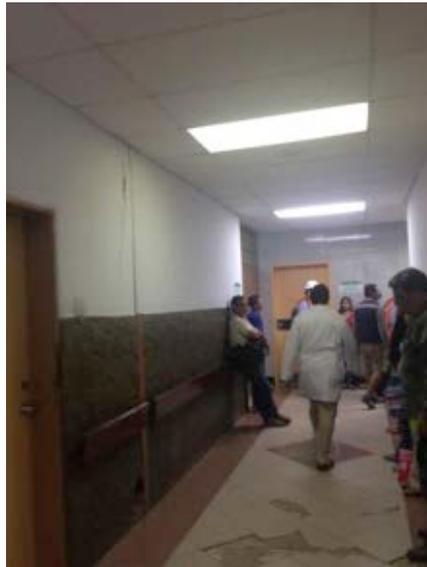
Figure 4-4. Minor damage at ground floor seismic joint (photo: Adrian Tola).

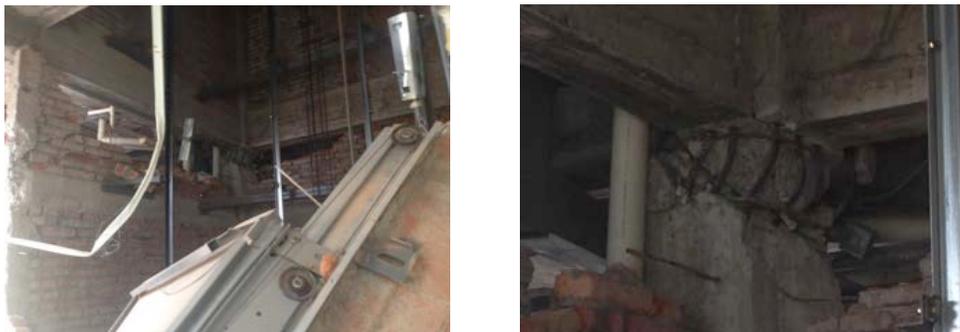
Structural damage was observed in one of the columns on the second floor (see Figure 4-6b). The concrete at the top of this column spalled and the longitudinal bars buckled in this region; also, no cross ties were observed in the top of this column, immediately below the column-beam joint, which caused too far spacing of ties in a critical region of this column.

Figure 4-6. Structural damage in a column on 2nd floor in hospital in SOLCA.

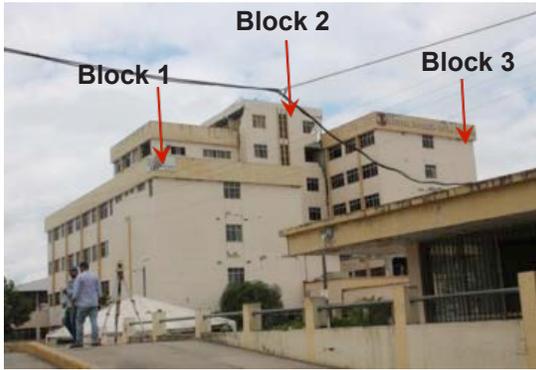
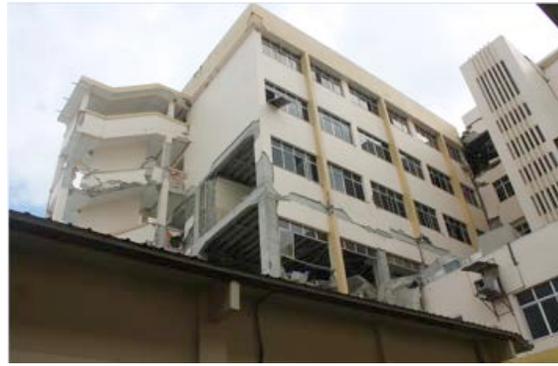
Figure 4-9a emphasizes three structurally independent blocks of particular interest in this hospital, where the observed seismic joint between Blocks 1 and 2, and between Blocks 2 and 3, were approximately two inches in width. There was extensive structural damage at the seismic joints due to pounding of adjacent structures, which illustrates the lack of adequate joint separation between these blocks. The pounding also led to the collapse of unreinforced masonry walls and damage to mechanical equipment in one of the blocks. Significant rebar corrosion at walls, slabs, and beams adjacent to seismic joints was observed.

Figure 4-9a and 4-9b show the front and back view of the hospital with the pounding damage to Blocks 1, 2, and 3. Figure 4-9c shows the debris from collapsed walls in Block 2 at the second floor. Figure 4-7d shows that the upper floor of Block 2 seemed to be out of plumb with the floors below. Block 1 and 3 had significantly less damage to non-structural components, as compared to Block 2.

a) Front view

b) Back view. Damage in Block 2 and Block 3.

Figure 4-9. Damage in Hospital Napoleón Dávila in Chone due to pounding of adjacent buildings (photo: Adrian Tola).

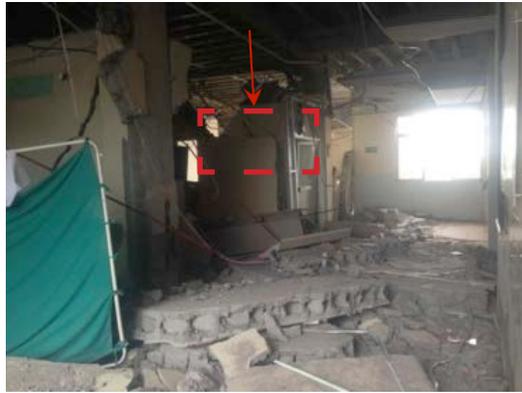
c) Damage at interior of Block 2, floor 2.

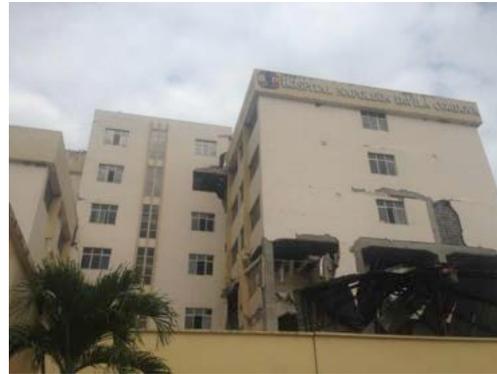
d) Possible out of plumb of upper floor in Block 2.

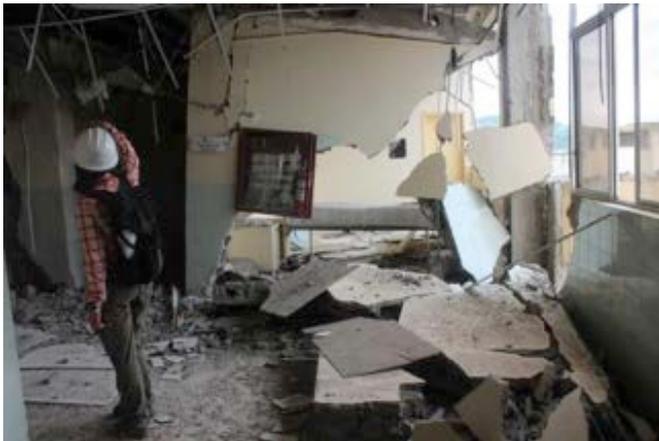
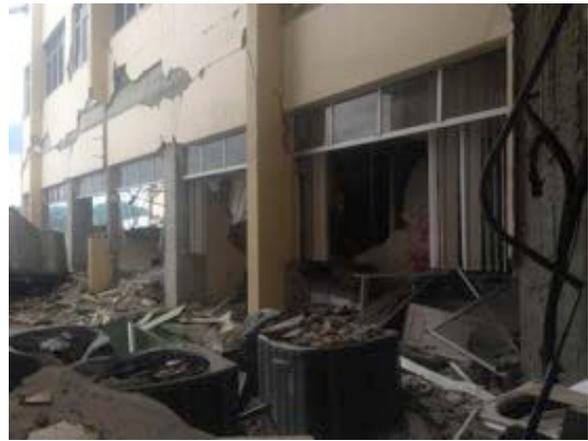
In Block 2, many interior unreinforced masonry partitions collapsed. Cementitious parge coats on the wall surface was quite thick and in some instances it was nearly one-and-a-half inches thick. The excessively thick cement parge was crushed during the April 16 earthquake and spalled in large chunks (see Figure 4-10).

Figure 4-10. Damaged walls inside Block 2 (photo: Adrian Tola).

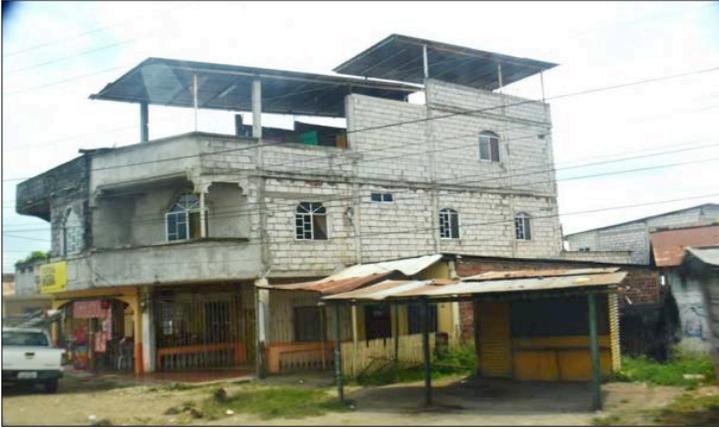
Figure 5-1. Non-engineered block masonry house (photo: Héctor Monzón)

Figure 5-1 is of a house on the Coastal highway, 70 km south of Manta in a low seismic intensity fringe of the April 2016 earthquake. The top stories illustrate the building system as described on the previous page. (The partial height walls appear to be intentional.) Figure 5-2 is another non-engineered construction, probably brick masonry, on the Coastal highway, about 50 km south of Manta. It is unclear whether the top stories incurred severe damage and the debris had already been removed (photograph was taken 25 days after the April 2016 earthquake) or if the construction was yet to be completed, but it clearly illustrates the weaknesses of the building system.

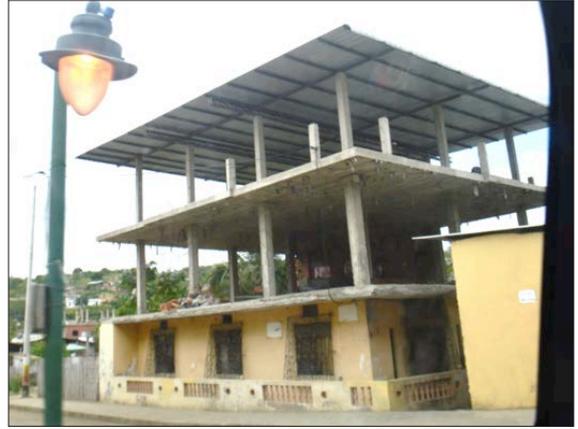
Figure 5-2. Non-engineered construction (photo: Héctor Monzón)

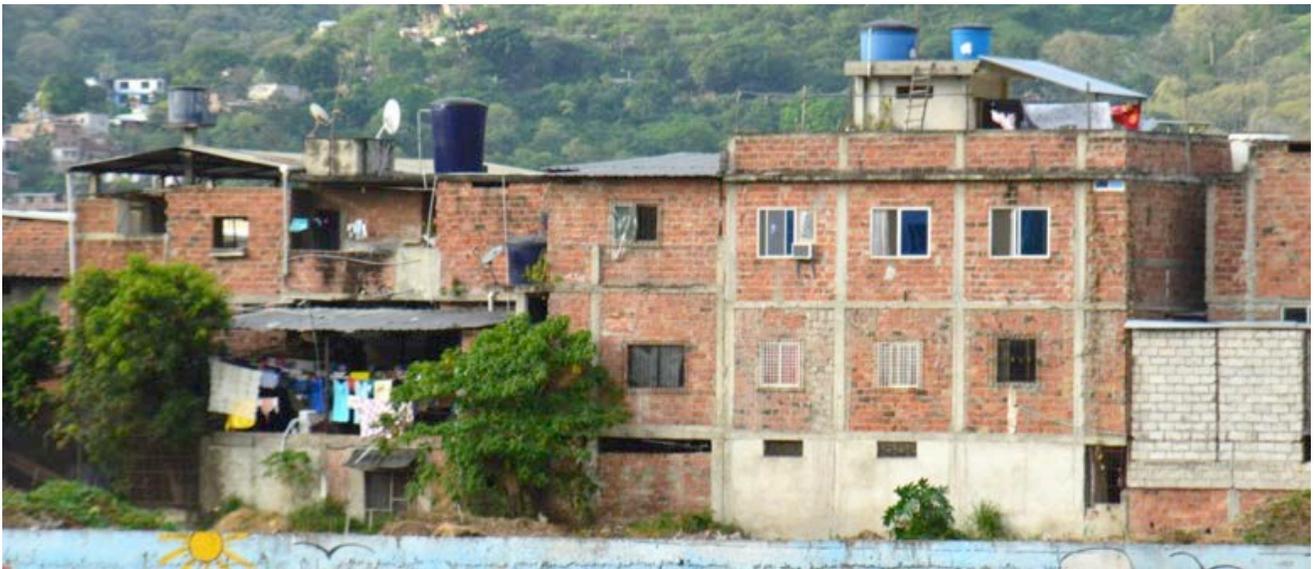
Figure 5-3. Non-engineered construction (photo: Héctor Monzón).

Figure 5-3 is an example of hand compacted brick masonry in downtown Portoviejo—a high seismic intensity area during the April 2016 earthquake. Only minor damage was observed in some units such as the one at the right of the photo. However, wall panels collapsed in the unit at the left. Such random performances were often observed.

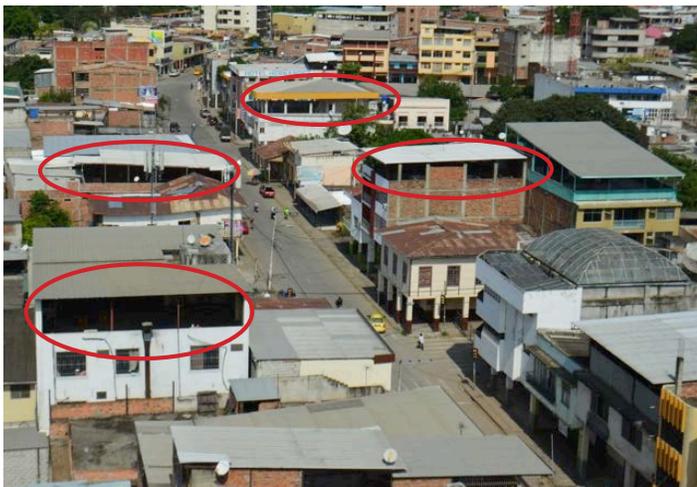
Figure 5-4. Masonry construction near downtown Portoviejo (photo: Héctor Monzón).

While there weren't many collapsed units, Figure 5-4 shows many collapsed walls in the upper stories of buildings near downtown Portoviejo. Figure 5-14 shows severe damage to non-engineered construction in a small town north of Bahía called Canoa. In the high intensity shaking area, there were about 30 % collapses—judging from empty plots. In Figure 5-5, all debris from the upper story in the dwellings shown above has been removed.

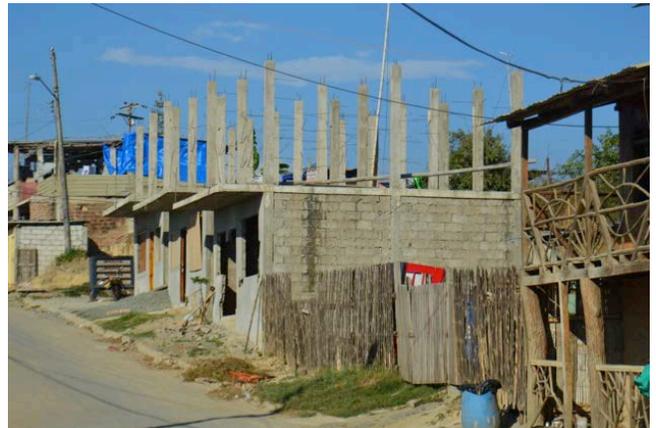
Figure 5.5. Severe damage to non-engineered construction in Canoa (photo: Héctor Monzón).

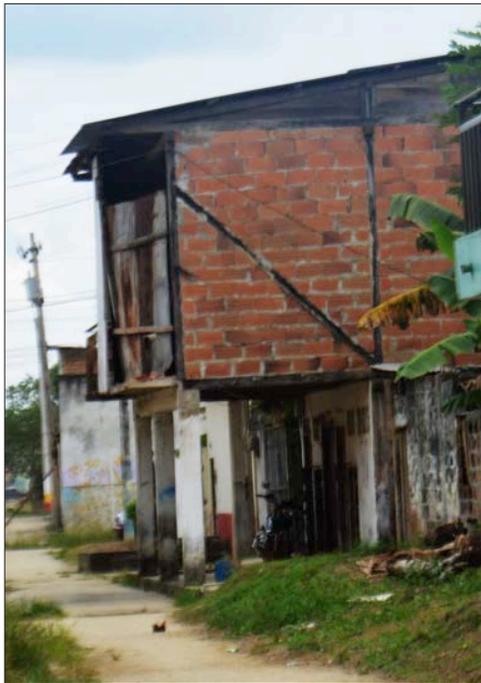
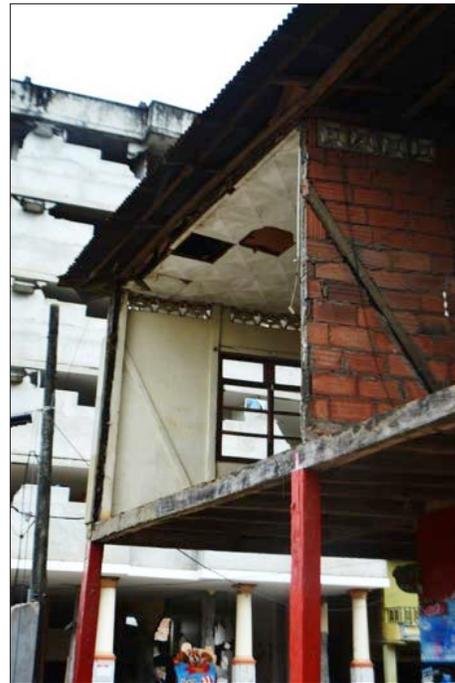
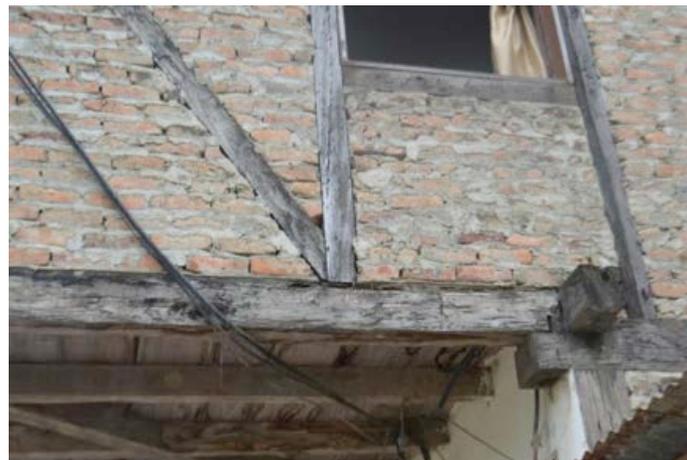
Figure 5-6. An older construction system of combined wood and masonry (photos Héctor Monzón).

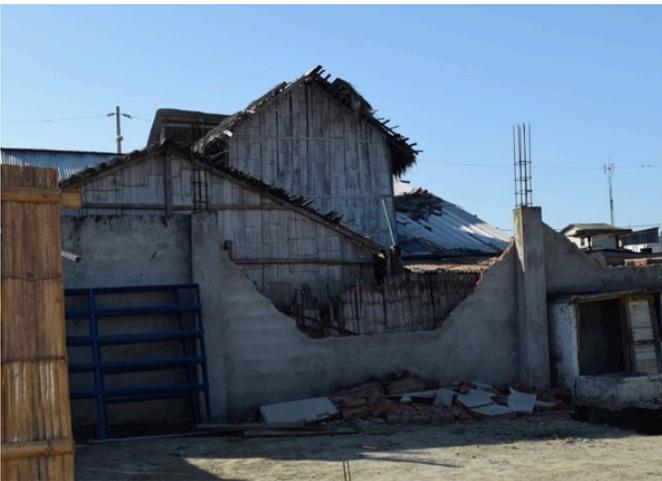
Figure 5-7 shows a two-story unplastered bamboo wall in the back of a building housing a restaurant and bar in the beachside town of Canoa. The front of the building was damaged from inadequate out-of-plane support of the streetside wall (Figure 5-8), but the back wall performed well. Traditional bahareque is more common in rural areas of coastal Ecuador. In urban areas, the mud and straw are often replaced with clay brick, and bamboo is often replaced by timber. Figure 5-9 shows a building in the historic sector of downtown Bahía de Caráquez that is made of mixed construction including timber-framed walls with wood laths, and plaster along the street façade. The building

Figure 5-7. Unplastered bamboo wall in Canoa (photo: Arturo E. Schultz).

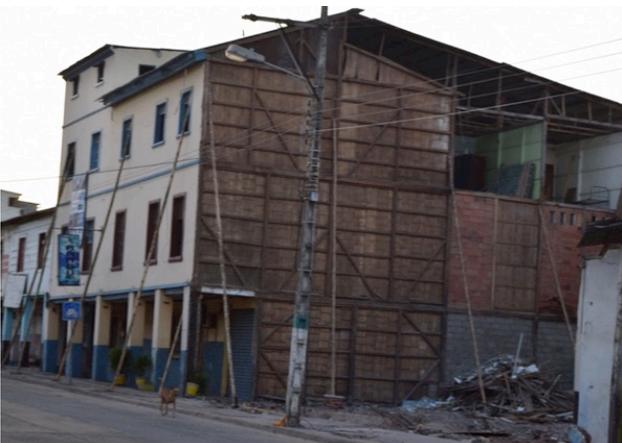
Figure 5-9. Timber framed building in Bahía de Caráquez with damaged party wall (photo: Arturo E. Schultz).

has been shored, but most of the damage is concentrated around the masonry infill panels in the party wall with the collapsed building in the foreground. Figure 5-10 shows the bottom of the overhang above the streetside colonnade in a building in the Tarqui district of Manta. The building is of mixed construction, including timber beams and posts encased in brick (Figure 5-11) and plastered bamboo laths, but these components have been covered by plaster and textured in the second floor to simulate block masonry construction. Unfortunately, the timber members (Figure 5-4) and bamboo laths (Figure 5-12) are heavily deteriorated in many locations.

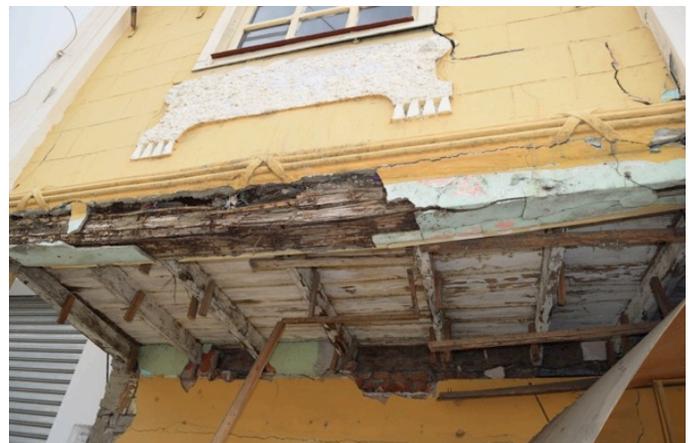
Figure 5-10. Timber and bahareque building in Tarqui district of Manta (photo: Arturo E. Schultz).

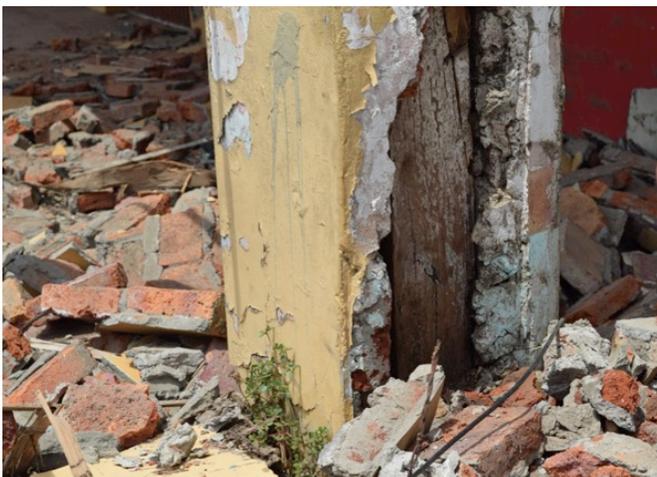
Figure 5-11. Timber post encased in brick masonry and plaster (photo: Arturo E. Schultz).

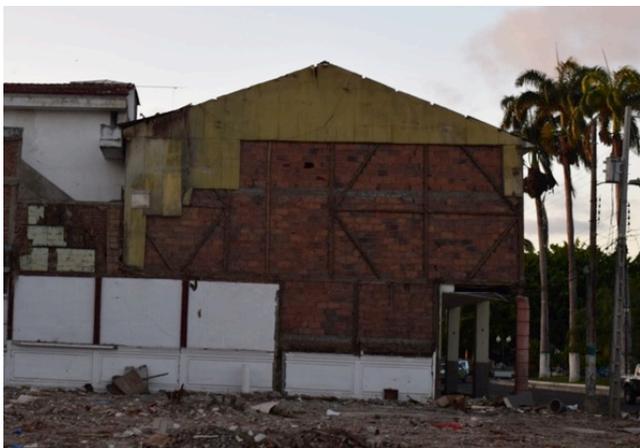
Another variant of traditional, non-engineered construction in Ecuador uses clay brick infill instead of plastered laths in timber frames given the greater durability of clay masonry (Figure 5-13). In this construction system, it is common to include inclined timber members in addition to the vertical and horizontal posts for greater strength and stability. The bricks are placed as “rowlock stretchers or shiners” to minimize wall thickness. Exposed façades, especially along streets, are typically plastered (Figure 5-14). Performance of this system is often better than that of the non-engineered concrete frames with brick infill because the timber provides more ductile member behavior, and the smaller brick panels are better restrained. In fact, Saraf et al. (2012) studied an Indian version of this building system and have quantified the influence of brick panels and timber member lengths on the in-plane shear strength of the walls. However, the improvement, if any, provided by the inclined timber posts on out-of-plane strength and stability is not known.

Figure 5-13. Brick-infilled timber frame construction (photo: Arturo E. Schultz).

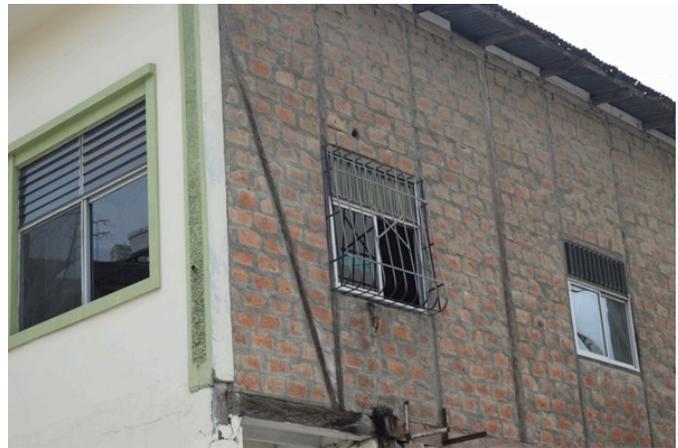
Figure 5-14. Plaster over brick-infilled timber frame construction (photo: Arturo E. Schultz).

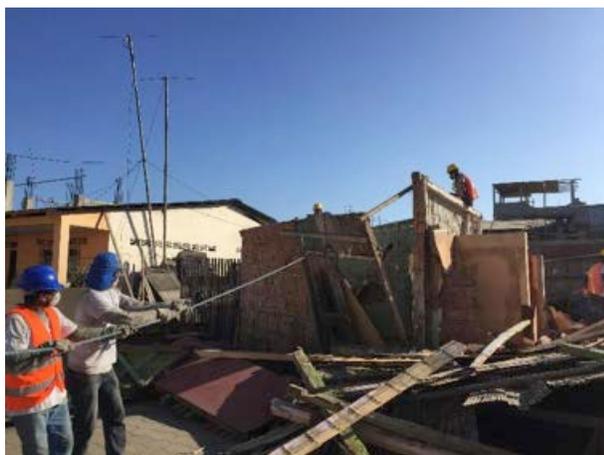
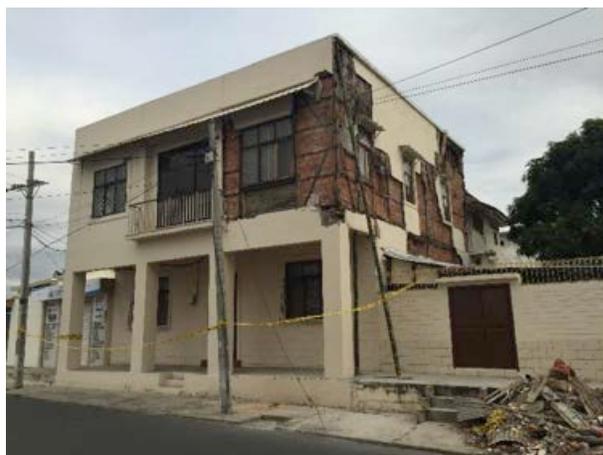
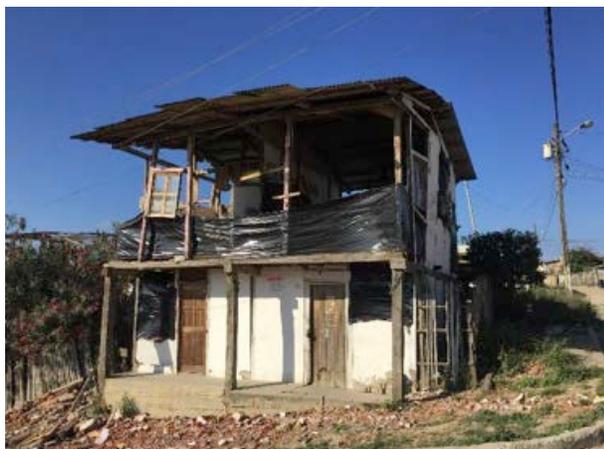
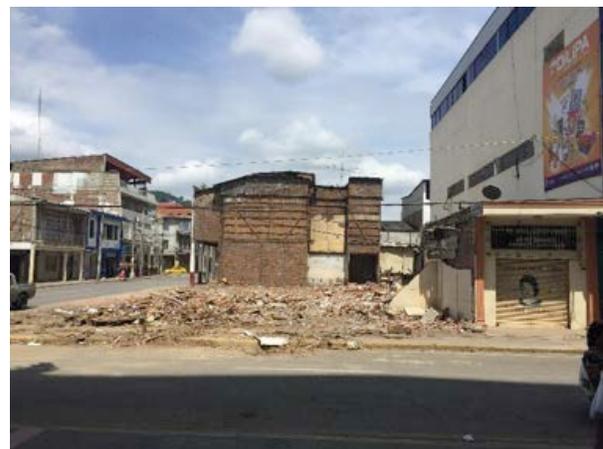
Other houses were constructed of concrete frames with masonry infill with wood elements. These elements are embedded in the masonry walls and are not part of the lateral force resisting system. This typology had a regular performance in this earthquake. Collapsed or heavily damaged houses of this type were not found, but rather showed spalling of concrete finishing (see pictures on the following pages).

Figure 5-15. Houses with spalling concrete finishing.

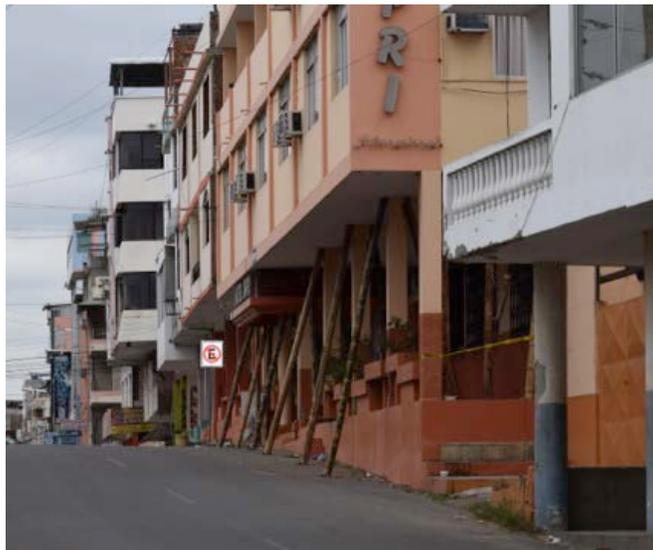
Figure 6-6. Hotel Capri in the Tarqui district of Manta (photo: Arturo Schultz)

Figure 6-6 shows the façade of Hotel Capri along 105th Steet near the waterfront in the Tarqui district of Manta (Malecón de Tarqui). This district is a destination for local tourism and offers hotels, restaurants, and other tourism-related business, especially along the streets closest to the Malecón. The Hotel Capri, like many buildings of its period, includes a street-side walkway with a cantilever overhang to maximize interior space in the stories above the first. Due to concerns about the stability of the cantilever overhang, the street-side façade was shored using bamboo posts following the April 16, 2016 earthquake. The aspect ratio ( $L/t$ ) for these shores clearly exceeds the recommended limit of 17.5, as well as the upper limit of 35. Additionally, the bamboo posts do not have headers, soles, or lateral braces to create a complete and stable shoring system.

The configuration of bamboo shores shown in Figure 6-6 was observed throughout the region affected by the April 16 earthquake. Figure 6-7 shows the Chavez Hotel Inn near the intersection of 106th Street and 106th Avenue, also in the Tarqui district of Manta. Individual bamboo posts are used to shore the cantilever overhang, but in this case, the posts span a two-story height, making their aspect ratio considerably larger than the suggested limits. Headers, soles, and lateral braces are not present either. Figure 6-8 shows a close-up of the detail between the top of the bamboo posts and the cantilever overhang in the Chavez Hotel Inn. The tops of the posts have been cut into a notch to enhance restraint by locking onto the edge of the building.

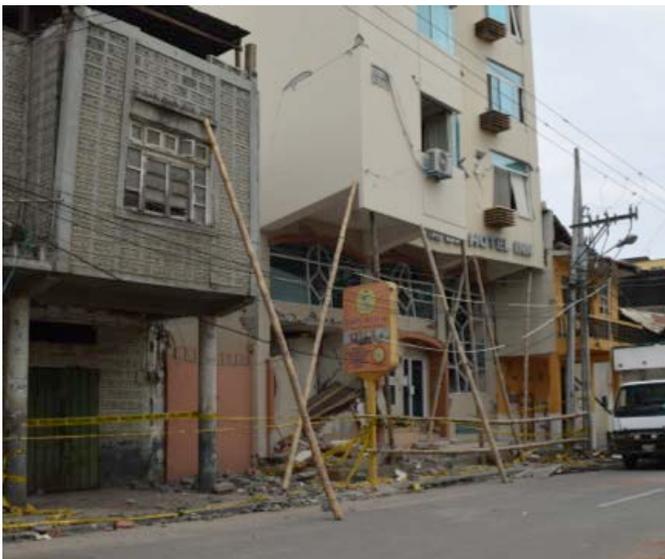
Figure 6-7. Chavez Hotel Inn in the Tarqui district of Manta (photo: Arturo Schultz)

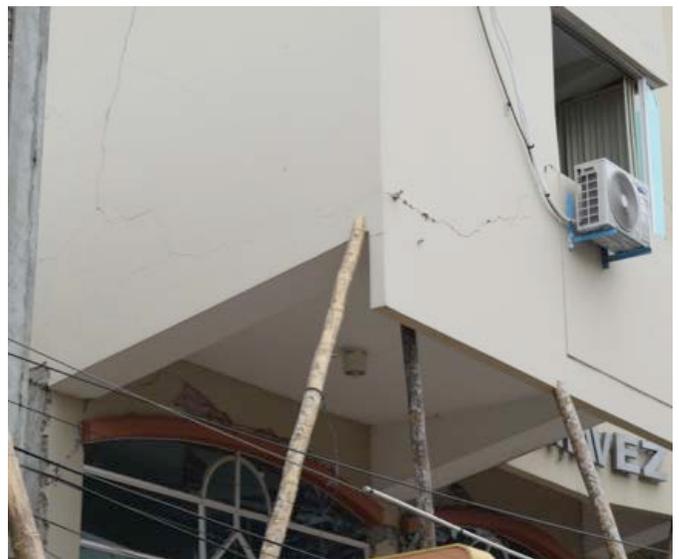
Figure 6-8. Close-up of bamboo shores used for the Chavez Hotel Inn (photo: Arturo Schultz)

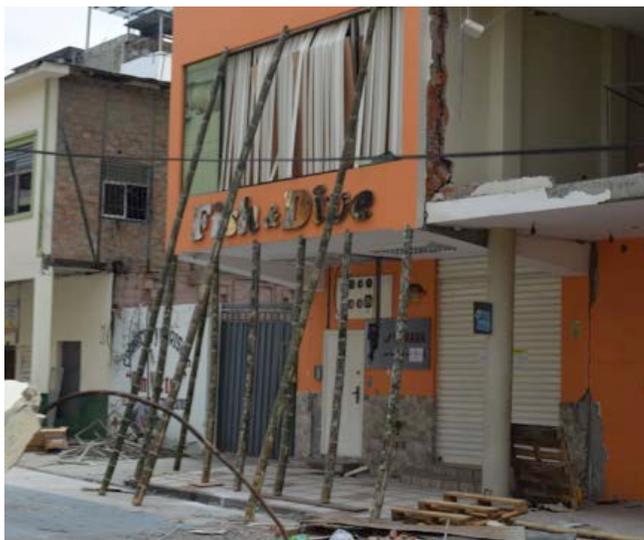
Figure 6-9. Fish & Dive store in the Tarqui district of Manta (photo: Arturo Schultz)

The Fish and Dive sport store (See Figure 6-9) catered to the water sporting needs of Tarqui tourists and was located on 105th Street near the intersection with and 106th Avenue in Manta. The cantilever overhang was shored using the common method relying on bamboo posts. Some of the shorter posts, which support the bottom of the overhang, appear to have developed curvature under load. The longer posts, which support the top of the window openings, do not exhibit such curvature.

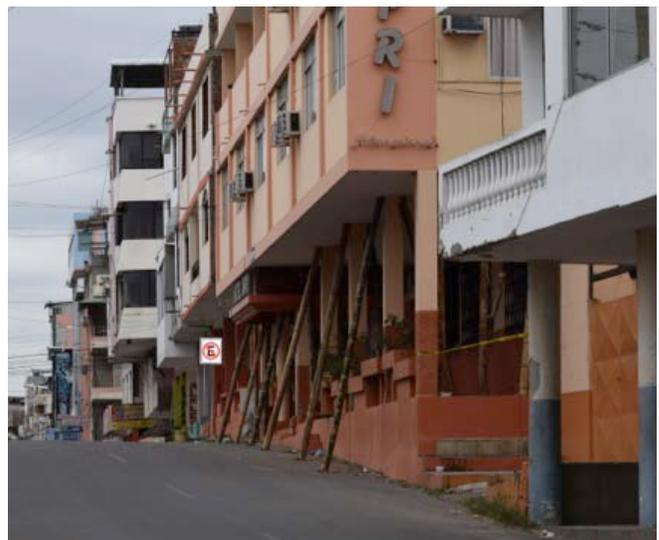
Figure 6-10. Hotel New York in Portoviejo (photo: Arturo Schultz)

The 3-story RC building (See figure 6-10) was located in the Francisco de P. Moreira Street near the intersection with Olmedo Avenue and near the Eloy Alfaro Park. The building was damaged heavily during the April 16 event, and was subsequently shored to prevent collapse of the cantilever overhang. Steel pipes were used to shore the building, but the shores buckled and became ineffective. The pipes appear to be excessively slender given the lack of lateral braces between pipes, and the connections between pipe segments do not appear to be sufficiently robust to ensure flexural continuity between connected pipes. This was the only shoring failure observed by the EERI team.

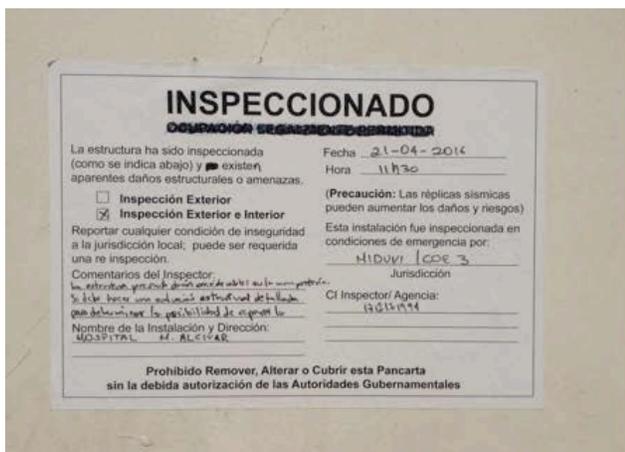
In some cases, placards were issued not necessarily to limit or restrict access to buildings, but to apparently inform the owner about the damages and future actions. In other cases, the placard associated with a GREEN tag was used as a general form. Figure 7-1 shows an INSPECTED (green) tag adapted as a RESTRICTED USE (yellow) tag in the main hospital of Bahía de Caráquez. This placard had no color and no information on the restrictions, further reducing the effectiveness of the placard. The ATC-20 procedures establish that restrictions should be displayed on the placard to inform occupants of the hazardous conditions in the building.

Figure 7-1. An INSPECTED placard used as a RESTRICTED USE placard. No information on the restrictions is indicated (photo: Alberto Monzo).

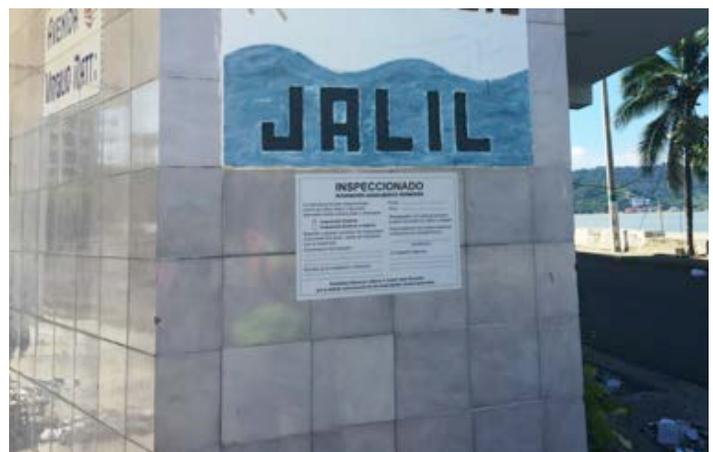
Some cases showed that the placards were placed at locations other than entrances, which could lead to confusion. Figure 7-2 depicts a case where the placard was posted on a wall that was not visible from the main entrance. At the time of the team's visit, other residential buildings in Bahía de Caráquez had not been evaluated since placards were not found, even though they suffered damage from the earthquake. Figure 7-3 shows a case where a placard is missing.

Figure 7-2. Placard posted on an inconvenient place Bahía de Caráquez (photo: Ana Gabriela Haro).

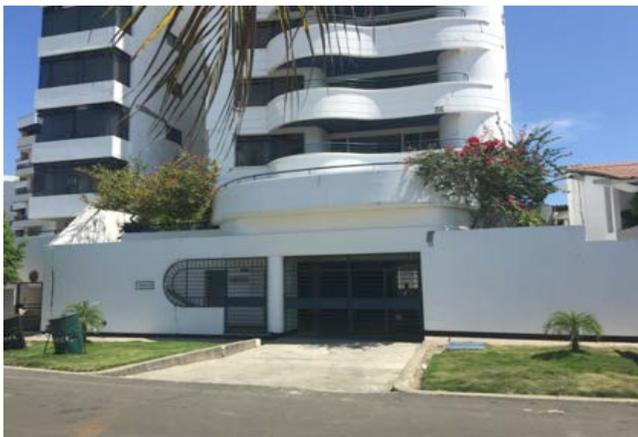
Figure 7-3. Missing placard in a residential building in Bahía de Caráquez (photo: Ana Gabriela Haro).

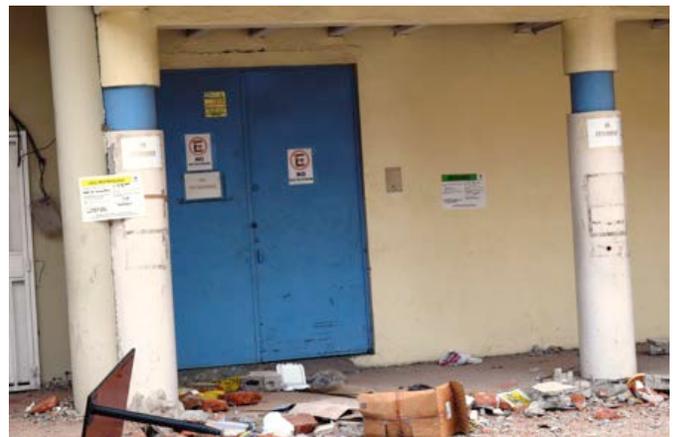
In Manta, two buildings shared a RESTRICTED USE (yellow) placard as shown in Figure 7-4. It can be observed that the structure on the right hand was also posted with an INSPECTED (green) placard, which could lead to ambiguity.

Figure 7-4. Structures sharing a RESTRICTED USE (yellow) placard in Manta (photo: Arturo Achultz).

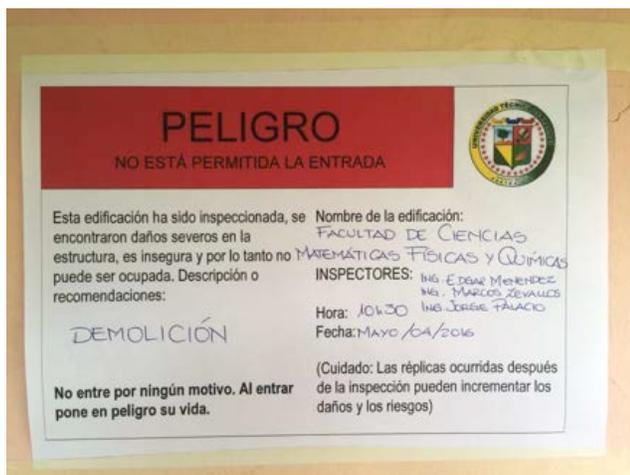
In Portoviejo, a “Demolition” recommendation was found in a reinforced concrete building tagged with an UNSAFE (red) placard. What was suggested in the placard presented in Figure 7-5, exceeds the purpose of the rapid assessment procedures established in the ATC-20. Since ATC-20 was based on very limited visual information, and except in very obvious cases, we do not agree that it should be used to inform building owners on further actions. Certain repairable buildings appear to have been demolished when they could have been repaired. Figure 7-6 depicts a case in the same city where a building had an INSPECTED (green) placard. It was noticed that it is not indicated if an external or internal inspection was carried on.

Figure 7-5. “Demolition” suggested on a RED placard used in an RC building in Portoviejo (photo: Alberto Mozon).
