# EERI Earthquake Reconnaissance Team Report: M7.8 Muisne, Ecuador Earthquake on April 16, 2016

Forrest Lanning, Ana Gabriela Haro, Mei Kuen Liu, Alberto Monzón,  
Héctor Monzón-Despang, Arturo Schultz, Adrian Tola

October 2016

*A product of the EERI Learning From Earthquakes Program*

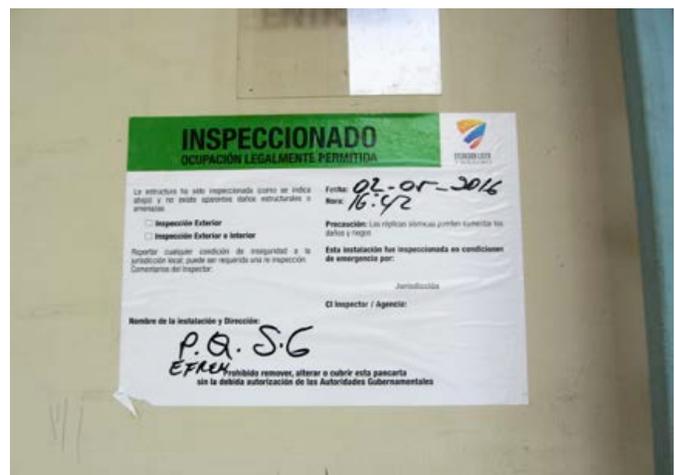
Figure 7-6. INSPECTED (green) tag on a building in Portoviejo where the type of evaluation was not established (photo: Mei Liu).

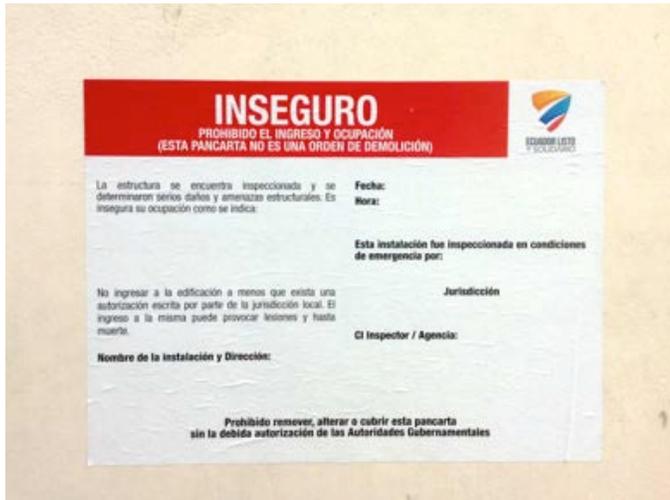
The main hospital in Chone was tagged with a blank UNSAFE (red) placard (Figure 7-7). In some cases tenants did not follow the placards. Figure 7-8 shows a shop in Calceta that was still open despite the building was posted with a RESTRICTED USE (yellow) tag. In Chone, we noted multiple cases where the UNSAFE (red) placard, which implied “unsafe for occupancy or entry, except as authorized by the local building department,” was not respected in residential buildings.

Figure 7-7. Unfilled UNSAFE (red) placard in Chone (photo: Alberto Monzon).

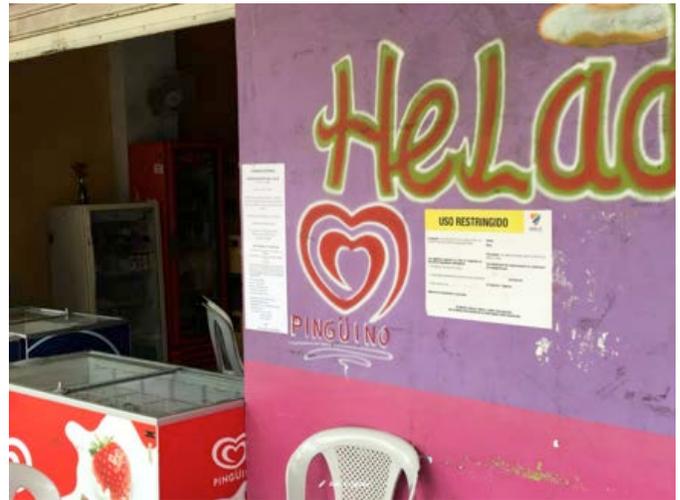
Figure 7-8. RESTRICTED USE (yellow) placard in a shop still open in Calceta (photo: Forrest Lanning).

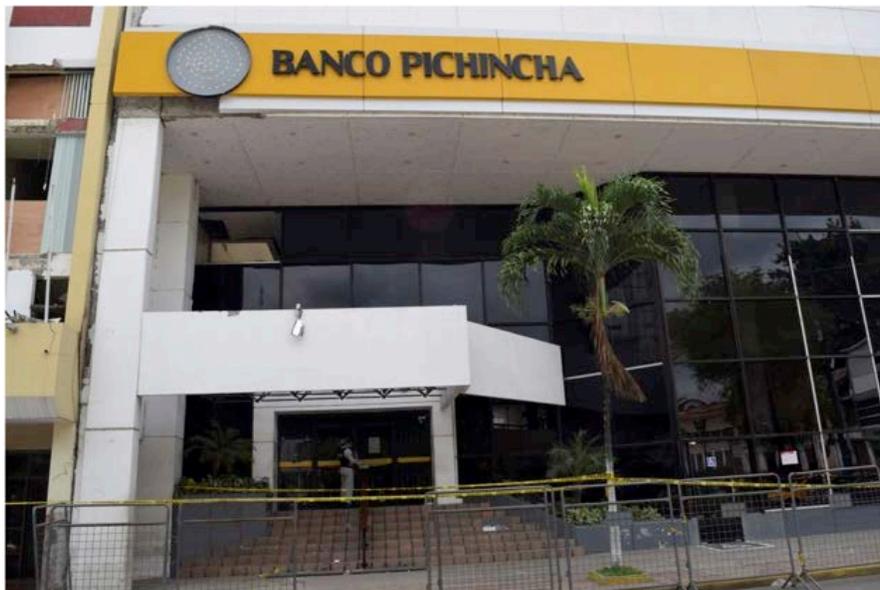
Figure 7-9. Portoviejo branch of Banco de Pichincha (photo: Arturo Schultz)

The Portoviejo branch of Banco Pichincha was located downtown on Olmedo Avenue near the intersection with Simón Bolívar Street (Figure 7-9). The four-story reinforced concrete building with unreinforced concrete block infill appears to be 30–40 years old, has a large atrium with staircases supported on cantilever overhangs, and a cantilever balcony along Olmedo Avenue. Heavy damage in non-structural components was observed, but the only structural damage was cracking along the supports for the stairs (Figure 7-10) and the street-side balcony. An UNSAFE (red) placard, visible in the lower right of Figure 7-10, is likely due to concern with potential collapse of these cantilever structures. The concern is commensurate with the hazard, but the structural damage is easily repairable. It is unclear if the building will be demolished, but the bank branch has been moved to a building at another location.

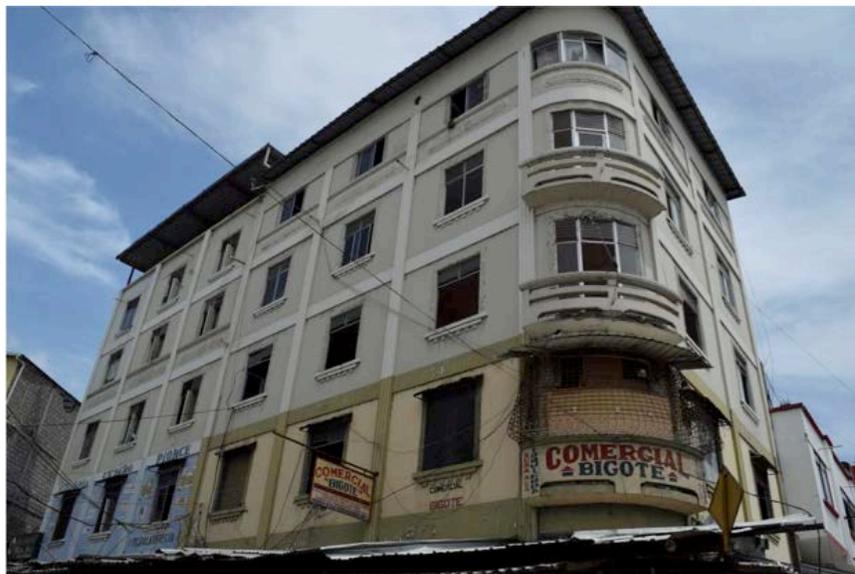
The Comercial Bigote Building is located on 109th Avenue and 103rd Street in the Tarqui district of Manta (Figure 7-11). The five-story reinforced concrete frame building with unreinforced concrete block infill appears to be well over fifty years old and harkens back to an Art Deco period. The building has a street-side colonnade supporting the overhanging floor in stories above the first. The building also features balconies on the corner of the two street-side façades. Earthquake damage was observed to infills, but not to the frame members.

Figure 7-11. 'Comercial Bigote' Building in Tarqui district of Manta (photo: Arturo Schultz)

Damage to the first floor balcony poses a falling debris hazard, and the main entry of the building is compromised. This hazard earned it an UNSAFE (red) placard, and the concern is commensurate with hazard. However, the building is repairable, misinterpretation/misuse of the placard could result in the demolition of an architecturally important building in a historic sector of Manta.
